# **Effects of the Earthquake and Tsunami on the Fukushima Daiichi and Daini Nuclear Power Stations**

May 24, 2011

Tokyo Electric Power Company

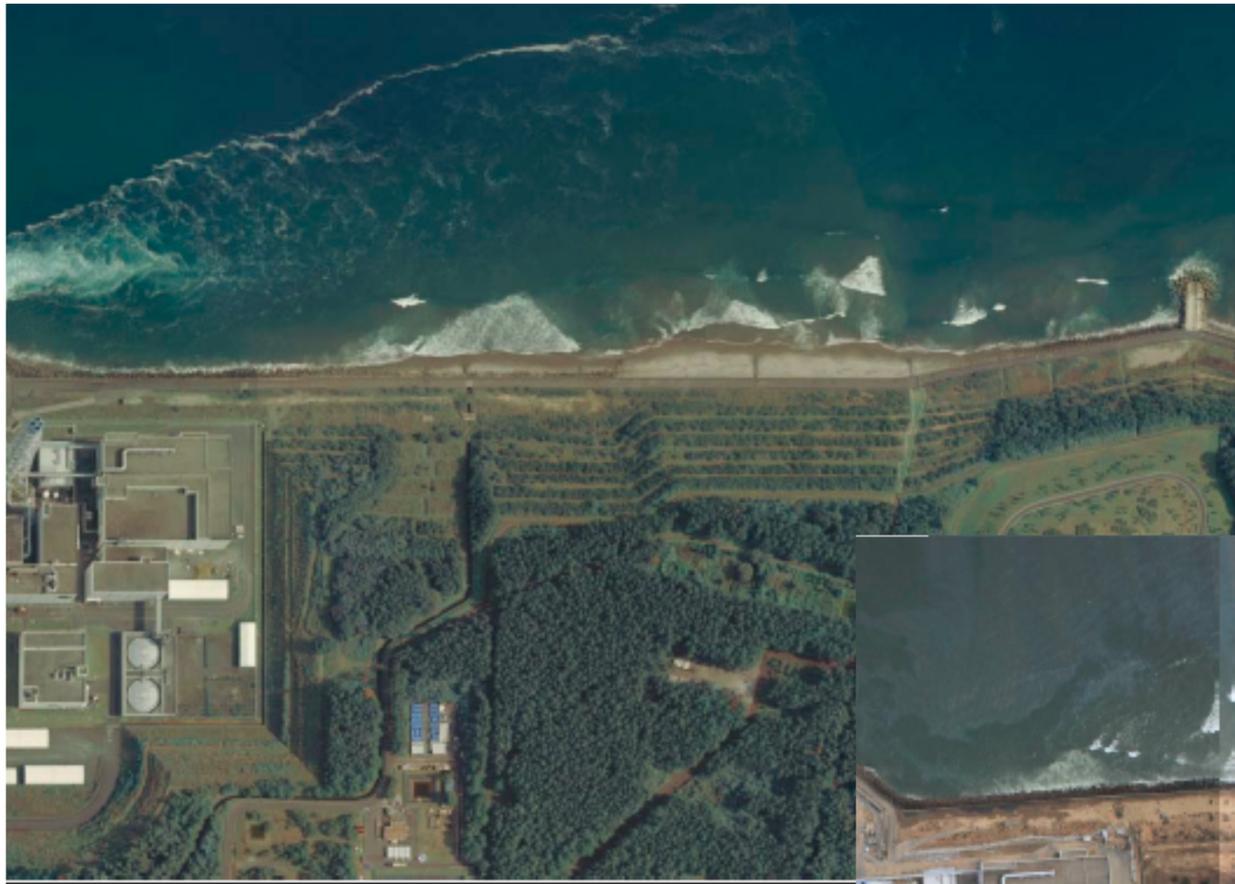
**Trees were stripped away**

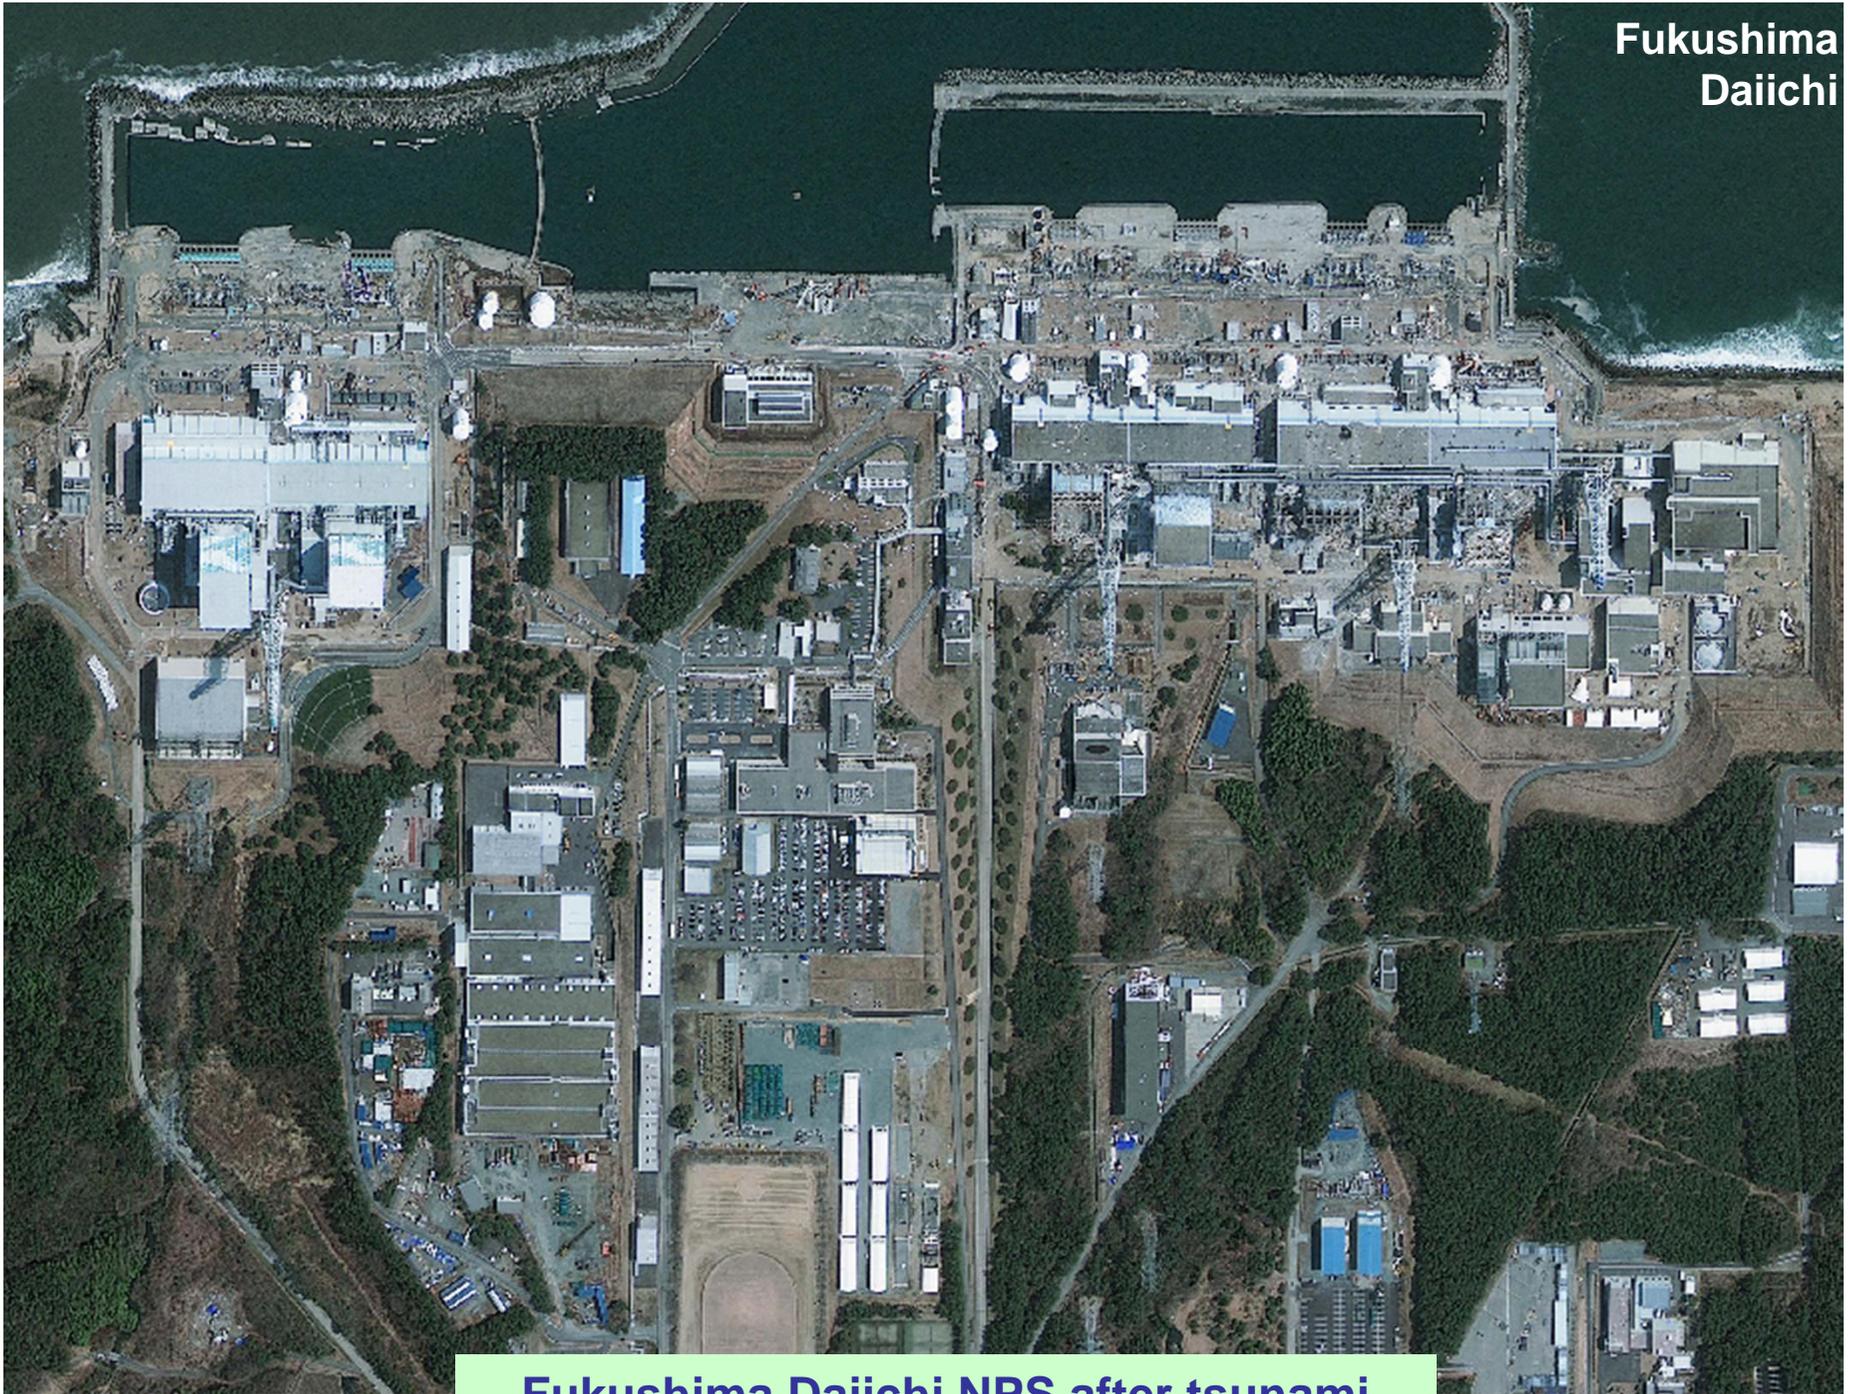
Fukushima Daiichi NPS after tsunami

Almost whole area was flooded

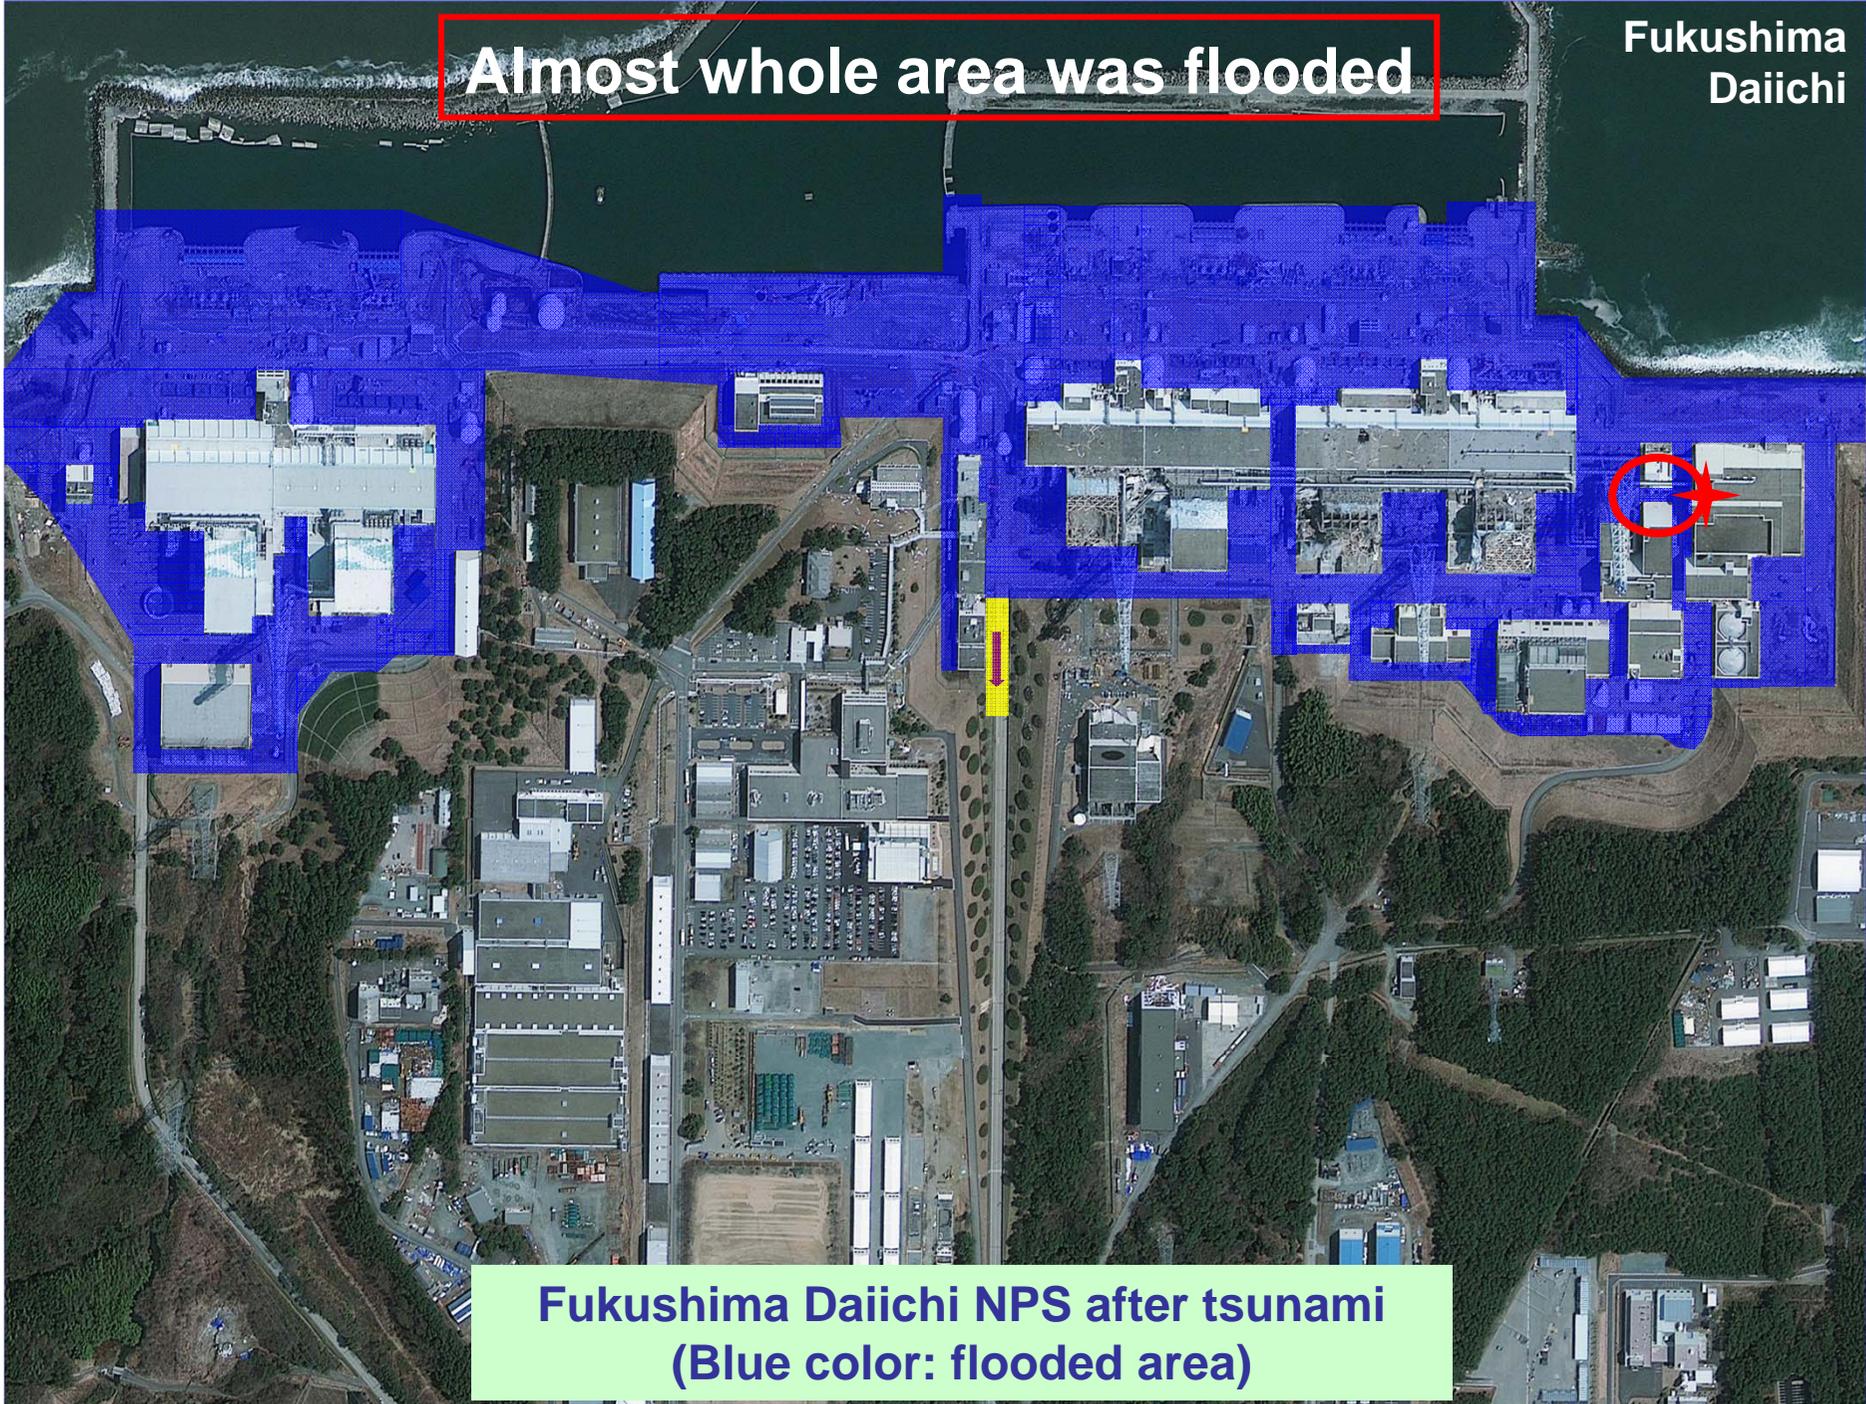
Fukushima Daiichi NPS after tsunami  
(Blue color: flooded area)

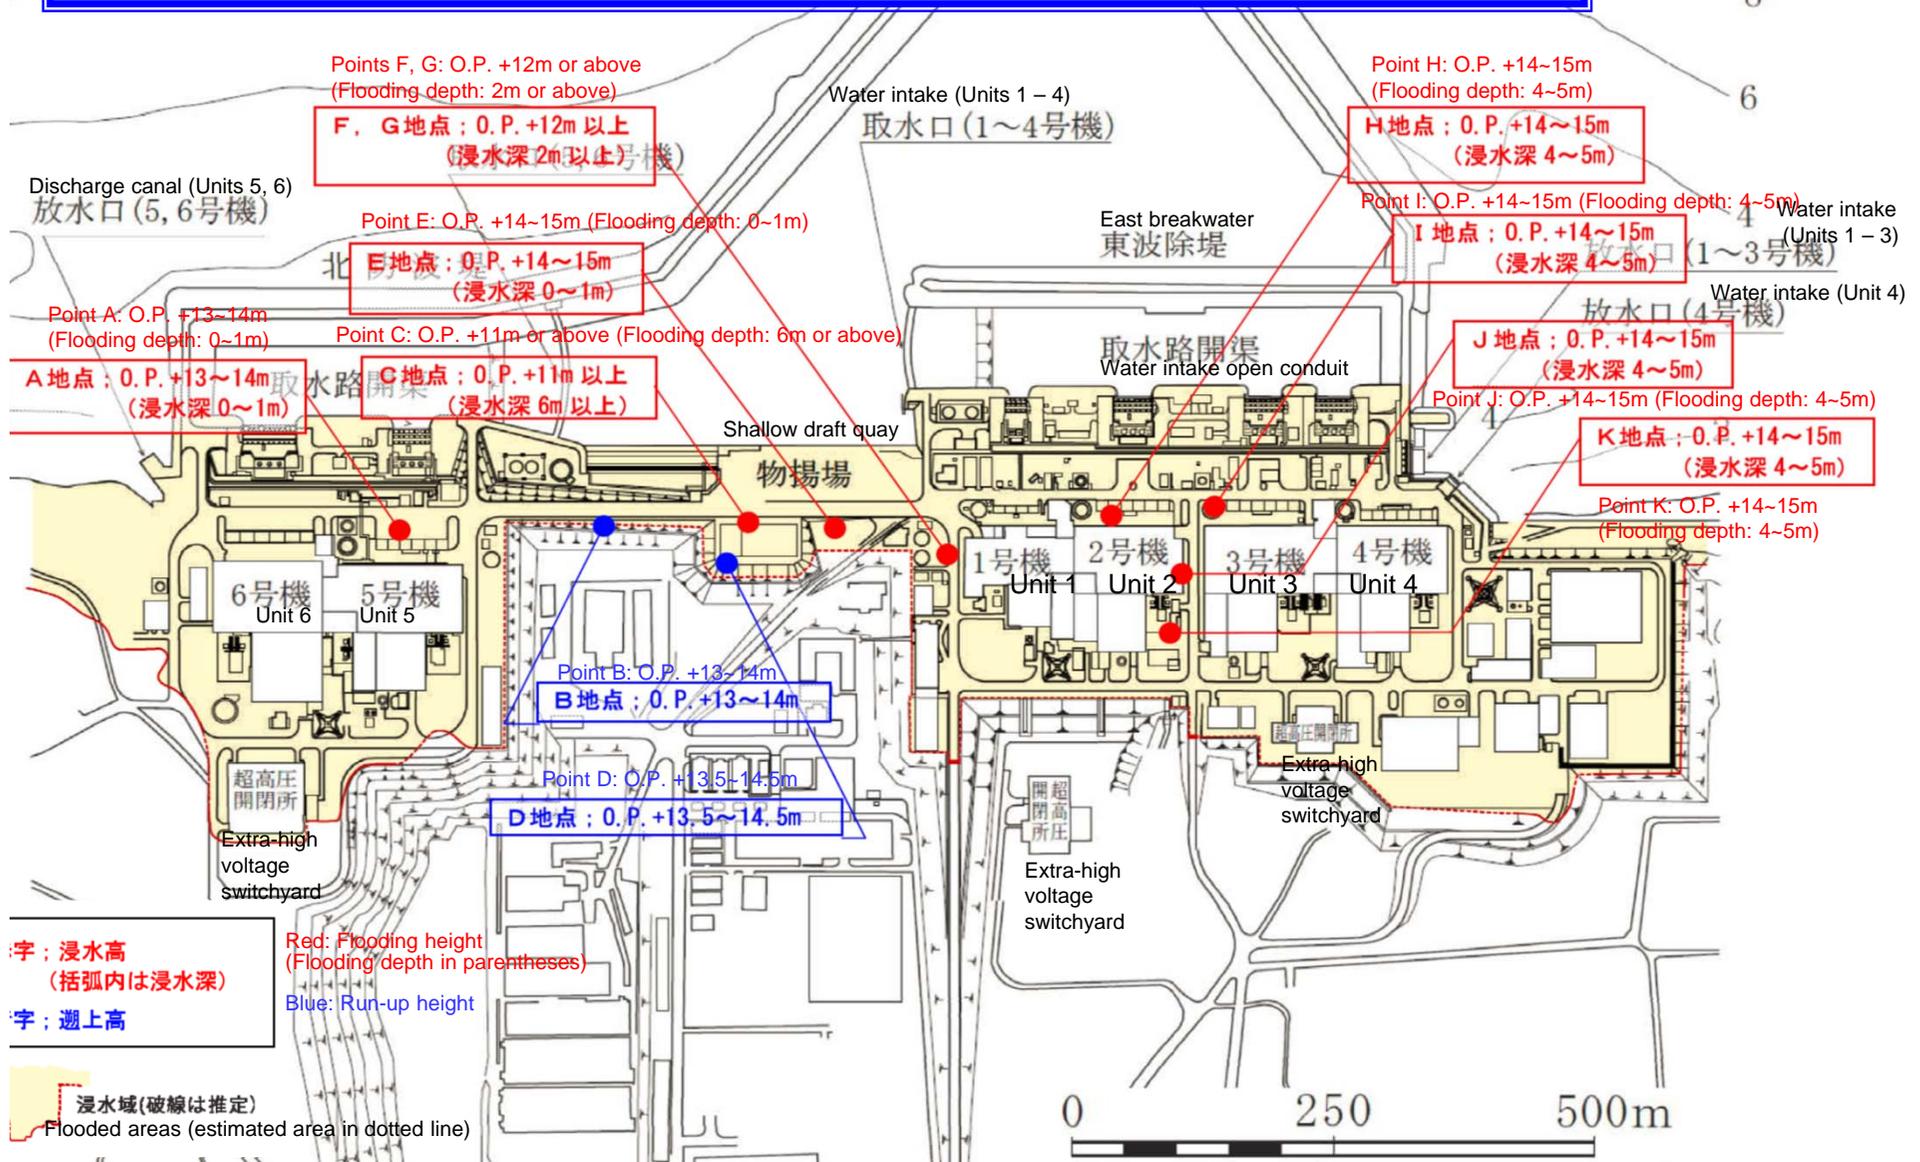
# A tsunami about 14m high swept over the entire site of Fukushima Daiichi, with flood waters reaching depths of 4 to 5m

**Fukushima Daiichi Nuclear Power Station Flooding height and depth, etc.**  
 (Further investigations are currently underway)

Assumed highest tsunami water level  
O.P. +5.7m

Inundation height  
apx. O.P. +14-15m

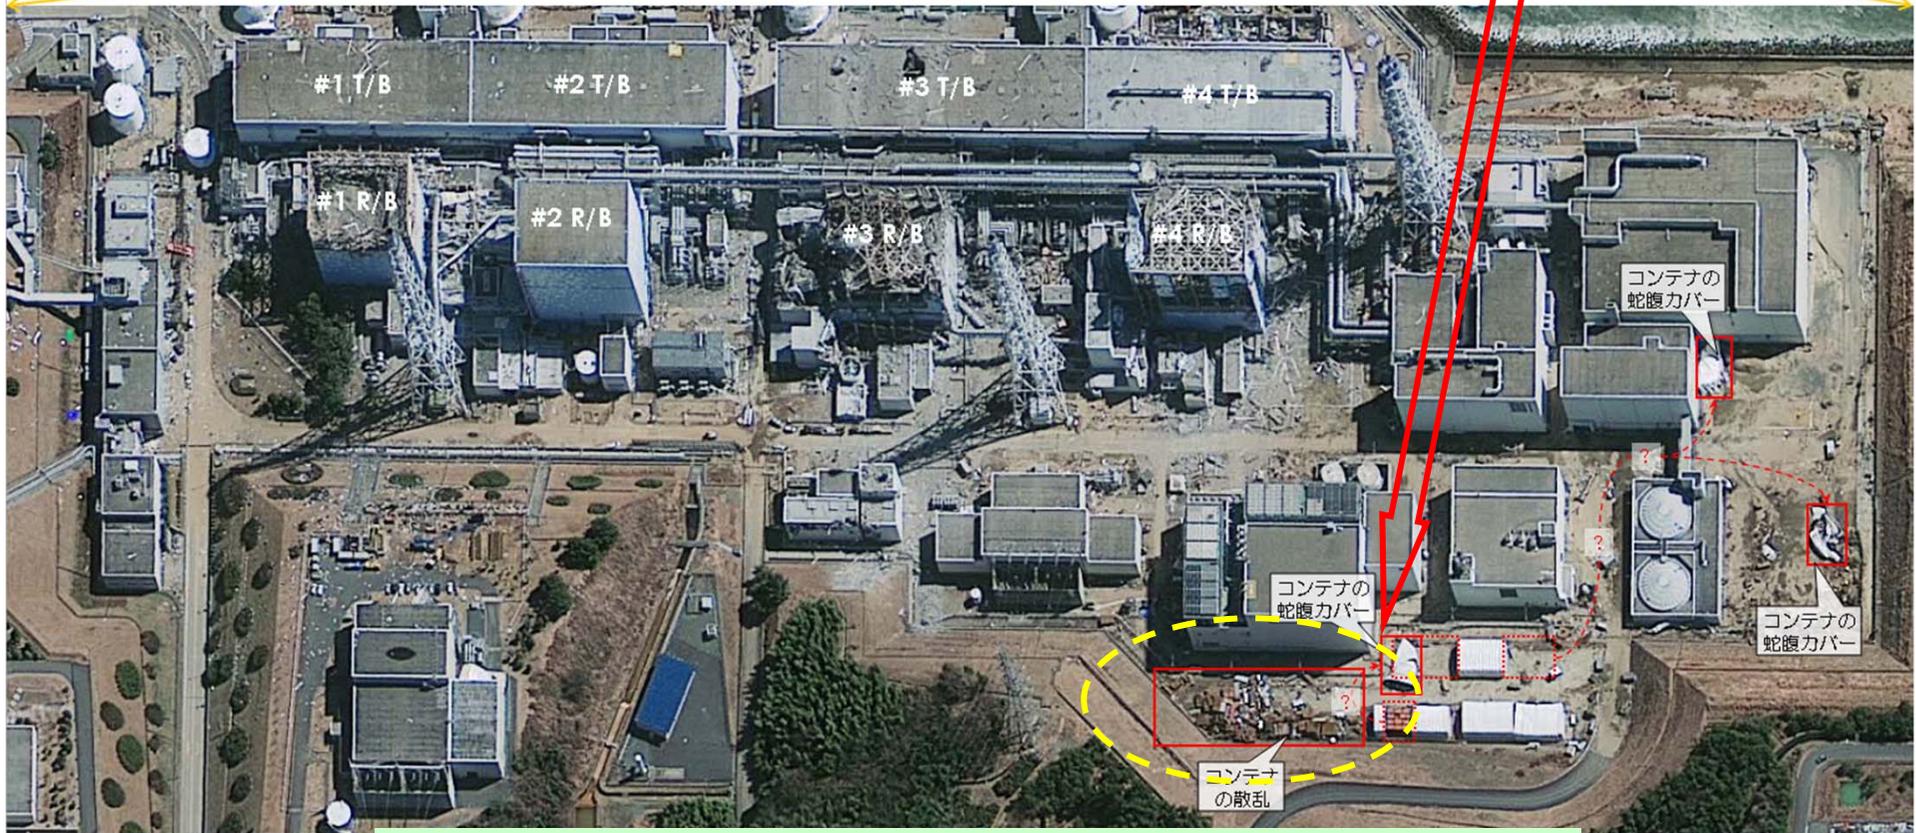
Area away from the coast was also flooded

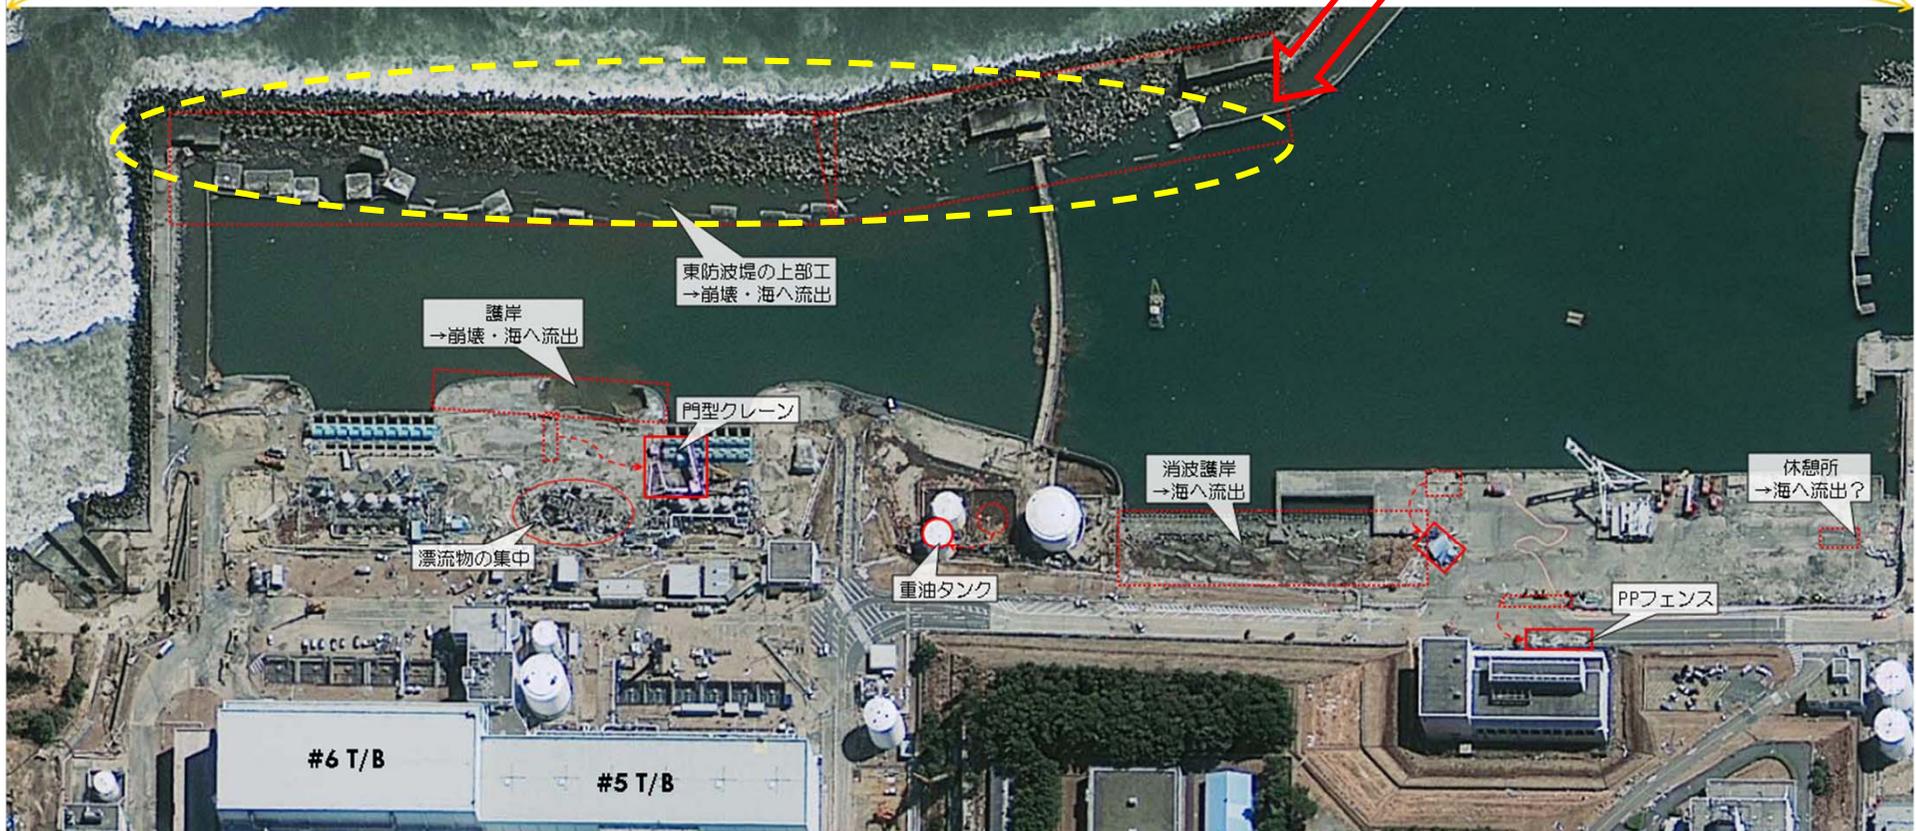
Breakwater was corrupted

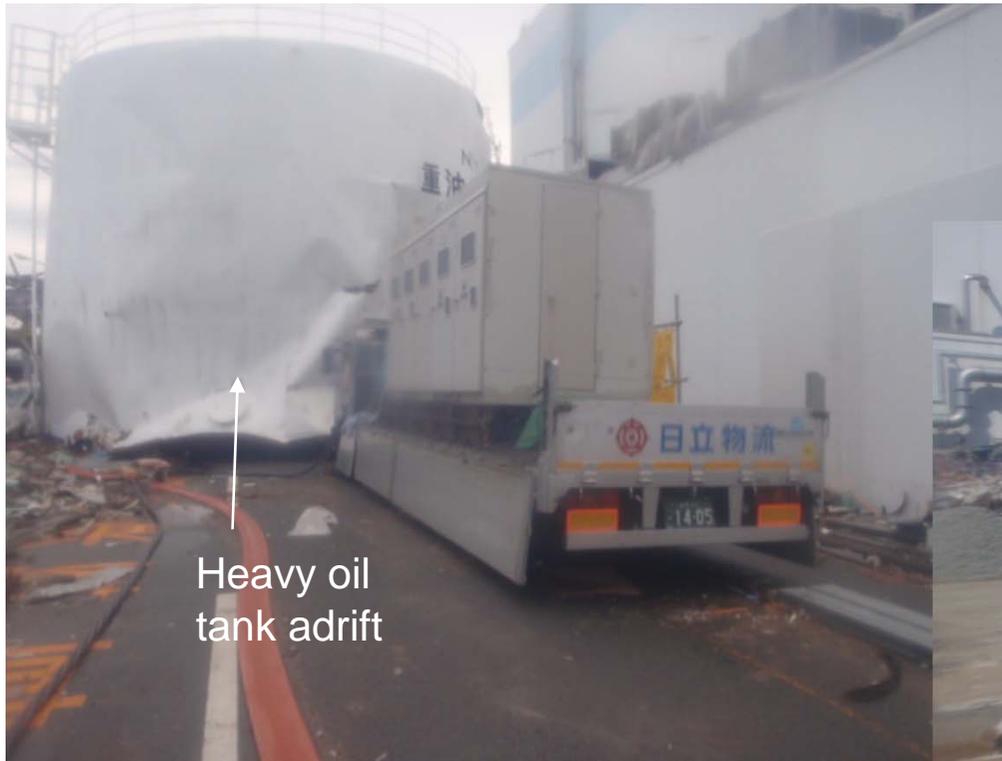
Heavy oil tank adrift

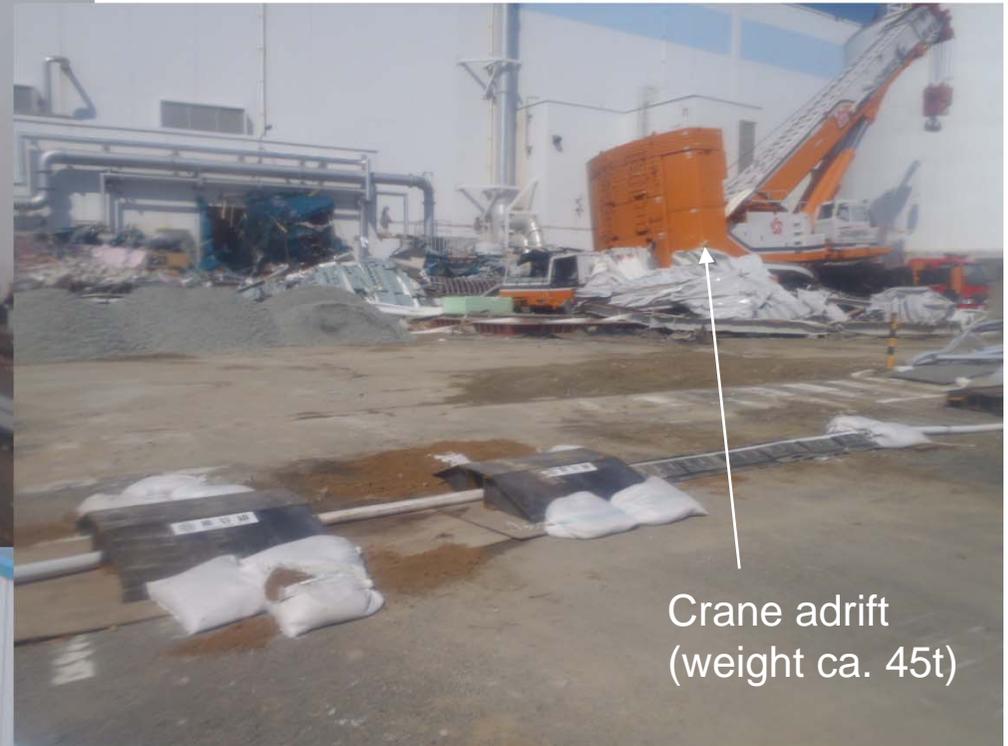
Crane adrift (weight ca. 45t)

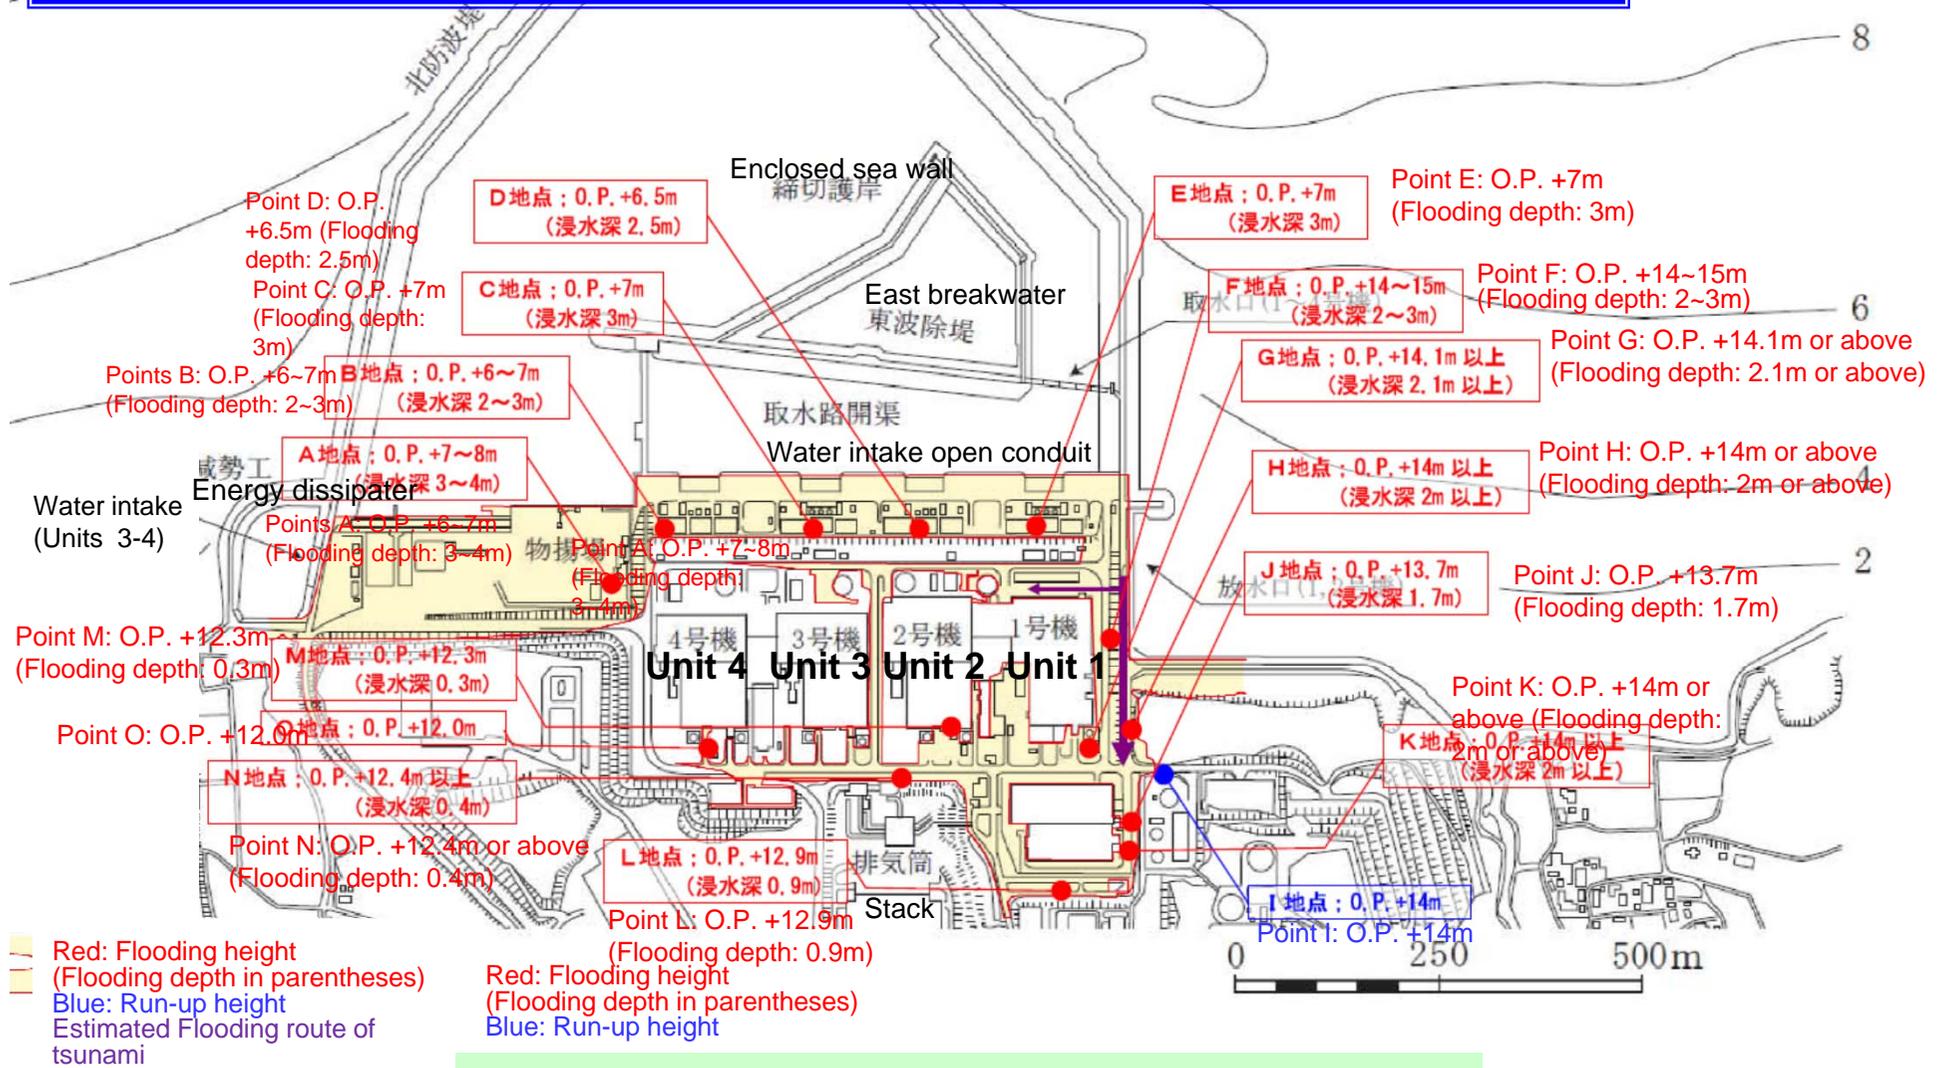
At Fukushima Daini, the height of the tsunami was about 14m on the south side of Unit 1, where it was highest, but the overall height was 7m, and the plant suffered less damage compared to Fukushima Daiichi.

浸水域(破線は推定)  
Flooded areas (estimated area in dotted line)

**Fukushima Daini Nuclear Power Station**  
**Flooding height and depth, etc.**  
**(Further investigations are currently underway)**

Assumed highest  
tsunami water level  
O.P.+5.2m

Inundation height apx. O.P. 7m  
(South of Unit 1 O.P. +14-15m)

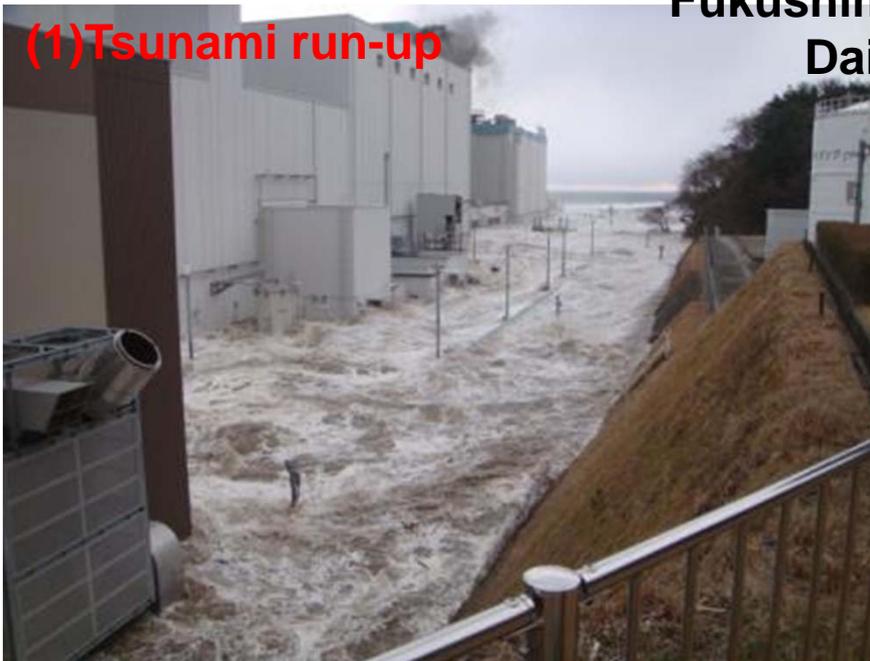
(1)Tsunami run-up

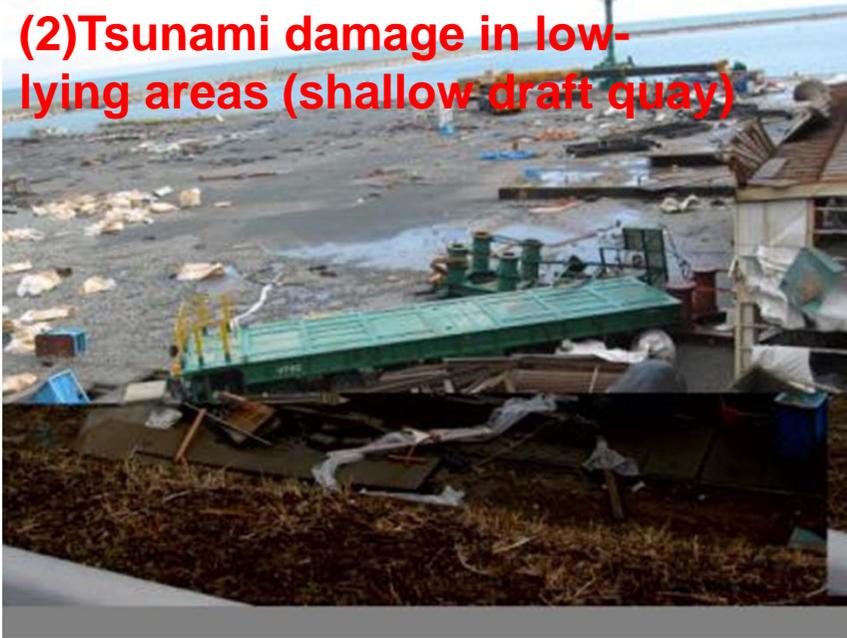
(2)Tsunami damage in low-lying areas (shallow draft quay)

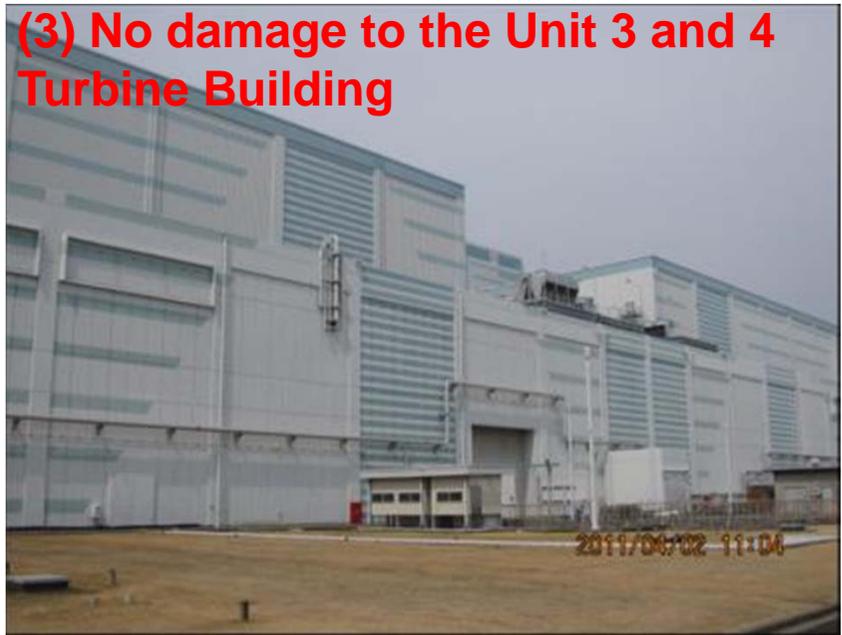
(3) No damage to the Unit 3 and 4 Turbine Building

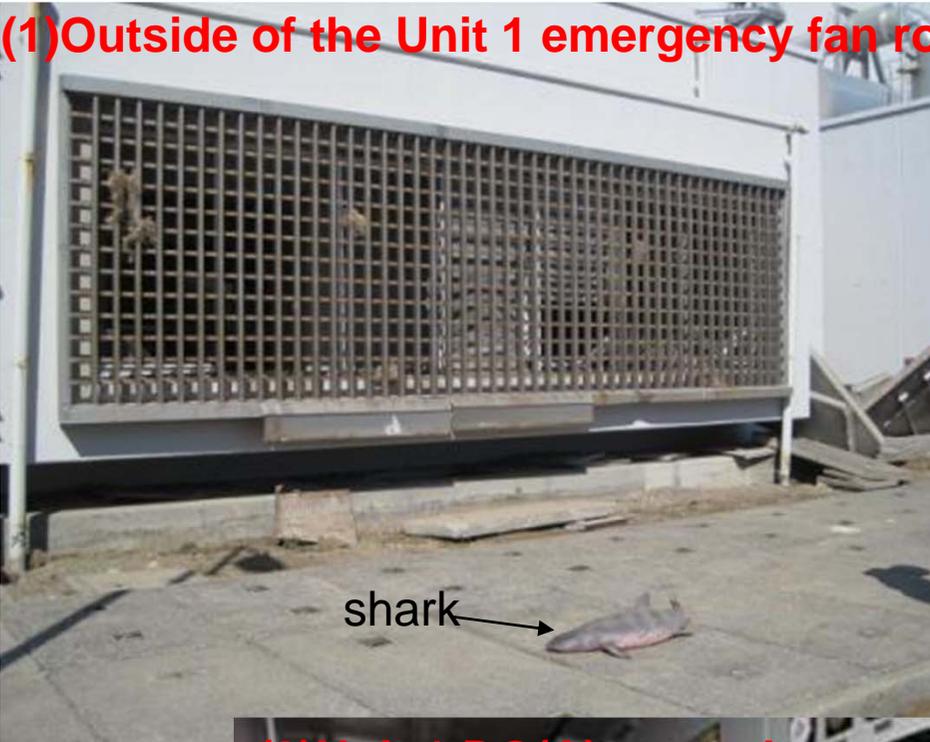
(1) Outside of the Unit 1 emergency fan room

Flooding of the Fukushima  
Daini Unit 1 Annex Area from  
the intake louver

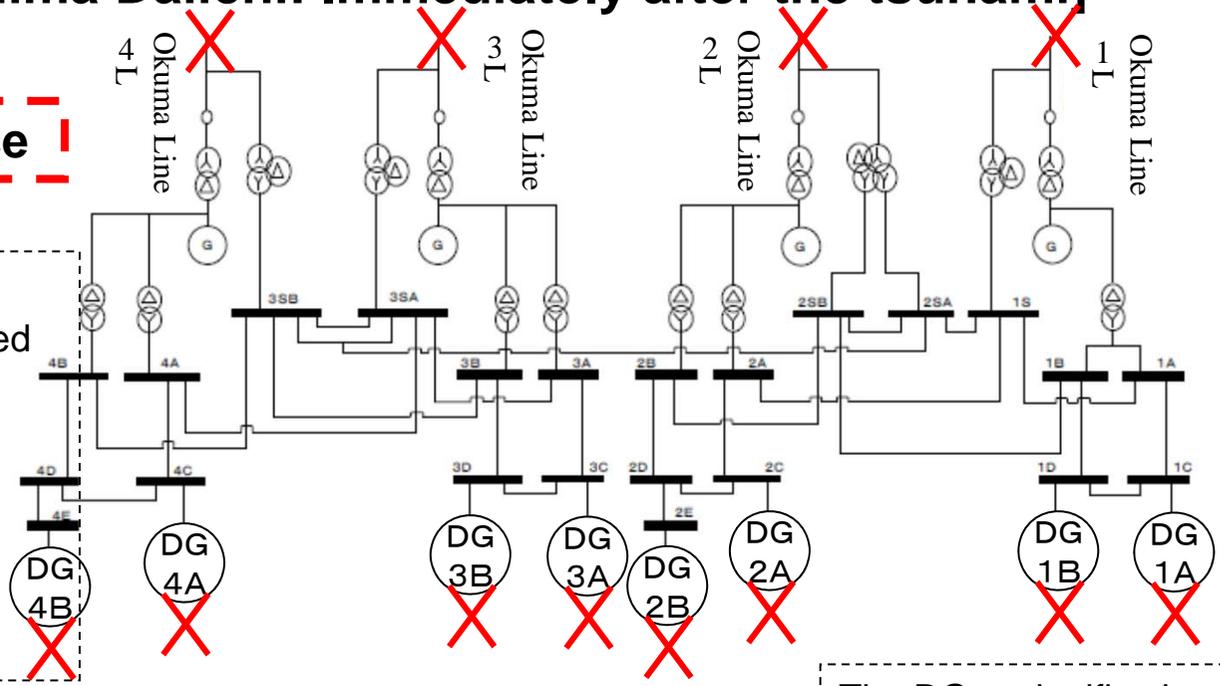
**No surviving power source**

Okuma Line 1L, 2L  
Receiving circuit breaker damaged in earthquake

Okuma Line 3L  
Renovation work in progress

Okuma Line 4L  
Cause of shutdown is currently being investigated

The DG × signifies loss of function due to either “M/C failure,” “loss of sea water system,” or “DG main unit failure.”

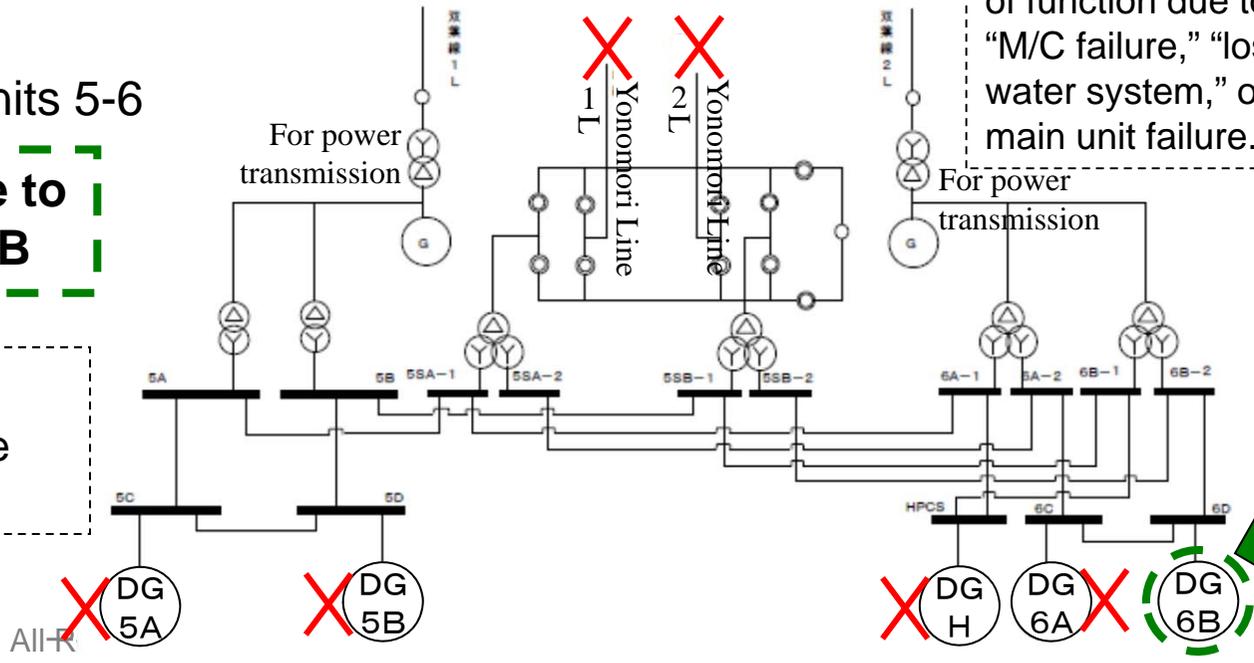
**Only power source to survive was DG6B**

Yonomori Line 1L, 2L  
Partial collapse of the iron tower

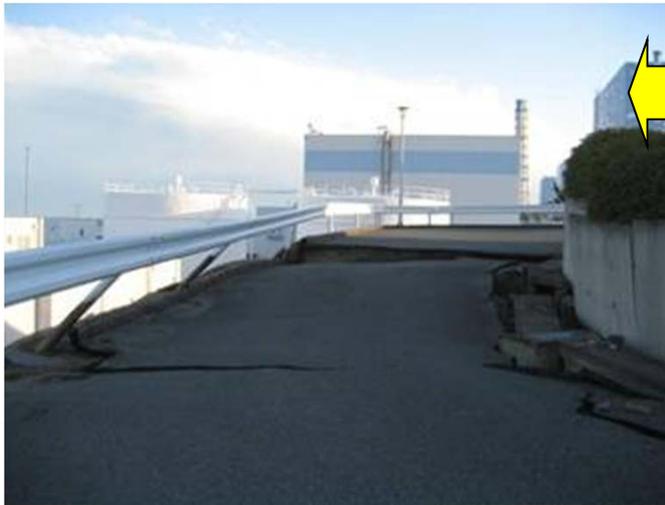
Depressions in roads, etc.  
Areas that were dangerous even to walk. Particularly dangerous at night.

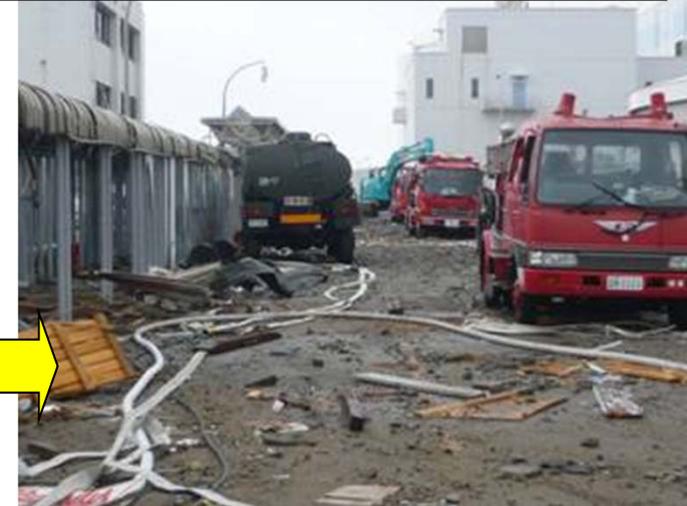
Obstacles on access routes  
Fire hoses, etc., were laid around access routes. After the explosion, rubble and damaged fire trucks became additional obstacles.

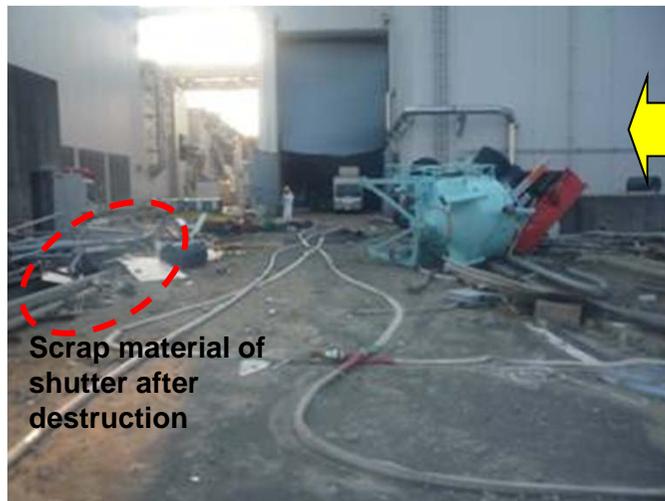
Scrap material of shutter after destruction

In order to enter the building, the large object delivery entrance was destroyed using heavy equipment.

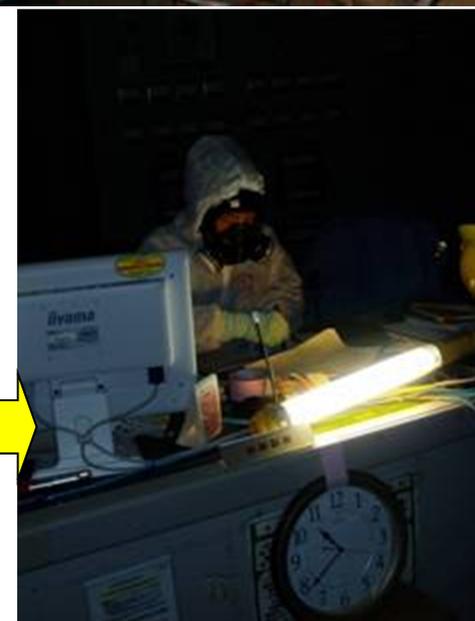
Condition of the assistant shift supervisor's desk. Monitoring in complete darkness wearing a full-face mask
