Fukushima Nuclear Accident Interim Report:

**Effects of the Earthquake and Tsunami on the
Fukushima Daiichi and Daini Nuclear Power Stations,
especially on electric and I&C systems and equipments**

July 27, 2011

Tokyo Electric Power Company

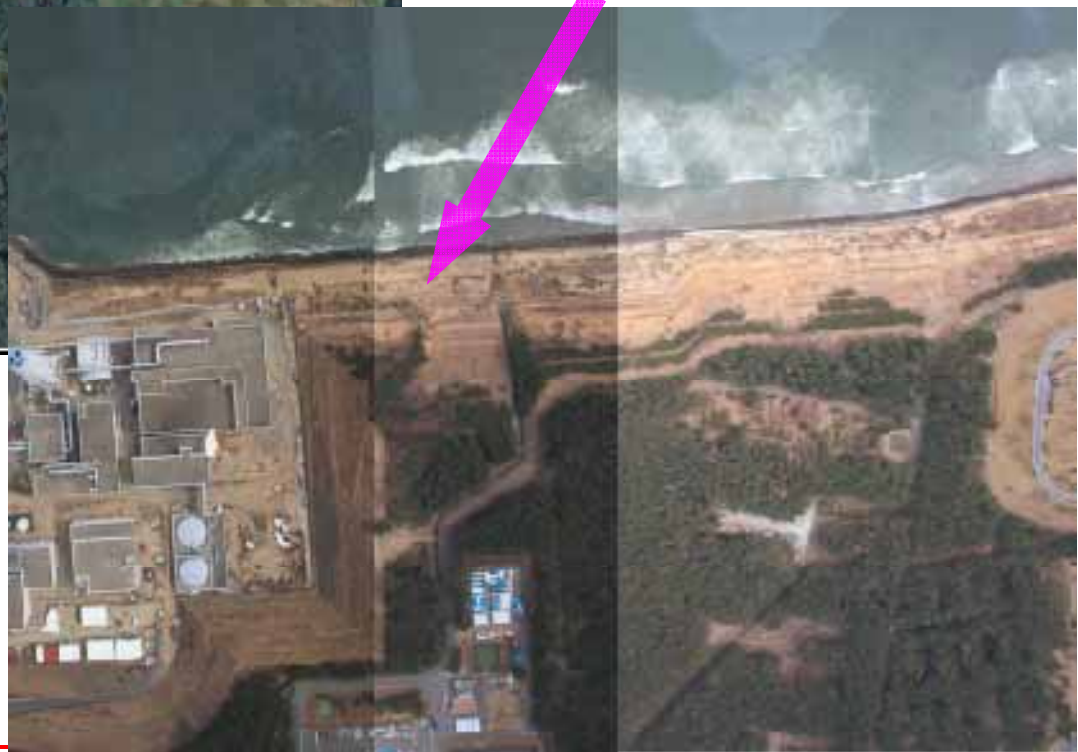
Trees were stripped away

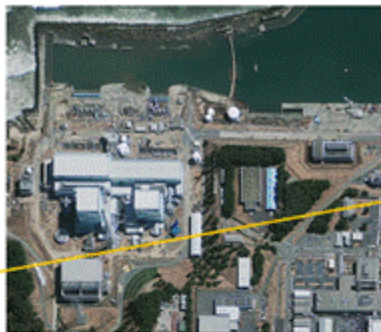
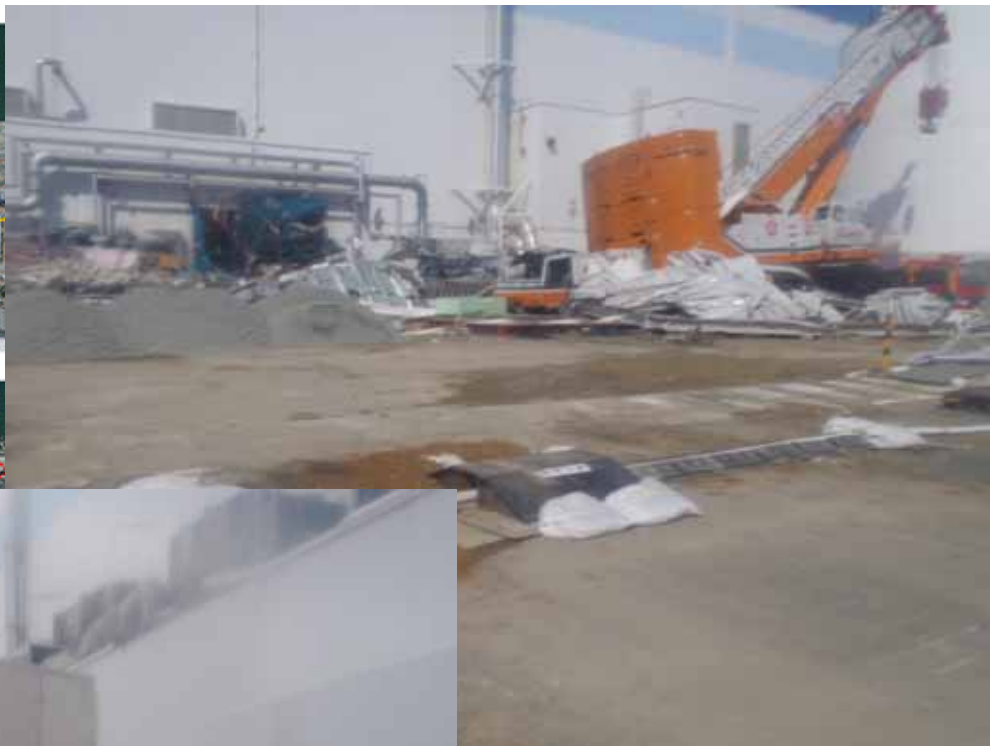
Heavy oil tank floated

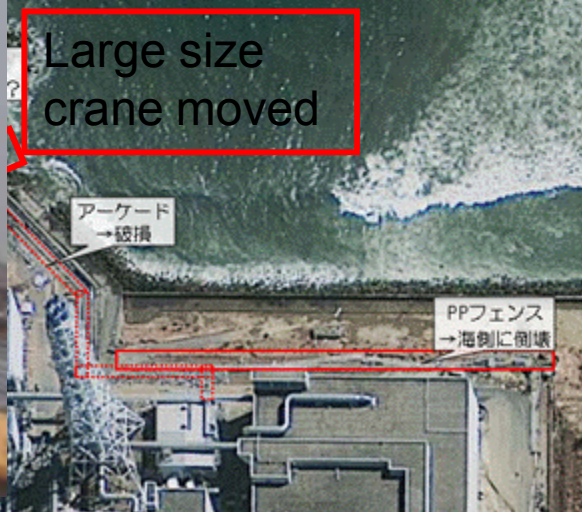
Large size crane moved

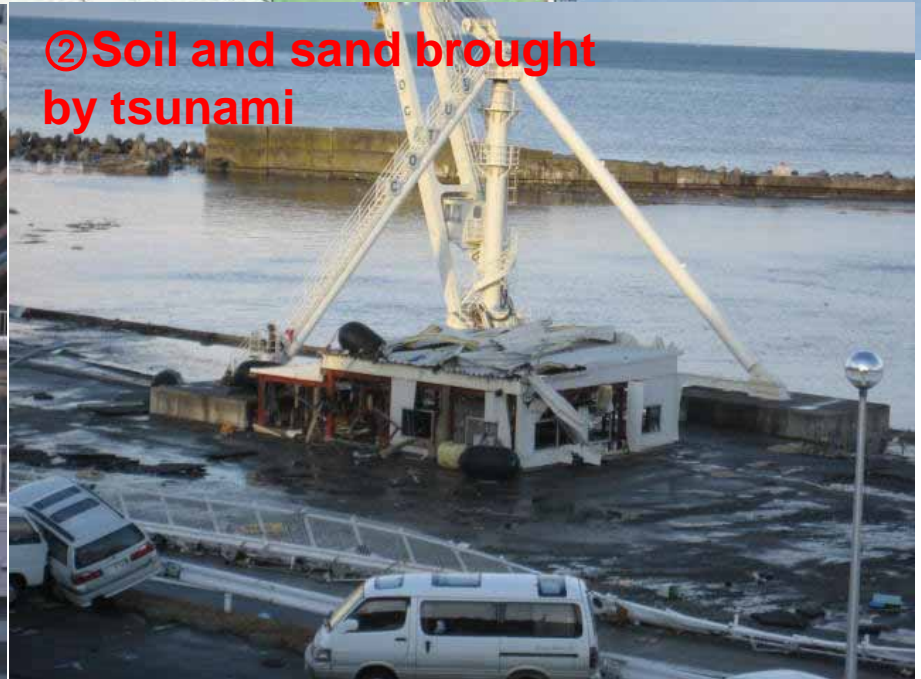
① Area on the opposite side of coast was also flooded

② Soil and sand brought by tsunami

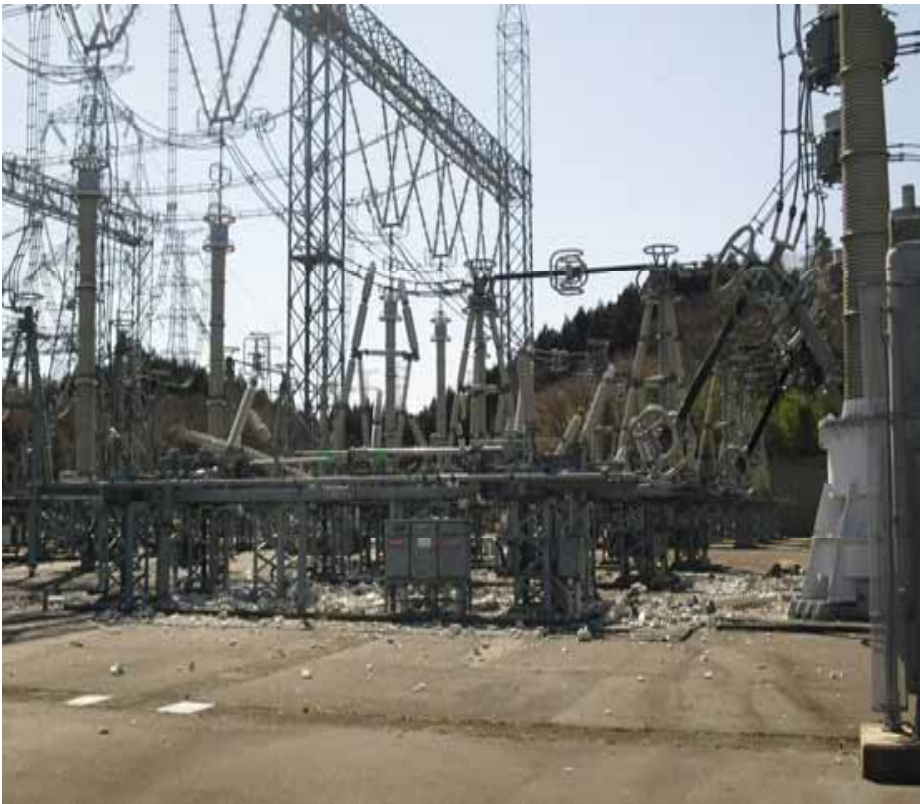
500kV Disconnector

Damages by earthquake @ Shinfukushima substation

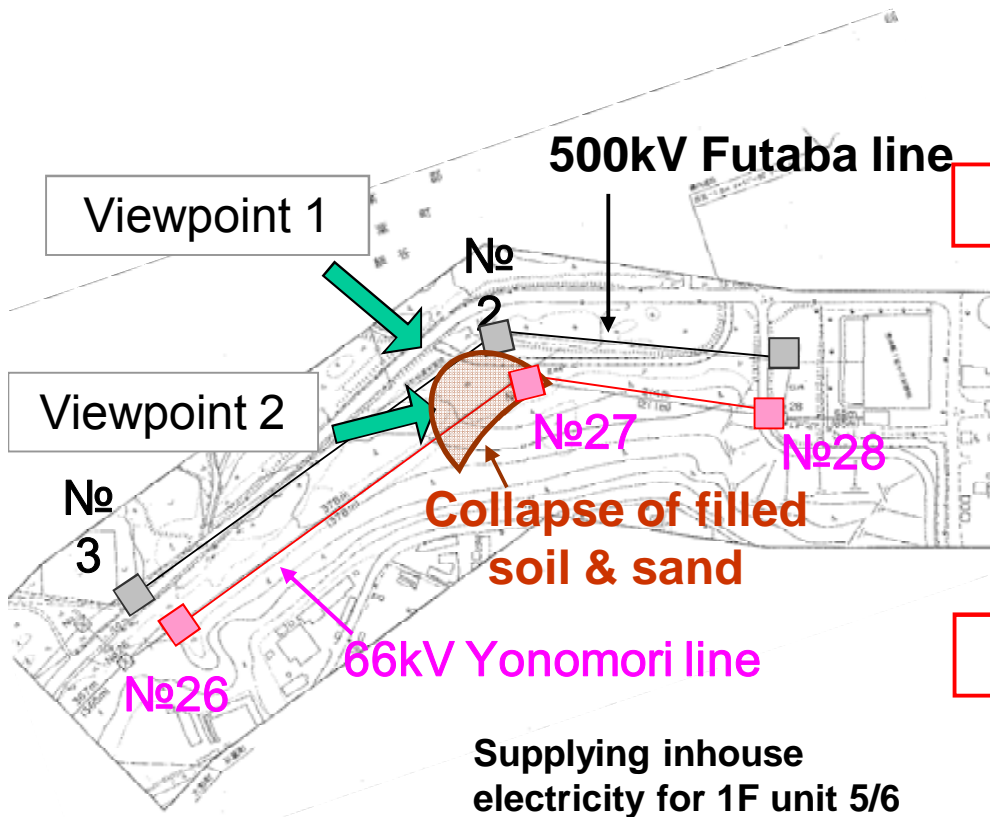
Yonomori line No.27 Iron tower collapse

Collapse of filled soil & sand (viewpoint 1)

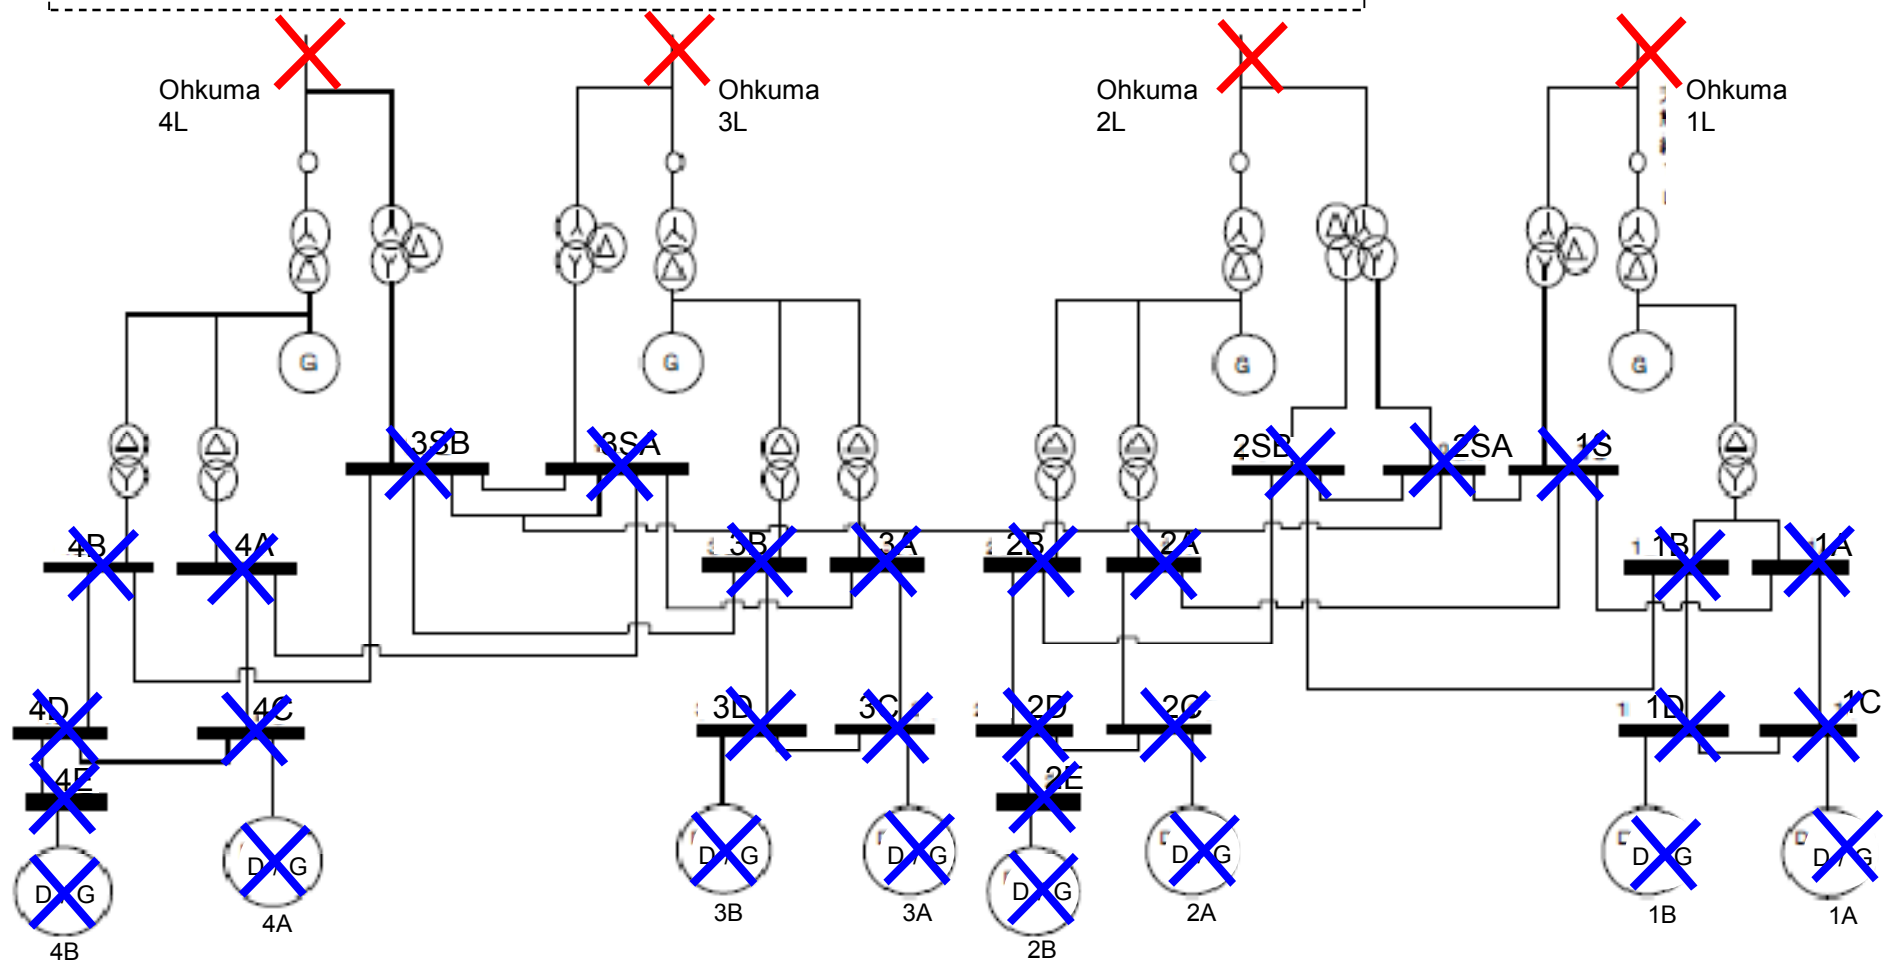
Power supply of Unit 1-4 @ 1F after Tsunami

Okuma Line 1L, 2L: Receiving circuit breaker damaged in earthquake
 Okuma Line 3L: Renovation work in progress
 Okuma Line 4L: Circuit breaker shutdown by protection relay activation

✗ Shutdown by earthquake
 ✗ Shutdown by Tsunami

The DG lost the function due to either "M/C failure," "loss of sea water system," or "DG main unit failure."

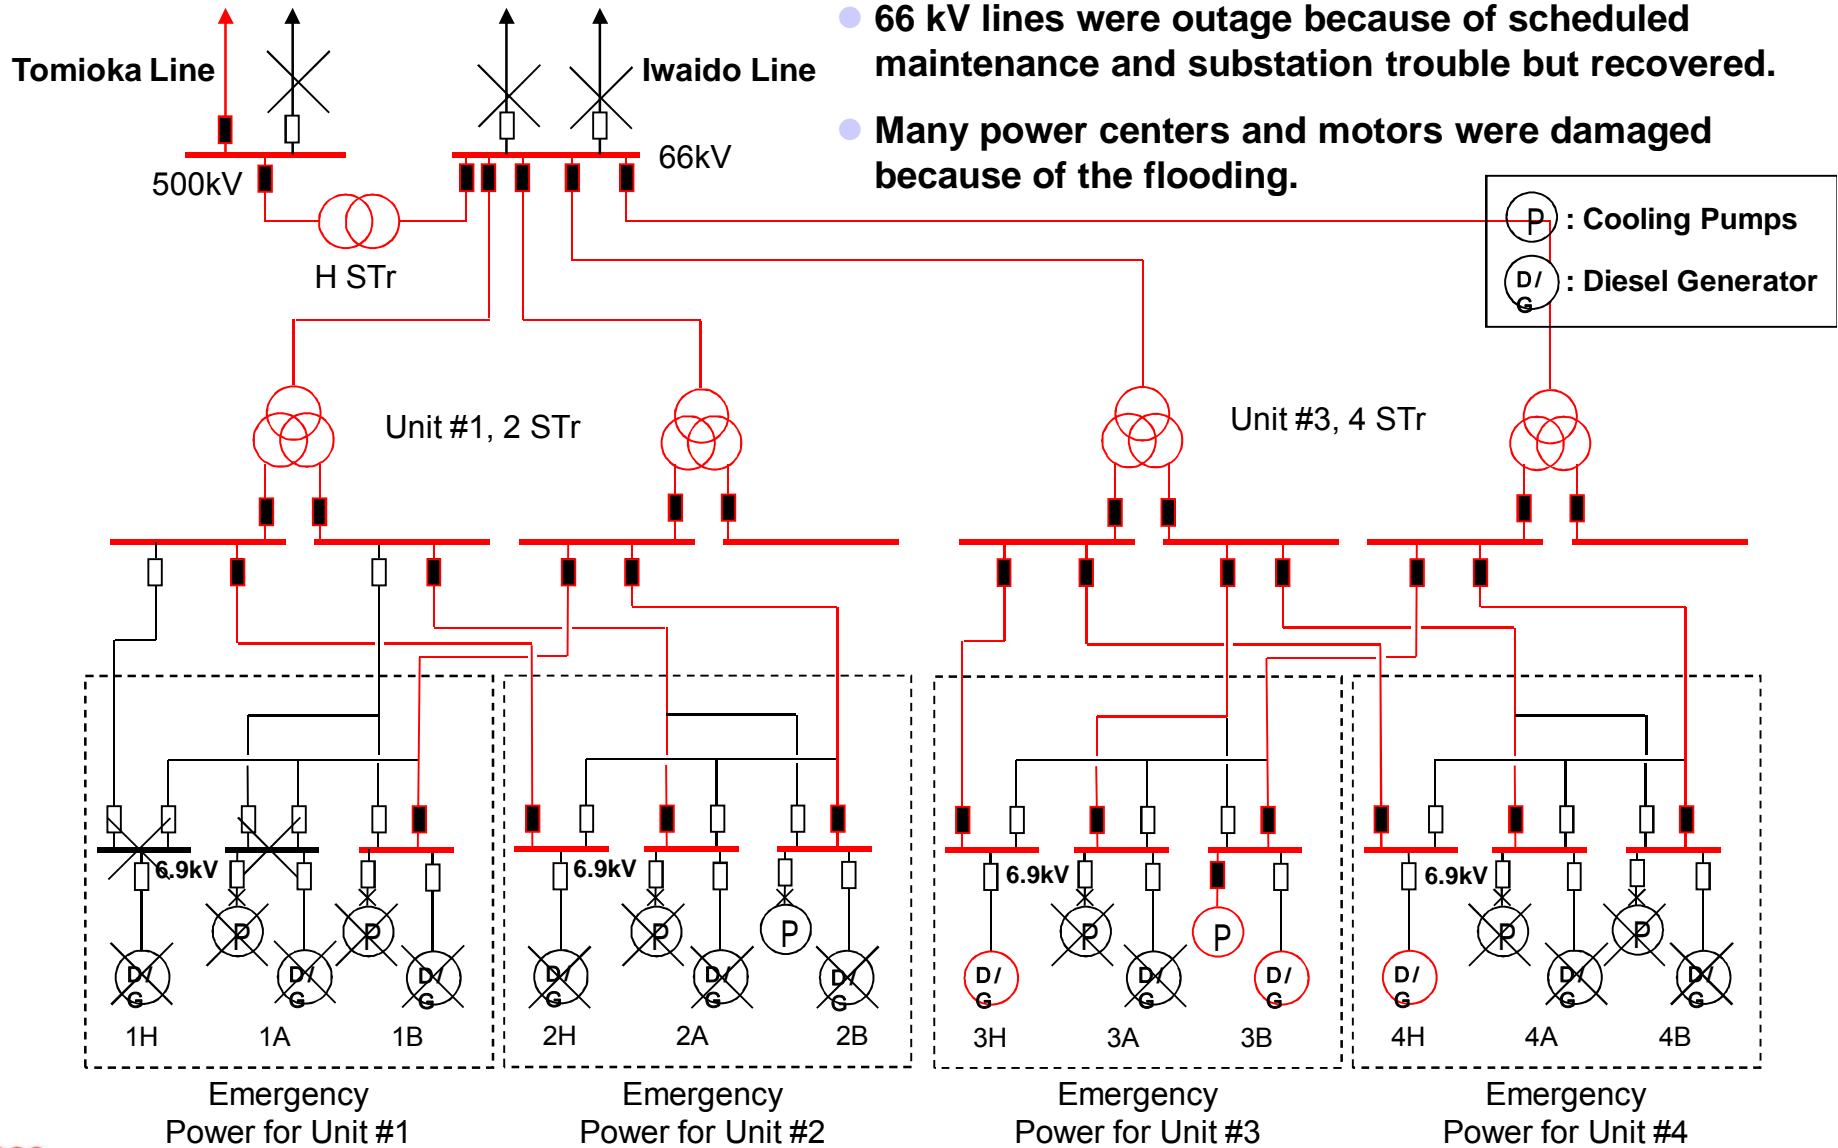
2F Offsite Power was secured after the Tsunami

- One 500 kV line was available.
- 66 kV lines were outage because of scheduled maintenance and substation trouble but recovered.
- Many power centers and motors were damaged because of the flooding.

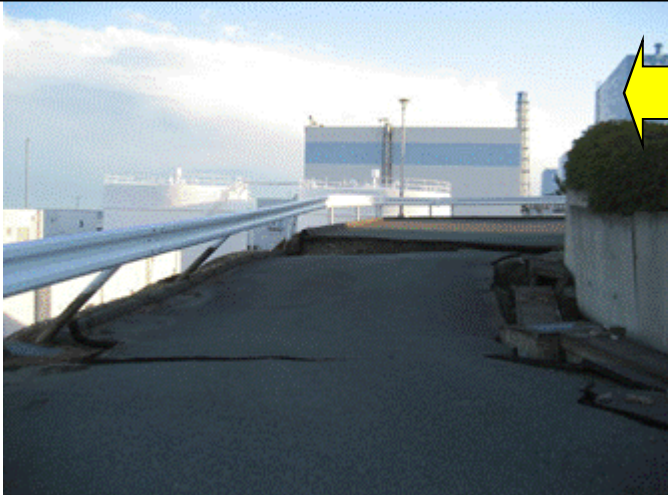
Cracks and holes on the roads: dangerous even for walking, especially during night.

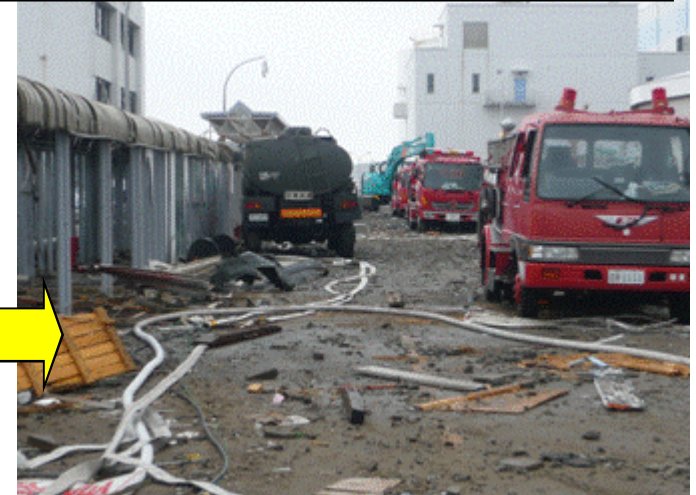
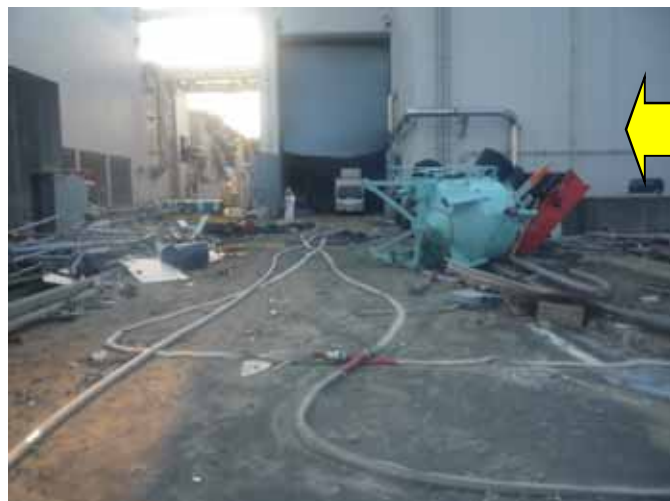
Obstacles on access routes: needed not to pass on the fire protection hose. After the explosions, damaged fire engines, rubble disturbed the access.

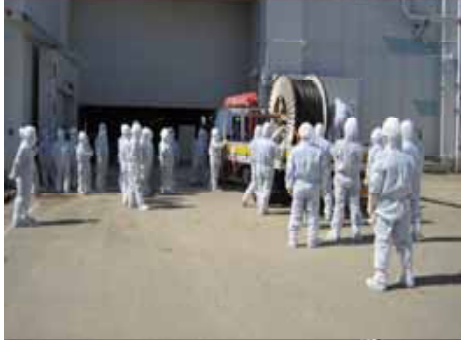
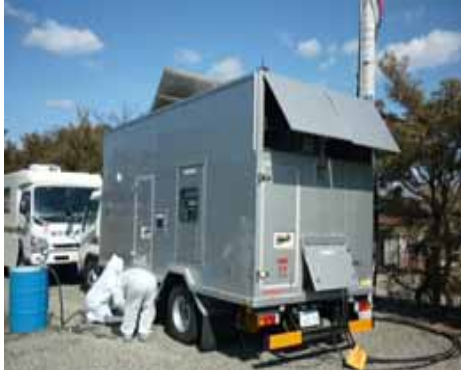
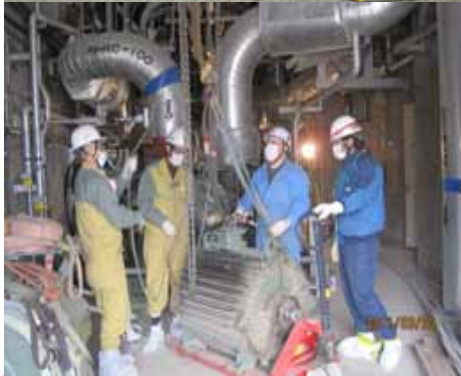
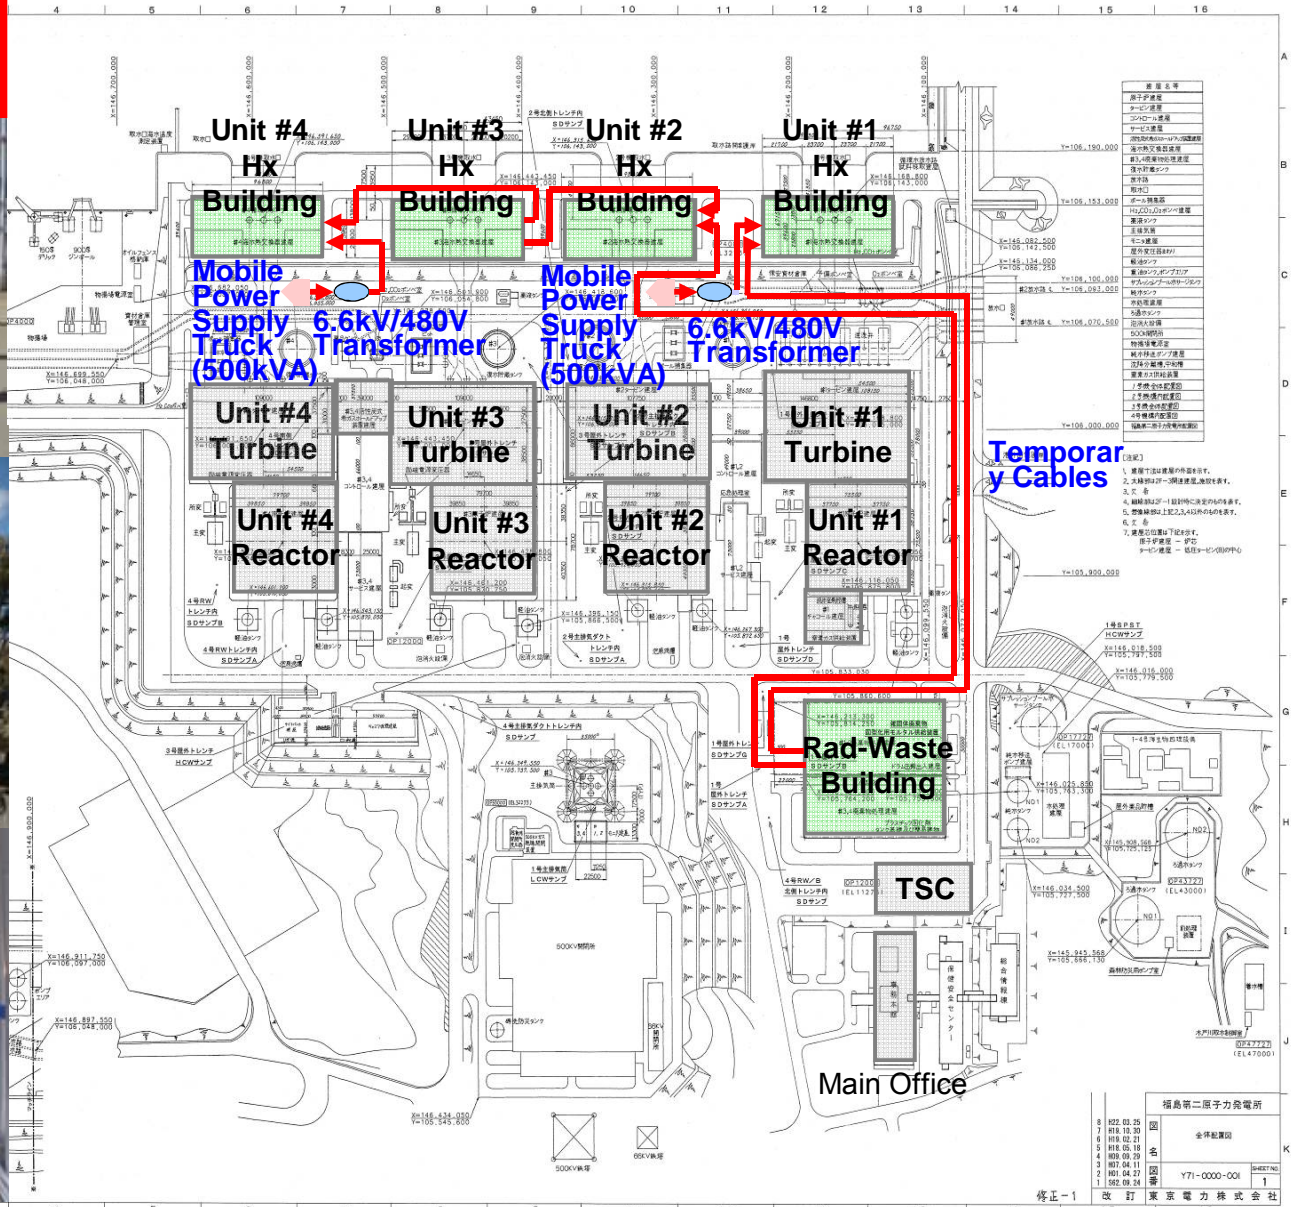
Temporary Power Supply and Motor Replacement @2F

About 9 km of temporary cables were laid and motors were replaced.
