Reactor Division

MSRE SYSTEMS AND COMPONENTS PERFORMANCE

JUNE 1973

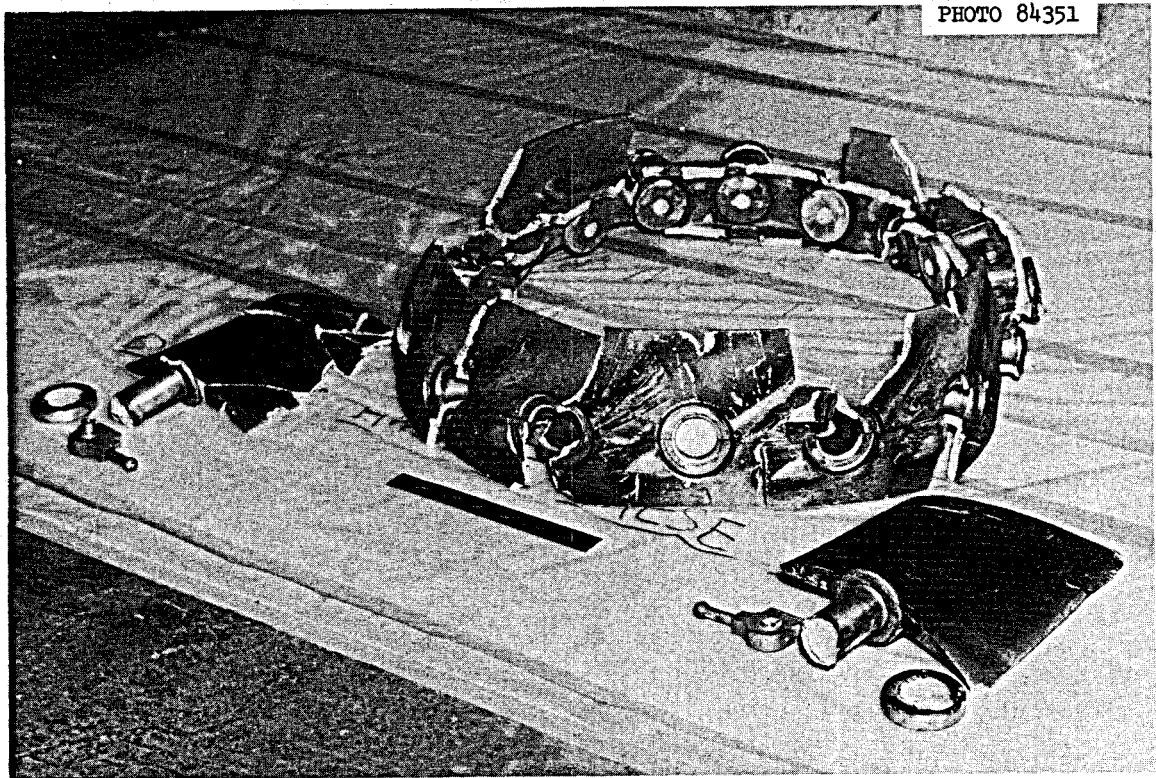
An inspection of the broken pieces of MB-1 revealed numerous "old" cracks in the blades and in the hub as evidenced by darkened or dirty areas on the fractured surfaces. One blade in particular had failed along a

Fig. 6.3 Outer Periphery of Failed MB-1 Hub and Typical Blade Fractures

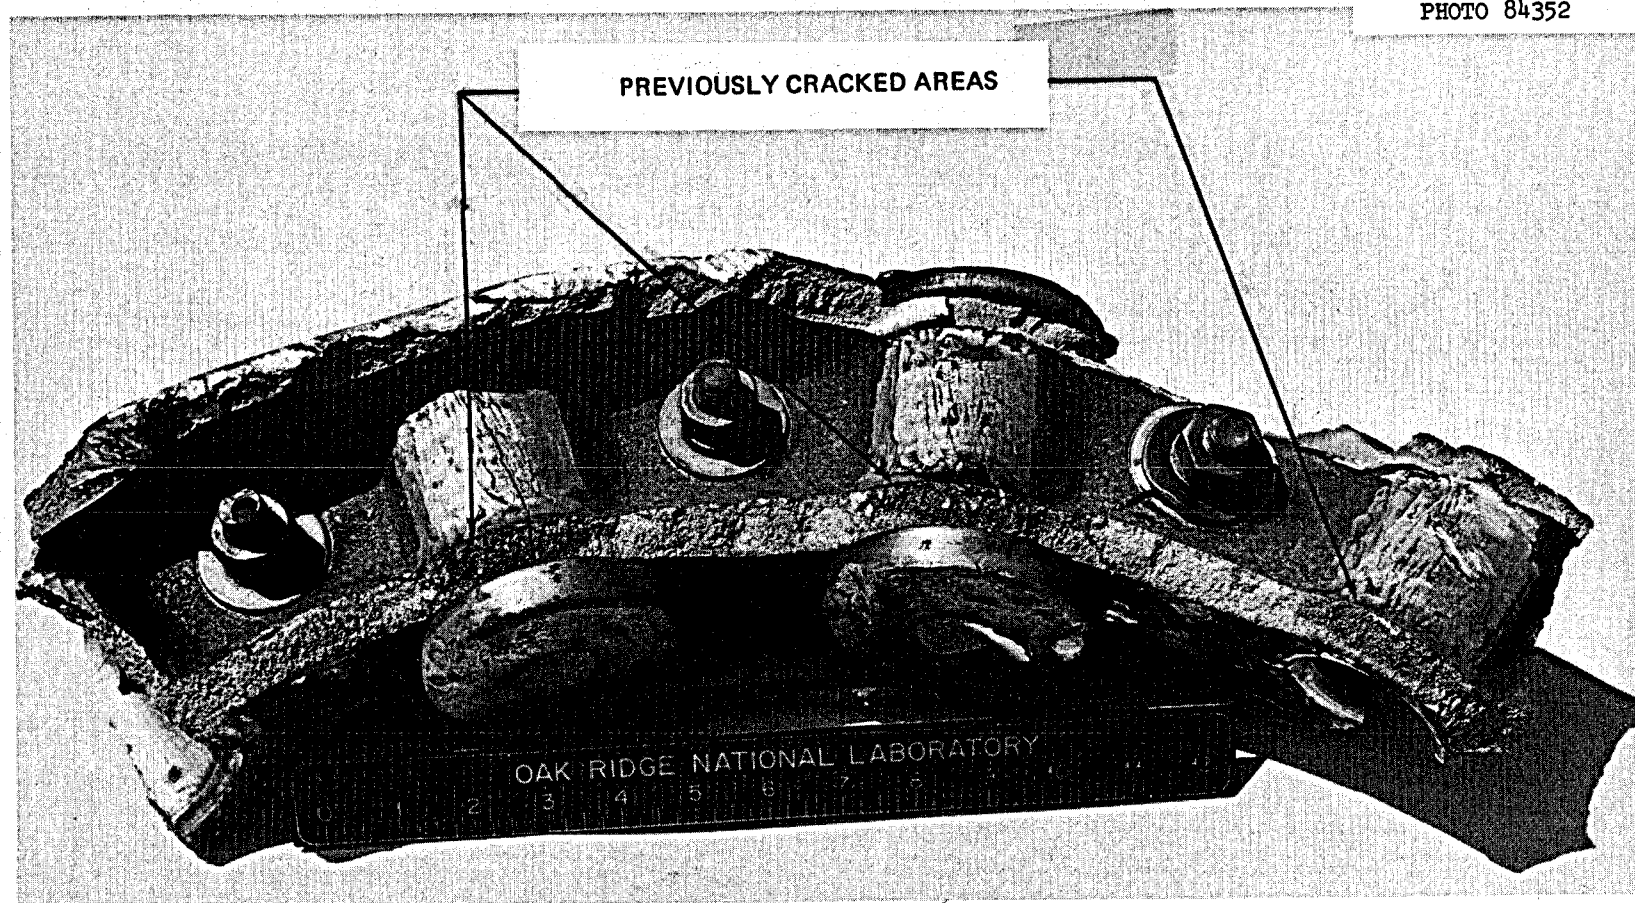
PHOTO 84352

Fig. 6.4 Fragment of MB-1 Hub Showing Areas of Previous Cracking

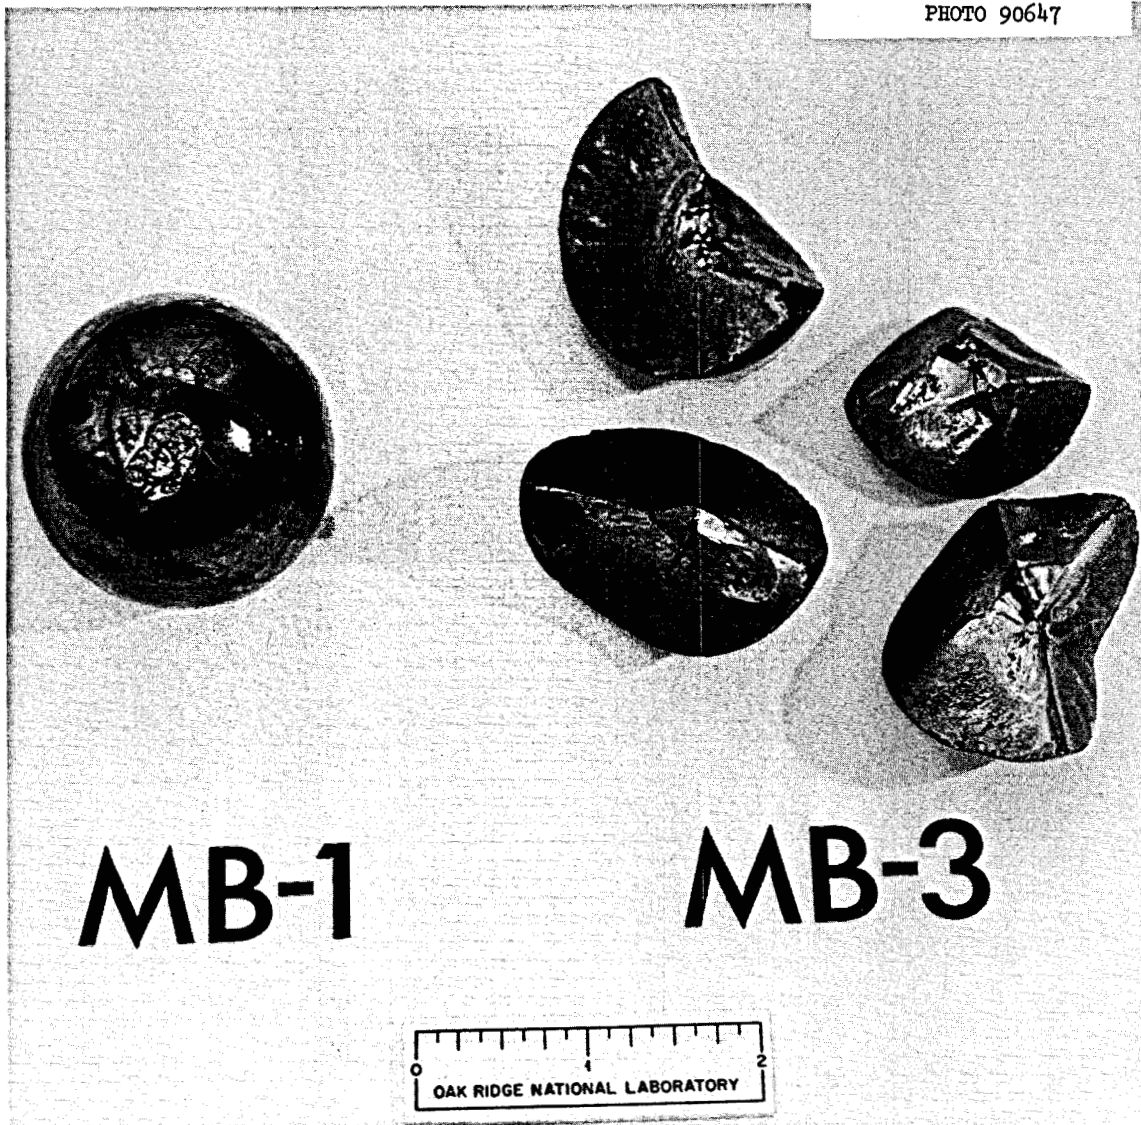
PHOTO 90647

Fig. 6.5 Ball Bearing Failures Taken from MSRE Main Blowers MB-1 and MB-3 in January 1968

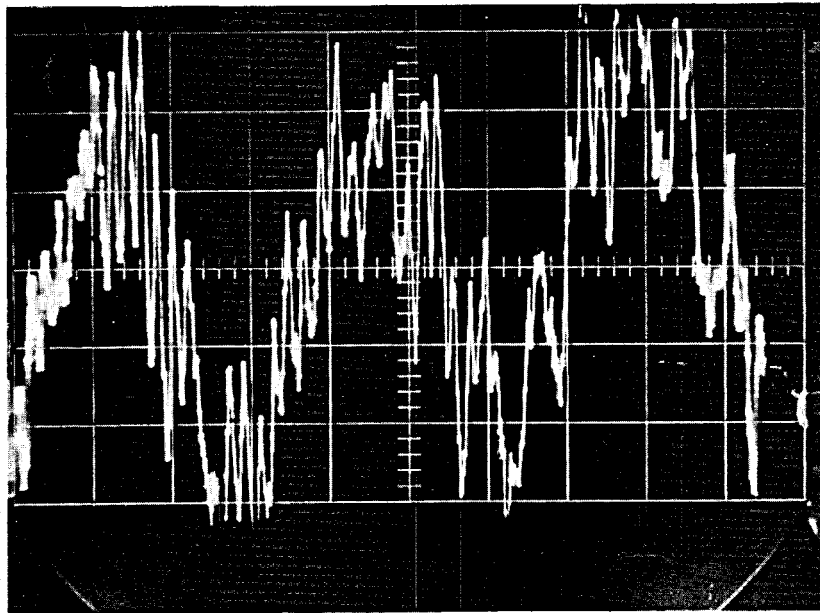
Trace with Fractured Ball - Taken 1/16/68

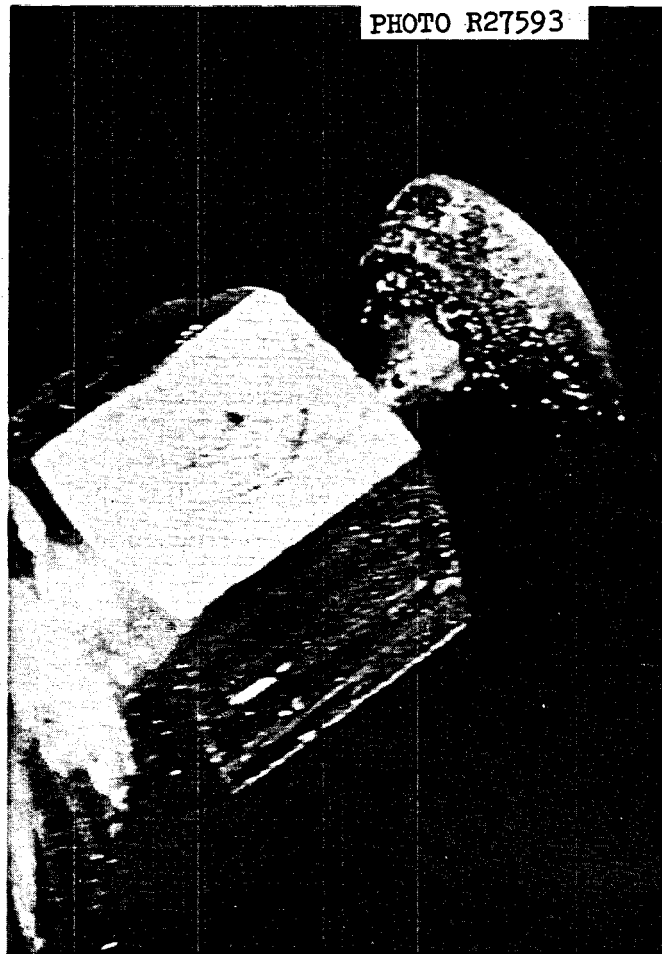
In April 1966, difficulty in venting through the auxiliary charcoal bed was found to be due to a check valve poppet which had become lodged in the inlet line to the bed. Apparently the poppet had vibrated loose from

Fig. 8.4 Check Valve CV-533

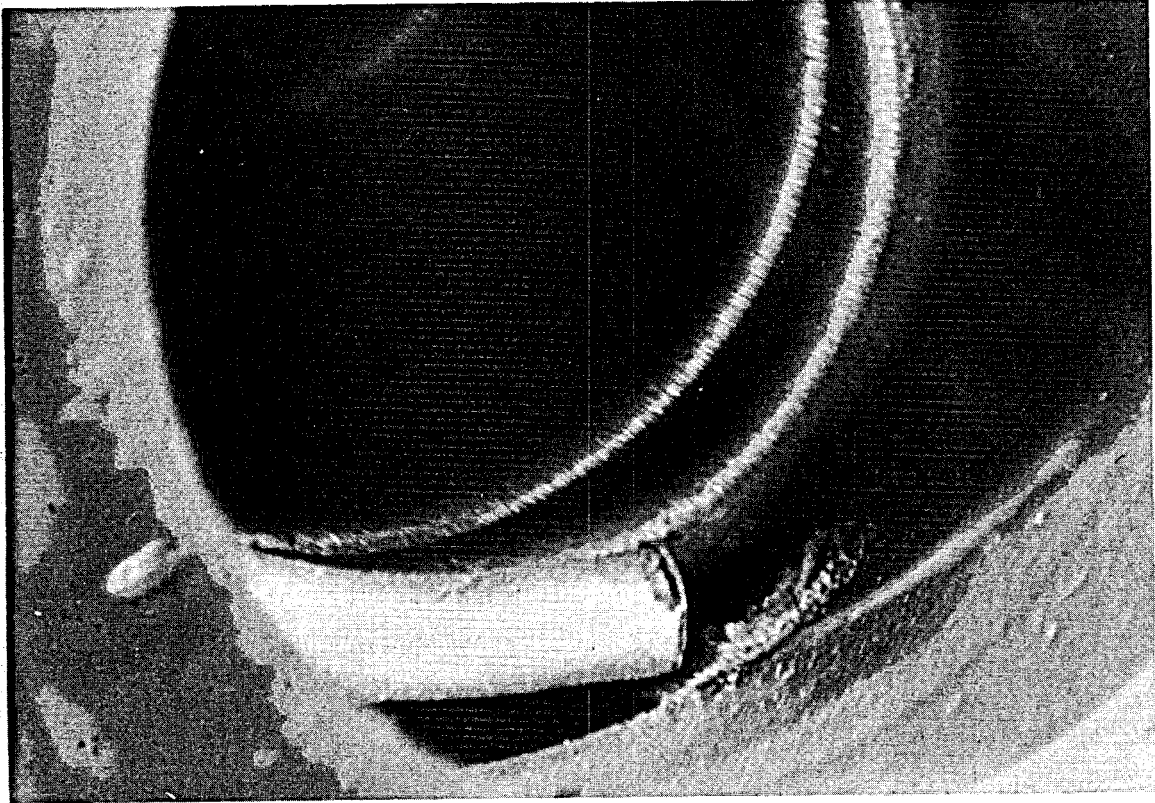
PHOTO R27589

Fig. 8.5 Deposit in Flow Restrictor FE-521.

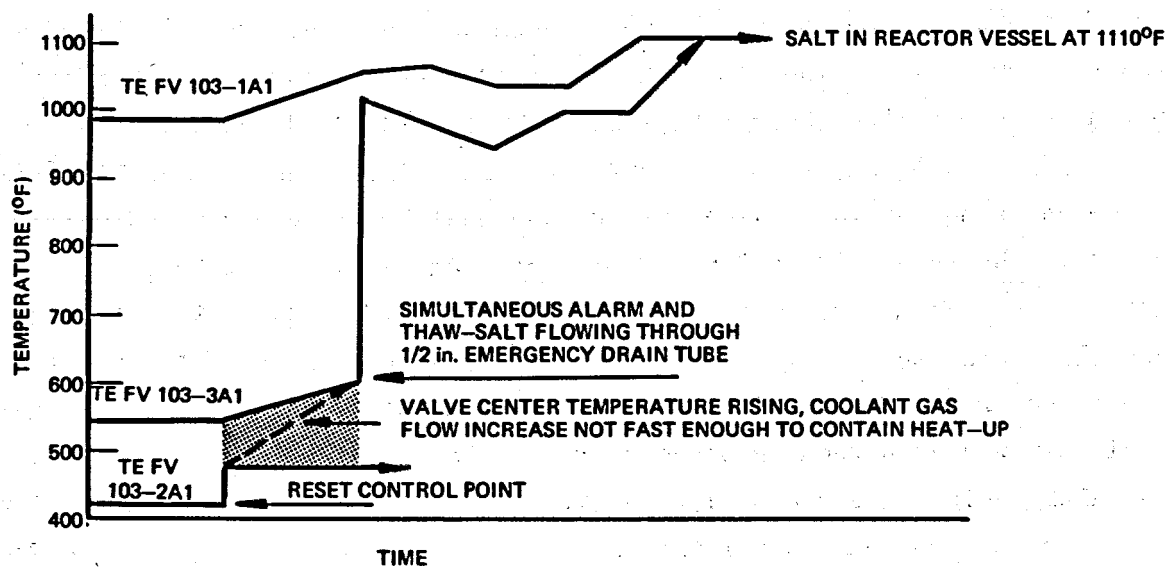
ORNL-DWG 73-607

Once the valve conditions were established, FV-103 operated well except for one unscheduled drain which occurred on April 15, 1969. This was caused by an upward 50°F drift of the setpoint of the FV-103-3A1 module from 750°F to 810°F plus an administrative change of the FV-103-1A1 setpoint from 1010°F to 1050°F.

Fig. 20.4 Temperatures During Unplanned Thaw of FV-103
