FUKUSHIMA CRISIS: UNMONITORED RELEASES

Preliminary Assessment of Accident Sequences and Potential Atmospheric Radiation Releases

By David Albright, Paul Brannan, and Christina Walrond
March 31, 2011

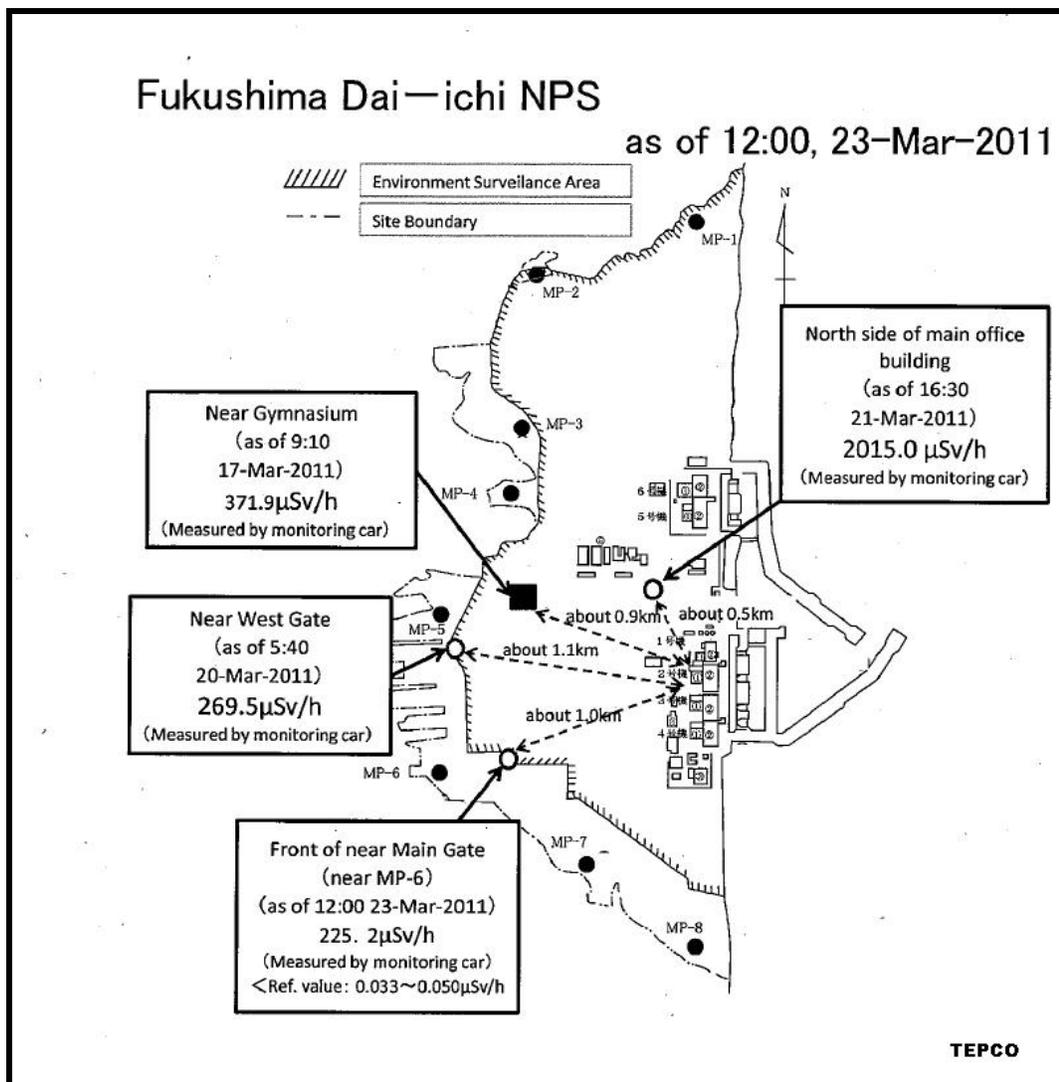
The following map of the Fukushima Dai-ichi nuclear station shows the location of the routine radiation monitoring posts (MP) arranged around the perimeter of the site (see figure 2). During normal operations, these monitoring posts record radiation levels and characterize releases that would affect the local population. However, all but one of these monitoring posts were rendered inoperative by the earthquake and tsunami and the resulting loss of electricity. In addition, radiation monitoring equipment at the reactor buildings was also damaged and unable to provide basic information about the radiation releases or “source terms” which are the amount and type of radioactive material emitted during the accidents.

Figure 2. Map of immediate area surround the reactors. The annotations list four specific radiation readings recorded several days after releases started that were taken by a mobile monitoring unit.

After the accident, TEPCO was unable to re-activate these damaged monitoring capabilities with one possible exception. It may have re-established one stationary monitoring post at the main gate.

In place of the non-functional stationary monitoring posts, TEPCO started using a car or cars equipped with monitoring equipment. The car has driven around the compound at Fukushima Daiichi and has taken readings at various times and locations.

After the tsunami, the car typically took readings at or near about half of the original monitoring posts, including the fixed station at the main gate. However, these monitoring points are closer together and do not intersect all the releases that occurred.

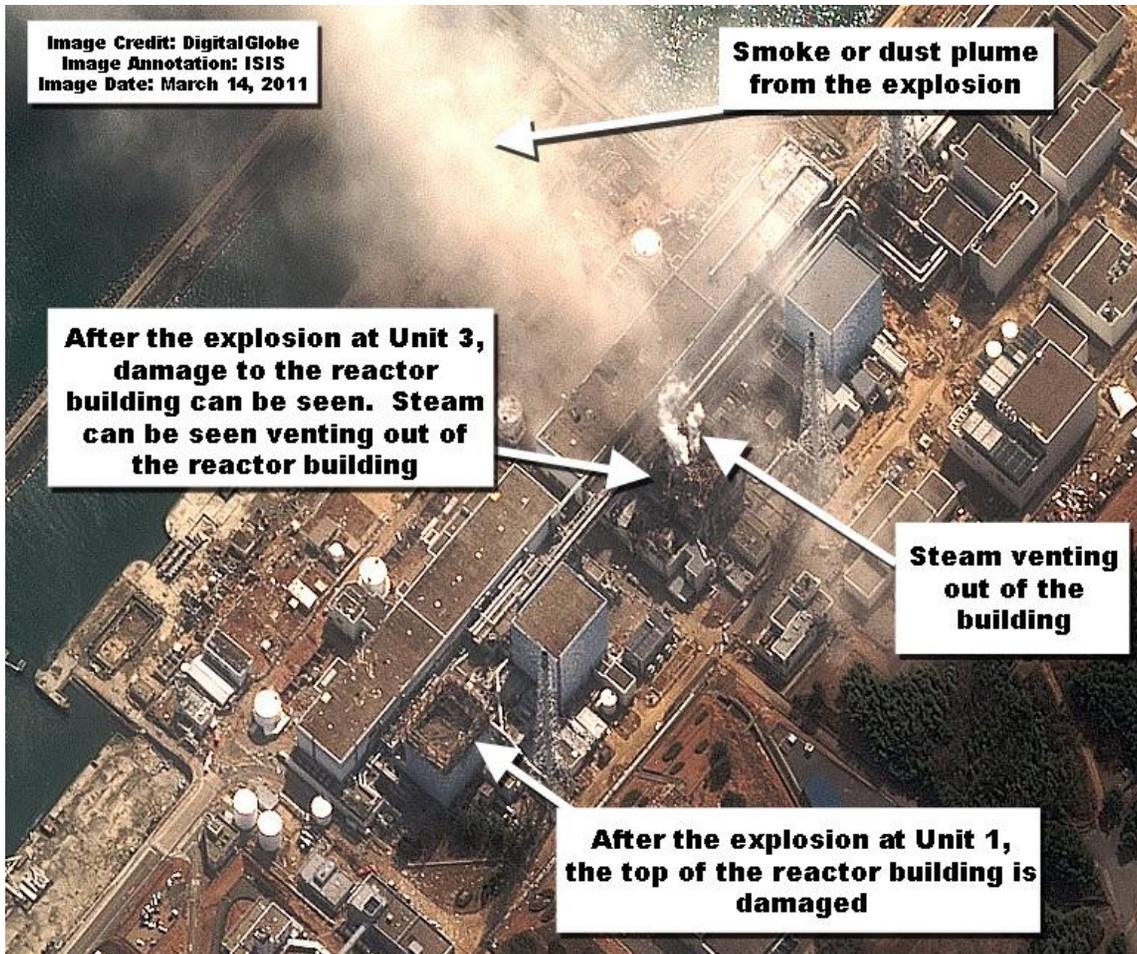
11:04 - Steam seen venting out of **unit 3** building in satellite image. Smoke or dust plume from the explosion three minutes earlier also seen above building. Substantial structural damage to **unit 3** building from explosion can be seen. The top portion of **unit 1** building shows damage from explosion as well.

Figure 3. Satellite image taken at 11:04am March 14, approximately three minutes after explosion at unit 3 building. Smoke or dust plume from explosion at unit 3 building can be seen extending out to the sea, wind direction from the west.

The smoke and dust plumes from the explosion at reactor building 3 can be seen at 11:04am extending out over the sea—the image was taken approximately three minutes after the explosion. Thus, the winds close to the time of the explosion were heading to the east (wind direction from the west), towards the ocean. This is consistent with the wind direction from the west-northwest reported at 11:37am.

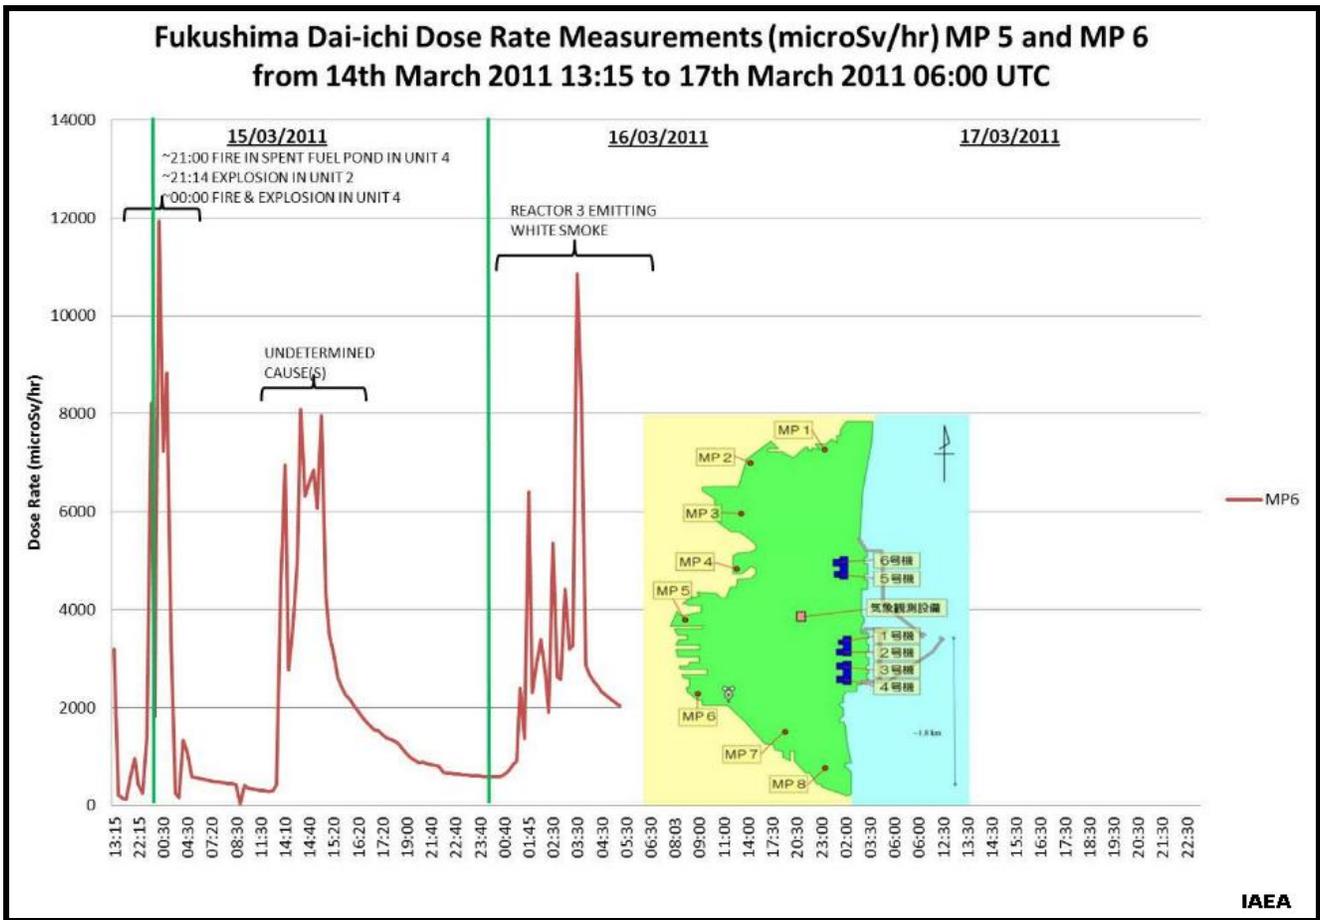
Figure 4 from the IAEA graphs the readings at MP-6, which is likely the same data as listed as the main gate on the TEPCO web site. The IAEA shifts the times to the UTC time zone, which is nine hours earlier. Three peaks are visible in the readings. In Japanese local time, the first two occur on the 15th and the third is on the 16th (see below). As discussed above, the first two spikes may reflect near continuous releases during the day, which were detected at this particular location as a result of the wind shifting so as to blow the releases over this monitoring point.

Figure 4. IAEA graph showing high radiation dose rates at Fukushima on March 15 and 16, the days with the highest monitored releases. Time is given in UCT, which is nine hours earlier than local Japanese time.

The monitors recorded large radiation dose rates on the 15th. At 9 am, the radiation levels at the main gate peaked at almost 12,000 $\mu\text{Sv/h}$. This radioactive plume likely resulted from the explosion in unit 4 and suspected fire in the spent fuel pond. The winds were from the north, northeast, blowing the radioactive material toward the south and southwest, intersecting the main gate. At about noon, the wind direction shifted to the south, southeast, and the radiation levels at the main gate went down. When the wind shifted back to northerly directions late in the day, the radiation levels increased again at the main gate. These readings imply that the reactors could have released large amounts of radiation during much of the day, and the monitoring stations detected these releases sporadically based on the wind direction and speed. The initial plume tended toward the south, southwest and later emissions blew to the north, northwest.

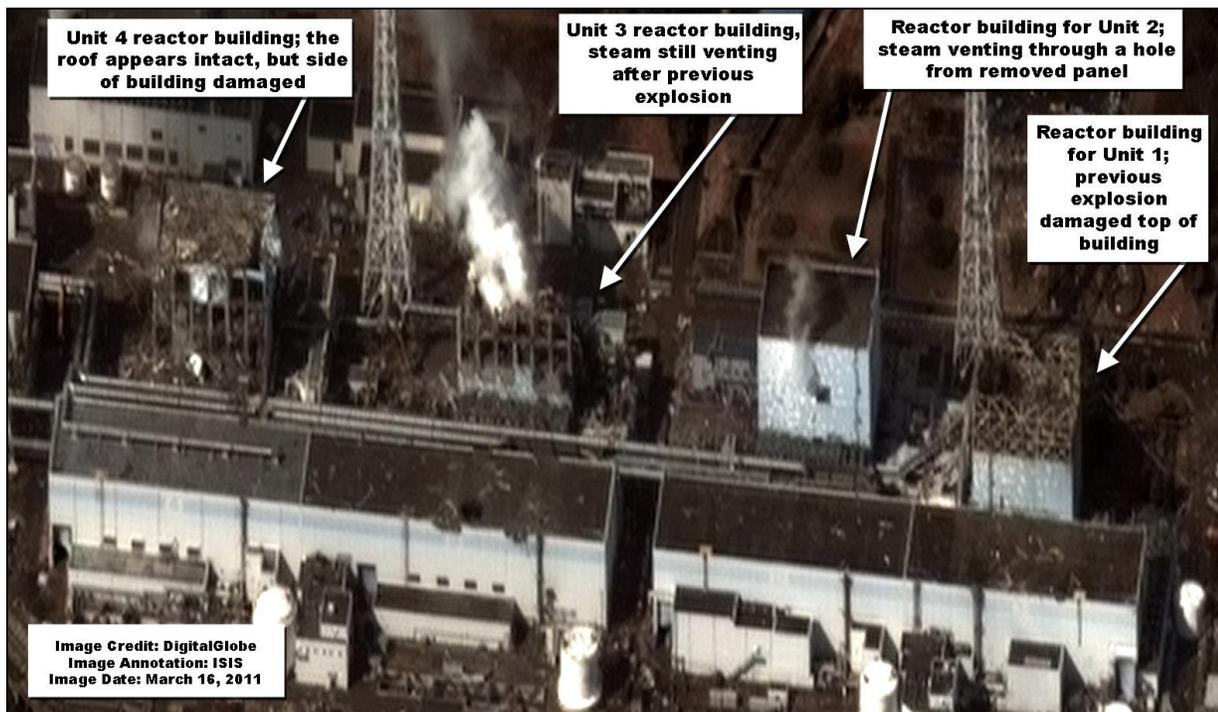
09:35 - Steam seen venting out of the side of **unit 2** building. Workers apparently removed panel from side of building to relieve pressure. Steam also seen rising from damaged **unit 3** building. Damage to **unit 4** building can be seen as well

Figure 5. Satellite image taken at 9:35am on March 16. Plumes can be seen venting out of reactor buildings 2 and 3.

Another major release appears to have occurred in the late morning. The spike in dose rate at 12:30pm at the main gate is preceded by winds out of the north, east, and east-northeast, in the previous 30 minutes. As the main gate is approximately a kilometer west-southwest of the four reactors, the winds carried a release that likely occurred between 12:10pm and 12:30pm towards the main gate. However, it is unclear from which reactor building this release originated. As noted above, fires were occurring in reactor 4 and plumes can be seen rising from both buildings 2 and 4 in satellite imagery taken at 9:35 am.

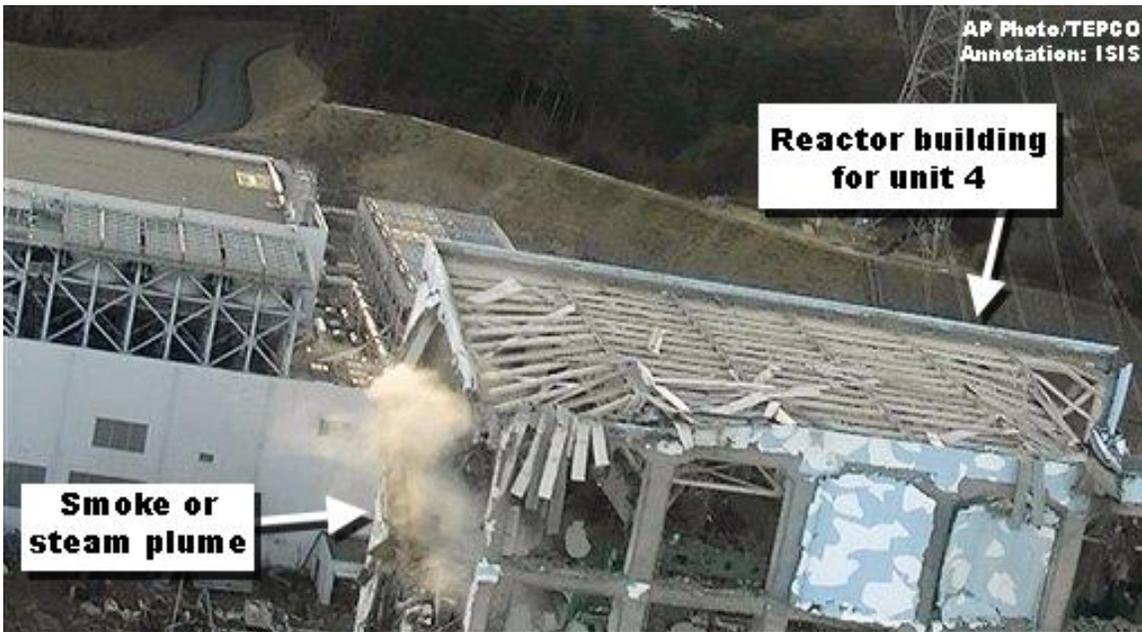
18:00 - Steam or smoke seen venting out of south-east corner of damaged unit 4 building. This spent fuel pool is located in this corner of the building in this reactor building design. Steam or smoke seen rising from damaged **unit 3** building

Figure 6. A still image from a video shot from a helicopter showing the southeast corner of the unit 4 building at approximately 6:00pm. A plume of smoke or steam can be seen rising from the building.

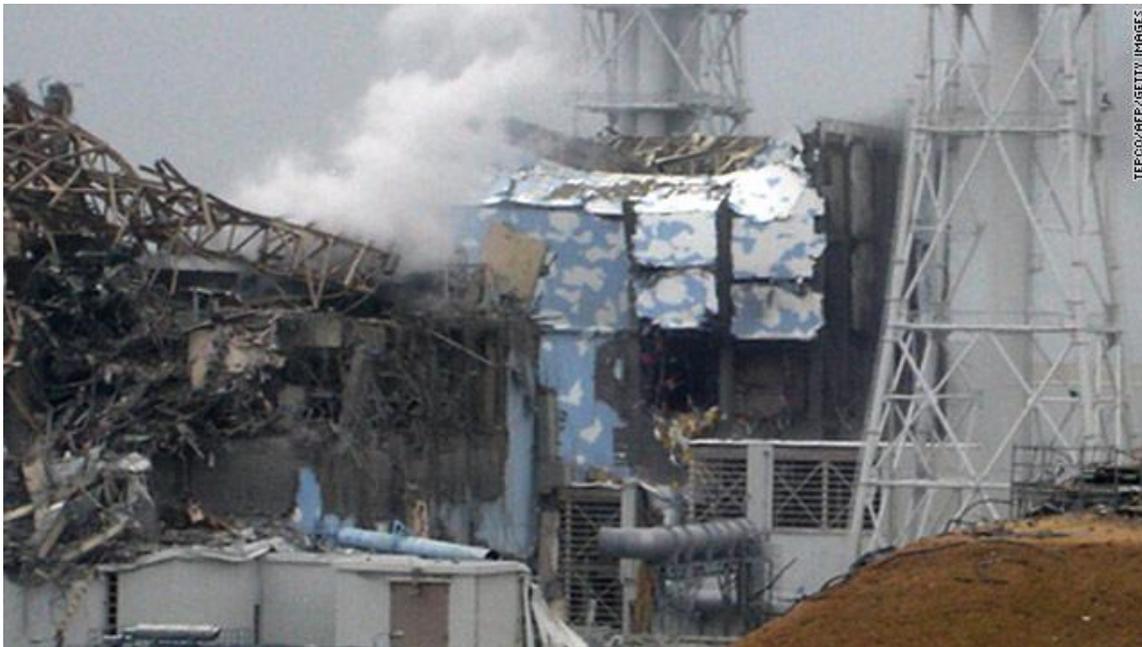
Figure 7. March 16th image showing unit building 3 in the foreground with a rising plume, and a unit 4 building in the distance. (TEPCO/AFP/Getty Images)

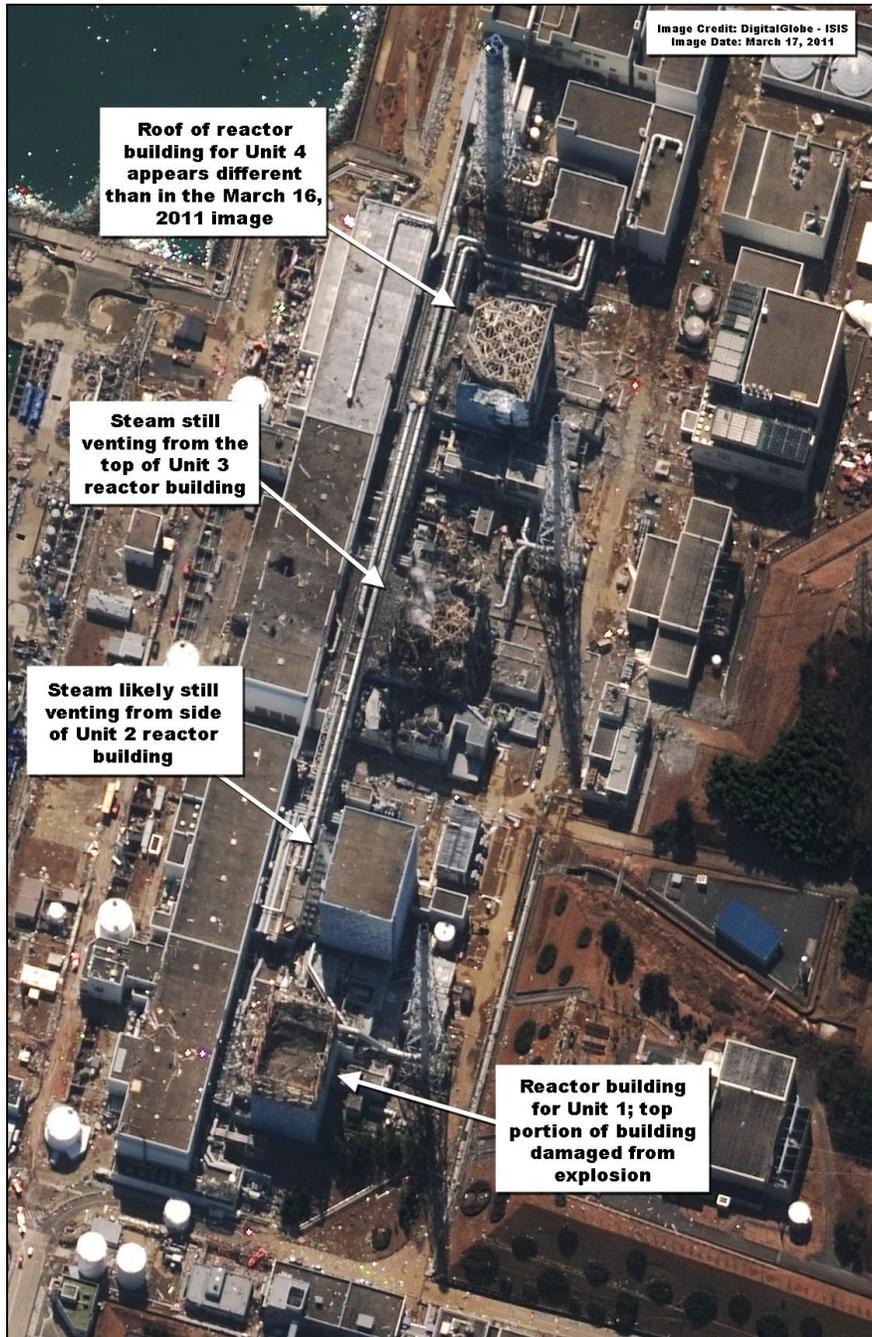
Figure 8. Satellite image from 10:55am on March 17. Steam can be seen venting from the top of unit 3 building.

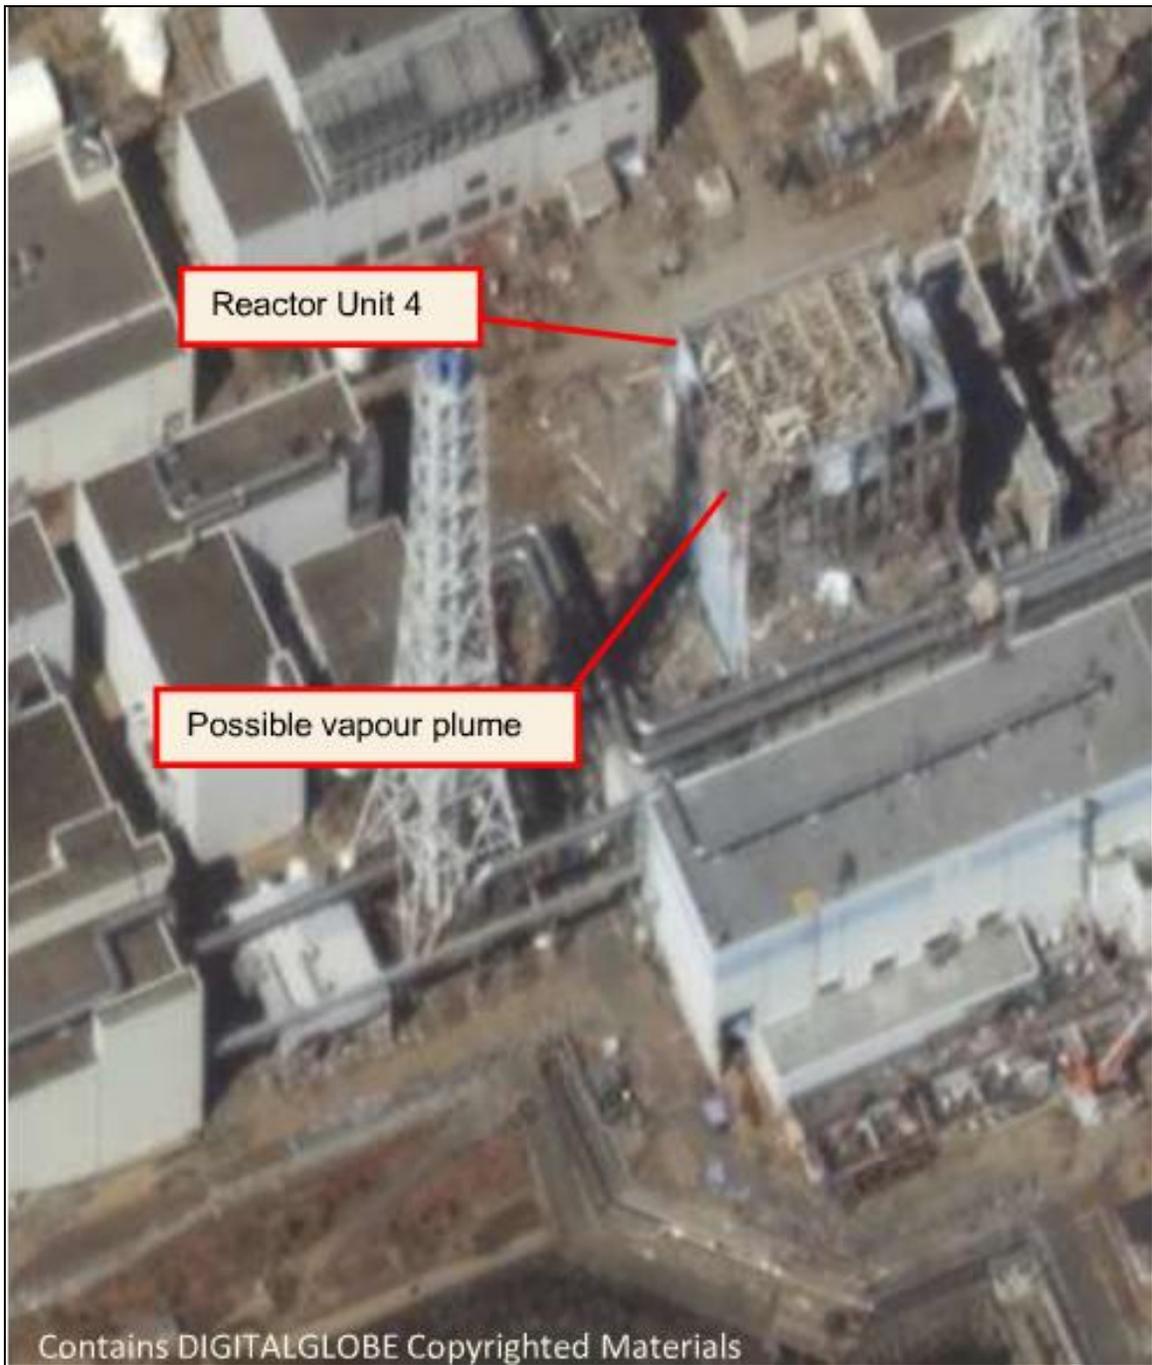
Figure 10. A satellite image taken on 10:19am on March 18th from an IAEA presentation. The IAEA observes a “possible vapor plume” on the southeast corner of the unit 4 building.

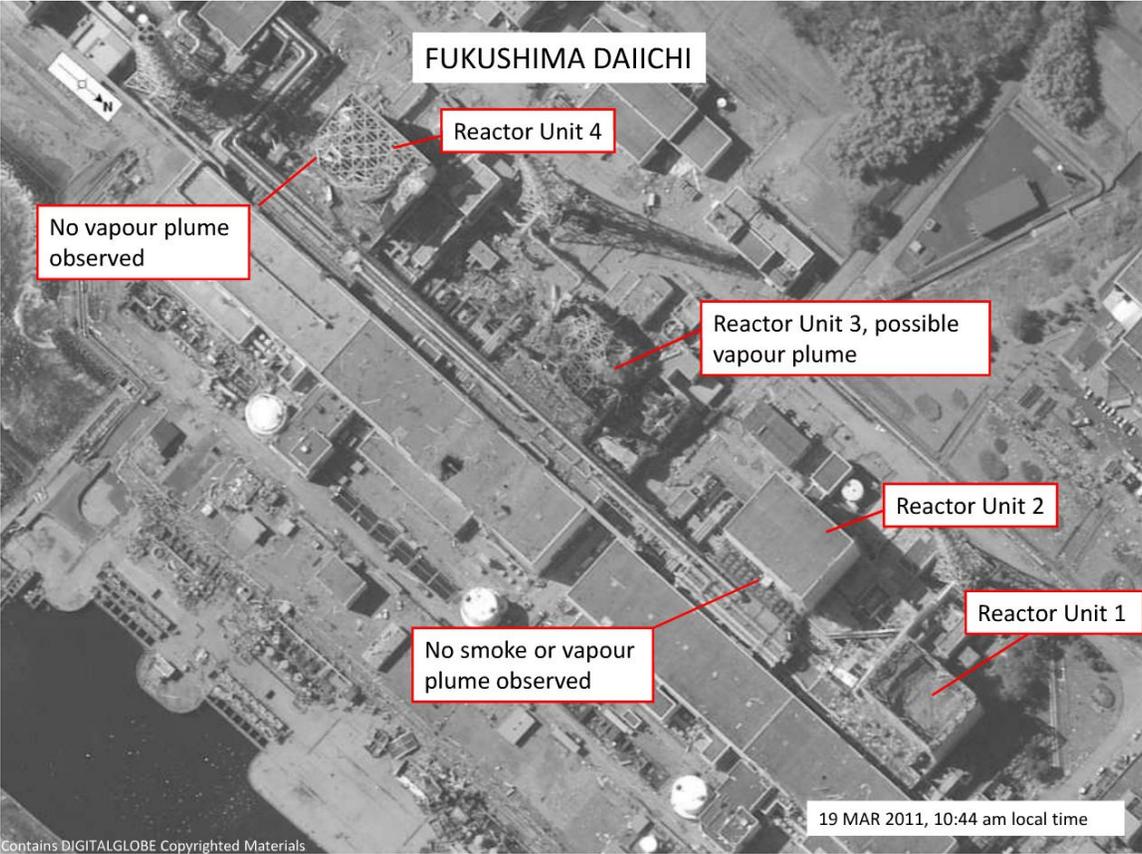
Figure 11. Satellite image taken at 11:44am on March 19 from an IAEA presentation. The IAEA does not observe a plume at the unit 4 building or unit 2 building. The IAEA does observe a possible plume above unit 3 building.

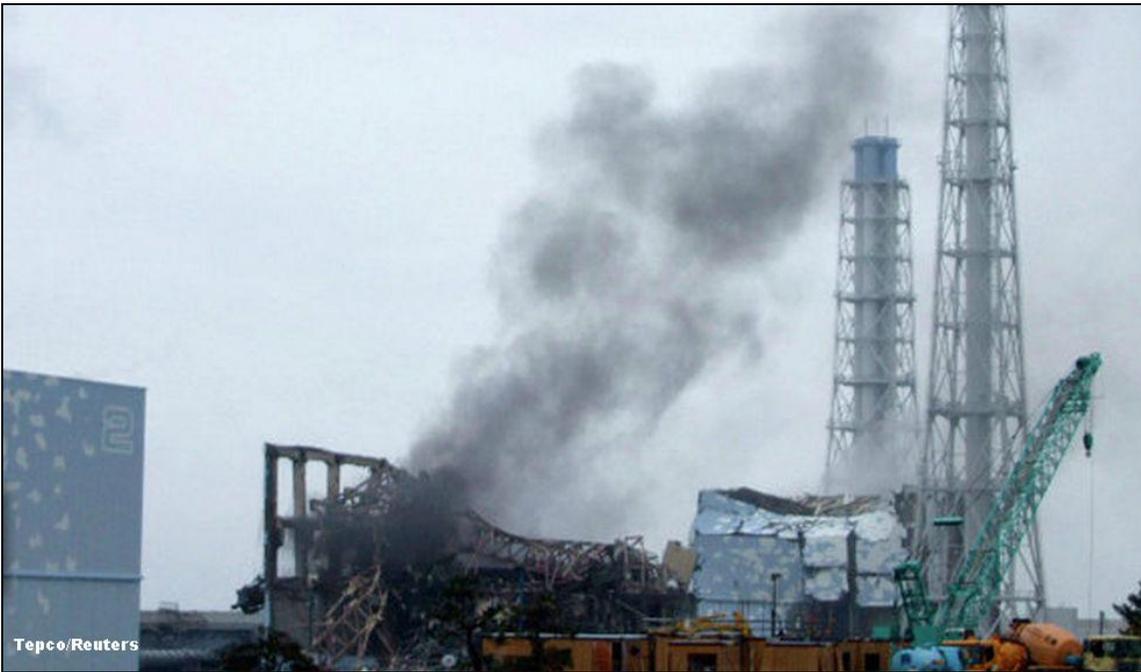
Figure 12. TEPCO/Reuters photograph from March 21 showing smoke rising from unit 3 building.

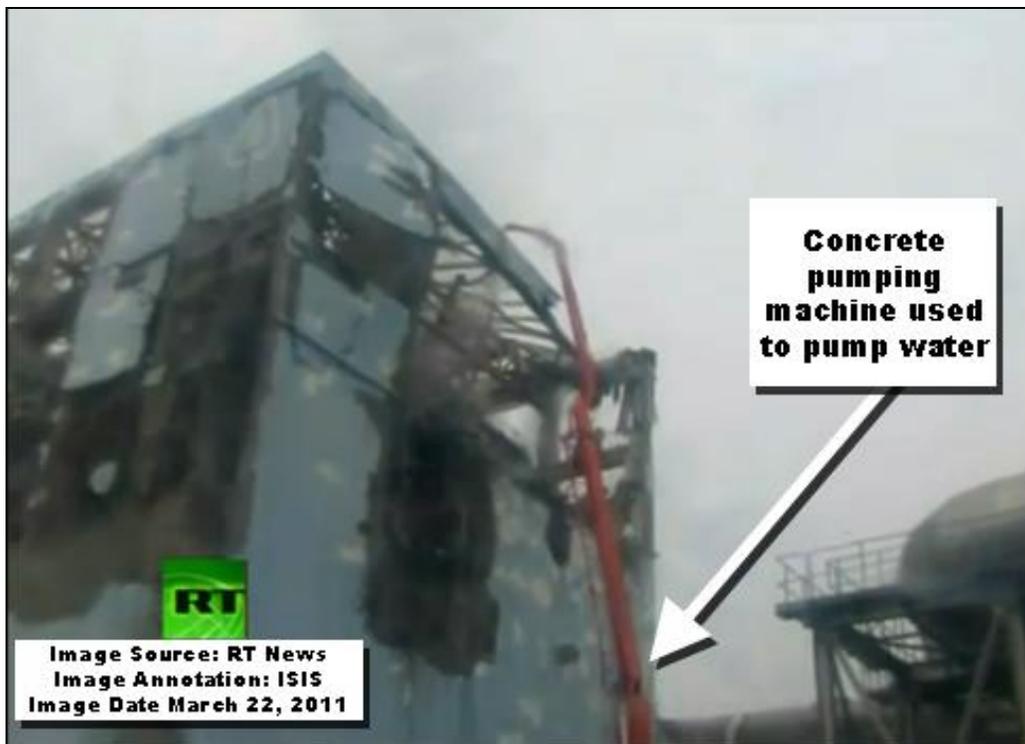
Figure 13. Still from RT News video from March 22, 2011 showing what the Federation of Electric Power Companies of Japan describes as a concrete pumping machine pumping water into the spent fuel pool in the unit 4 building. In the video, see [here](#), a plume of either steam or smoke can be seen rising from the building.
