# **Effects of the Earthquake and Tsunami on the Fukushima Daiichi and Daini Nuclear Power Stations**

May 24, 2011

Tokyo Electric Power Company

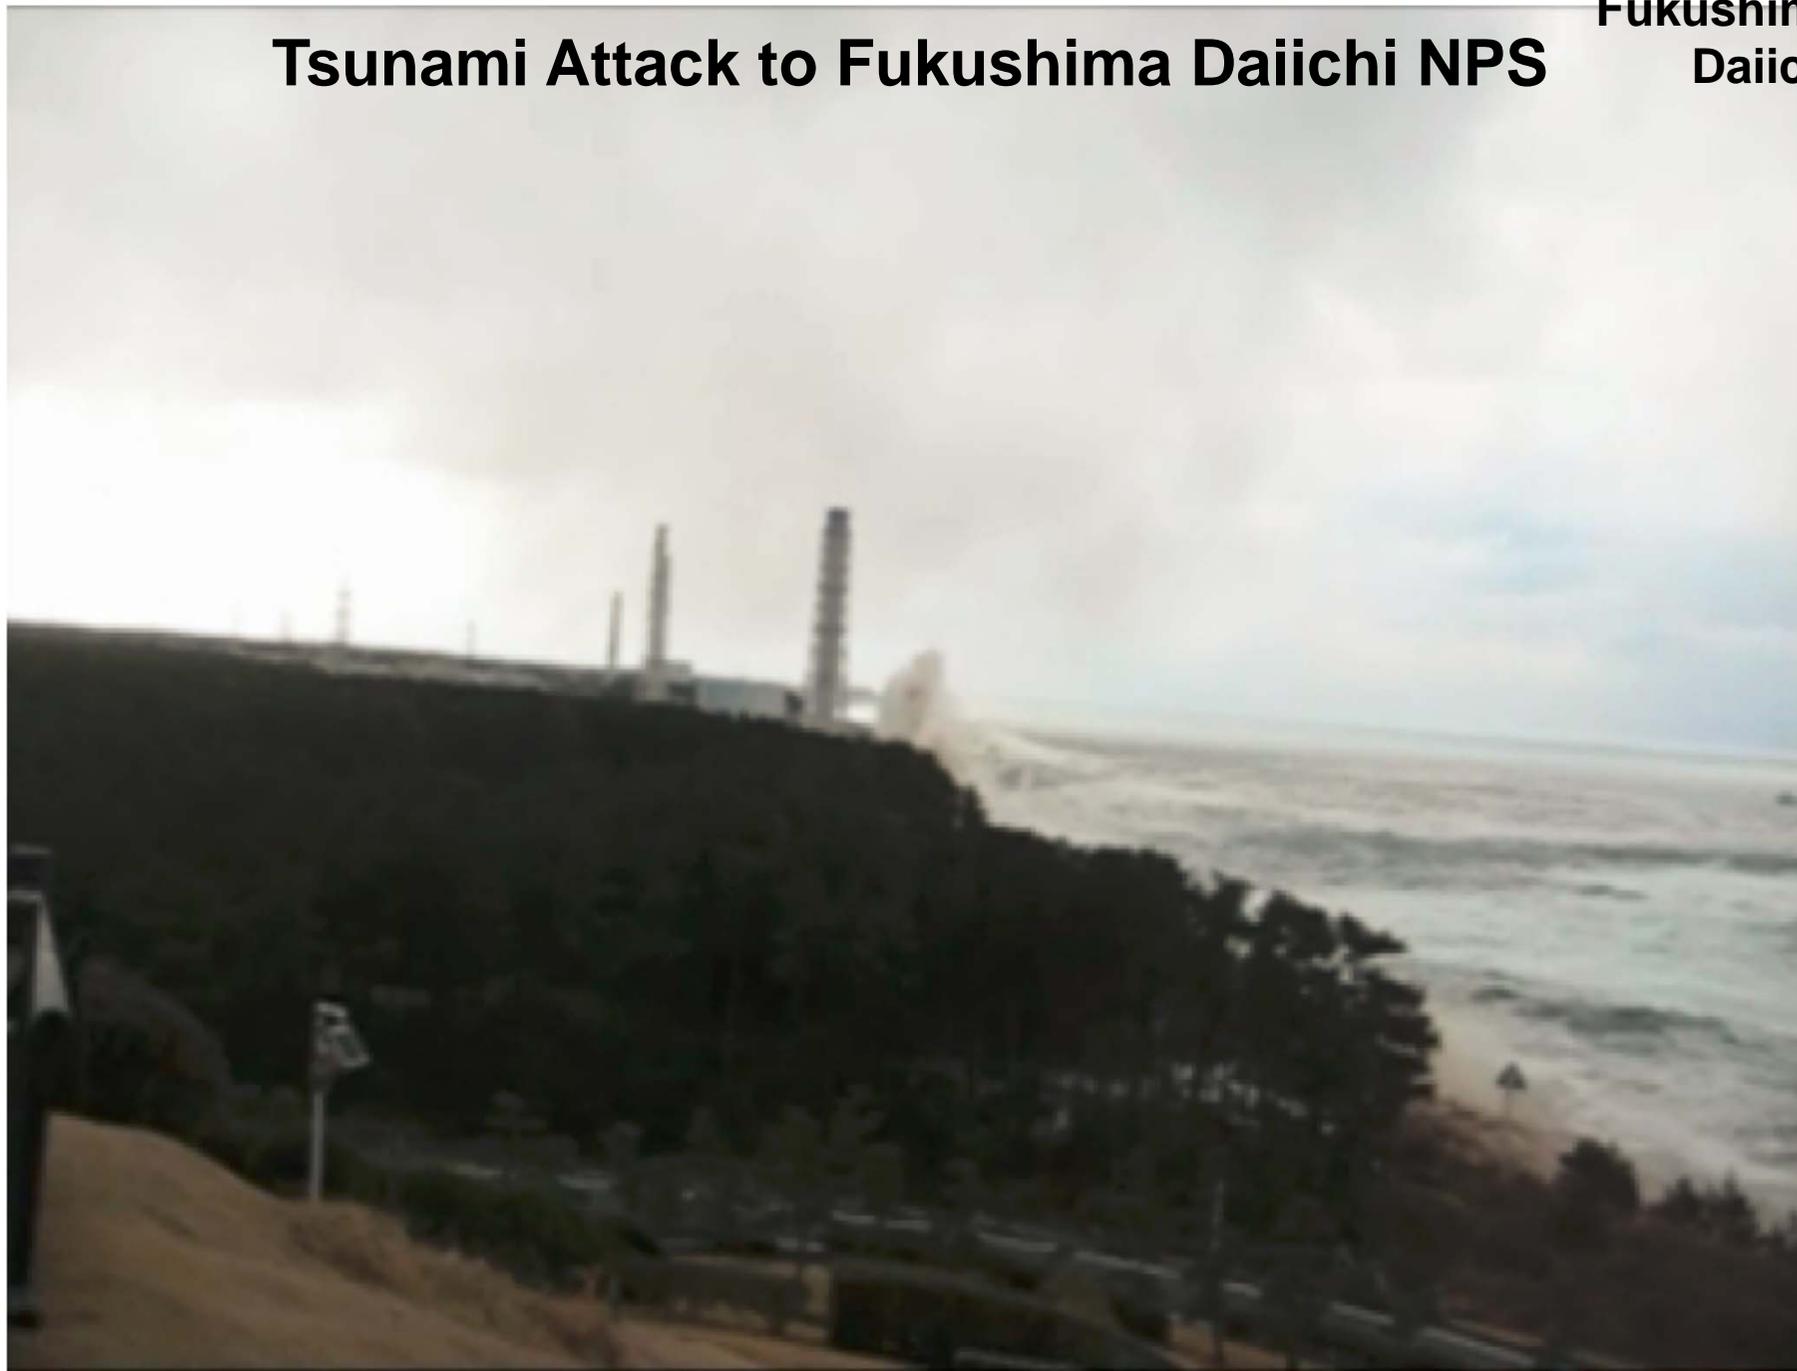
# Tsunami Attack to Fukushima Daiichi NPS

- Both Fukushima Daiichi and Daini suffered extensive damage due to the tsunami.
- Fukushima Daiichi experienced more flooding in comparison to Daini, and suffered more primary damage

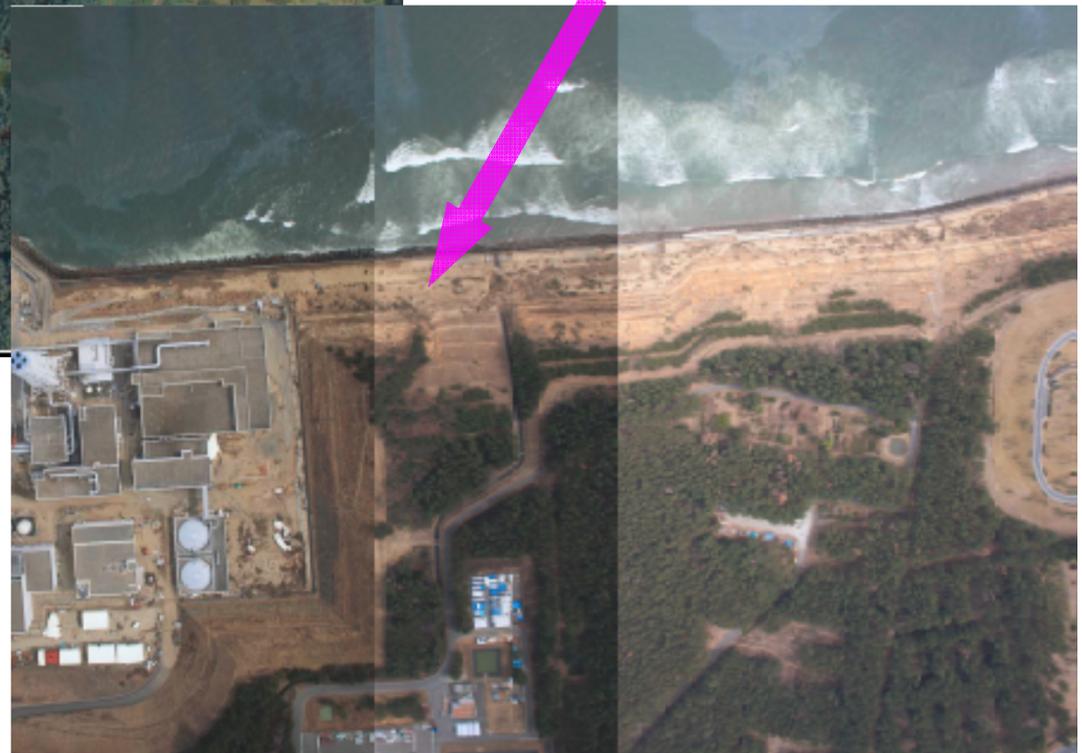
**Trees were stripped away**

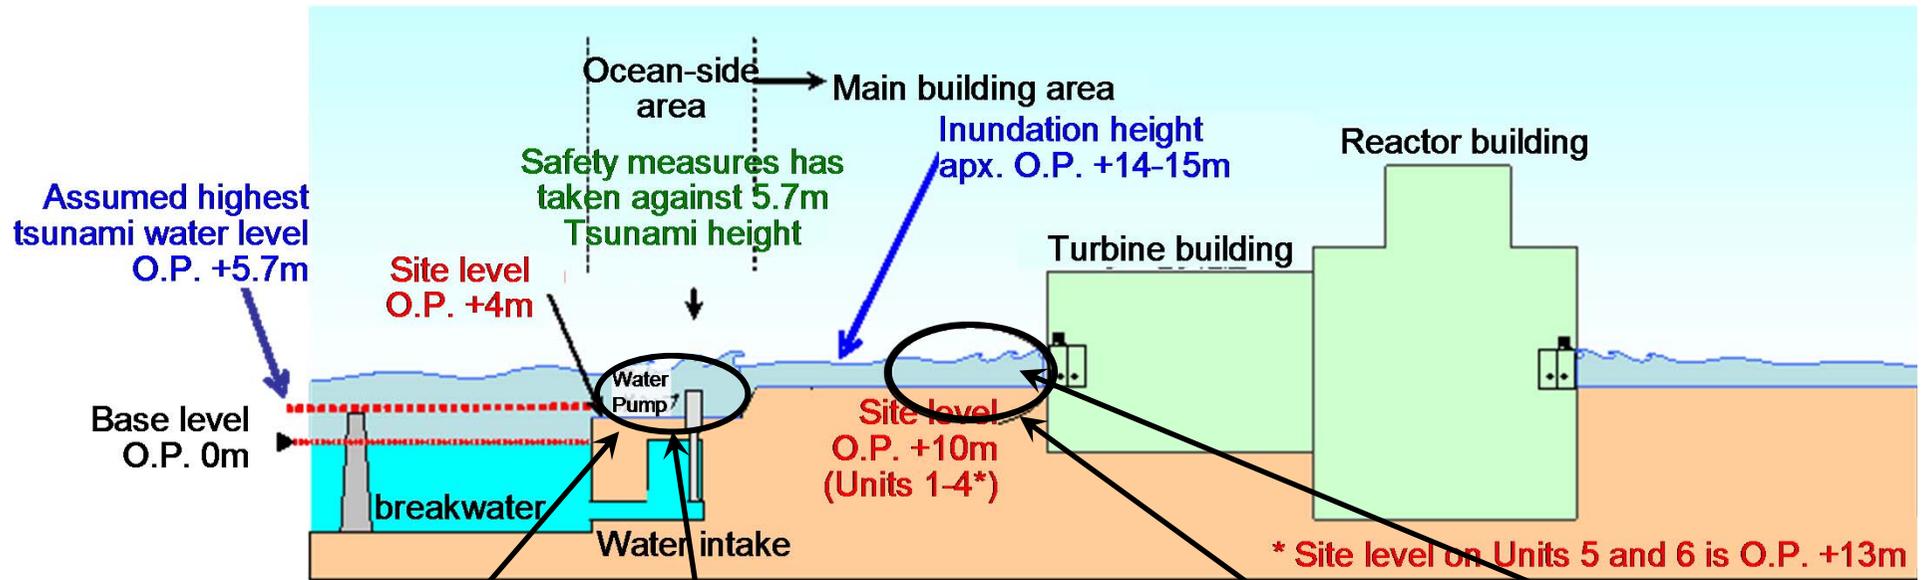
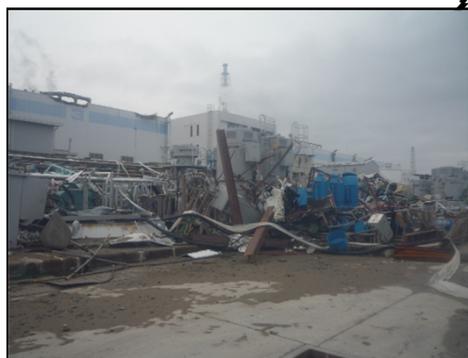
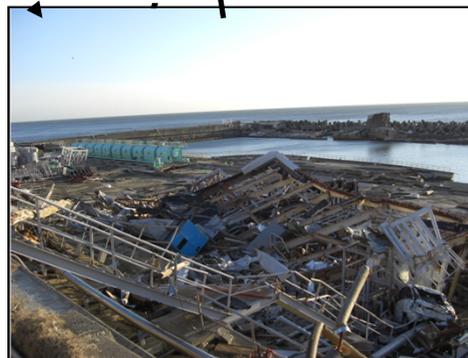
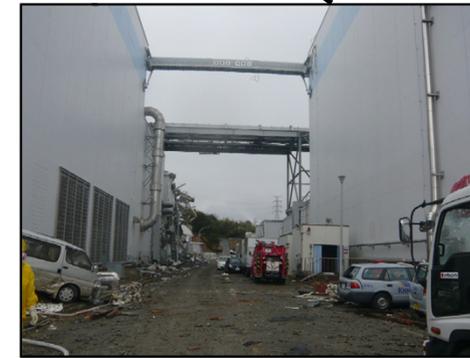
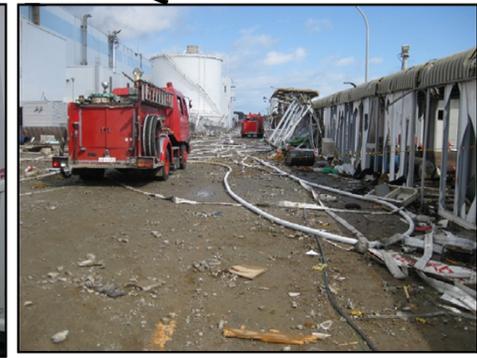
# A tsunami about 14m high swept over the entire site of Fukushima Daiichi, with flood waters reaching depths of 4 to 5m

Inundation height  
apx. O.P. +14-15m

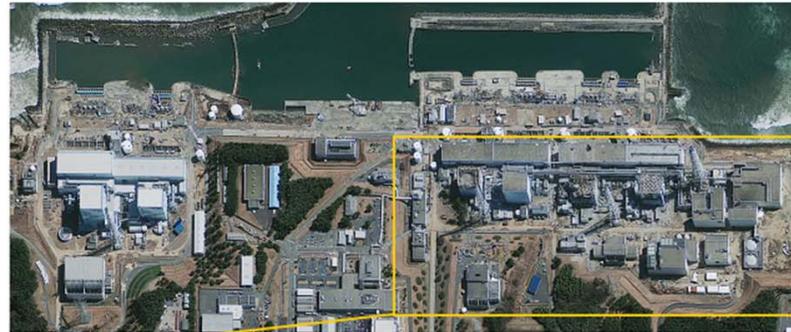
## Adrift equipments at Fukushima Daiichi NPS ①

Area away from the coast was also flooded

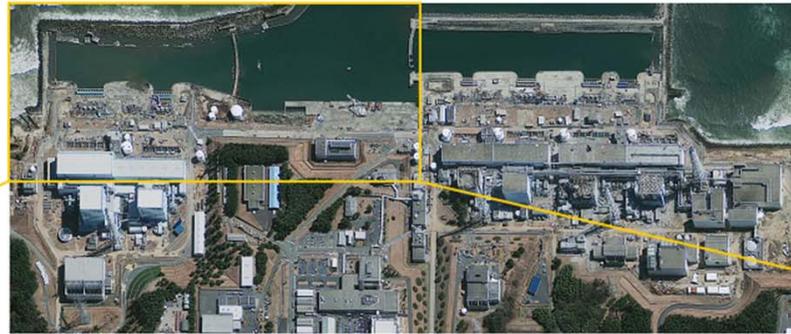
**Adrift equipments at Fukushima Daiichi NPS ②**

Breakwater was corrupted

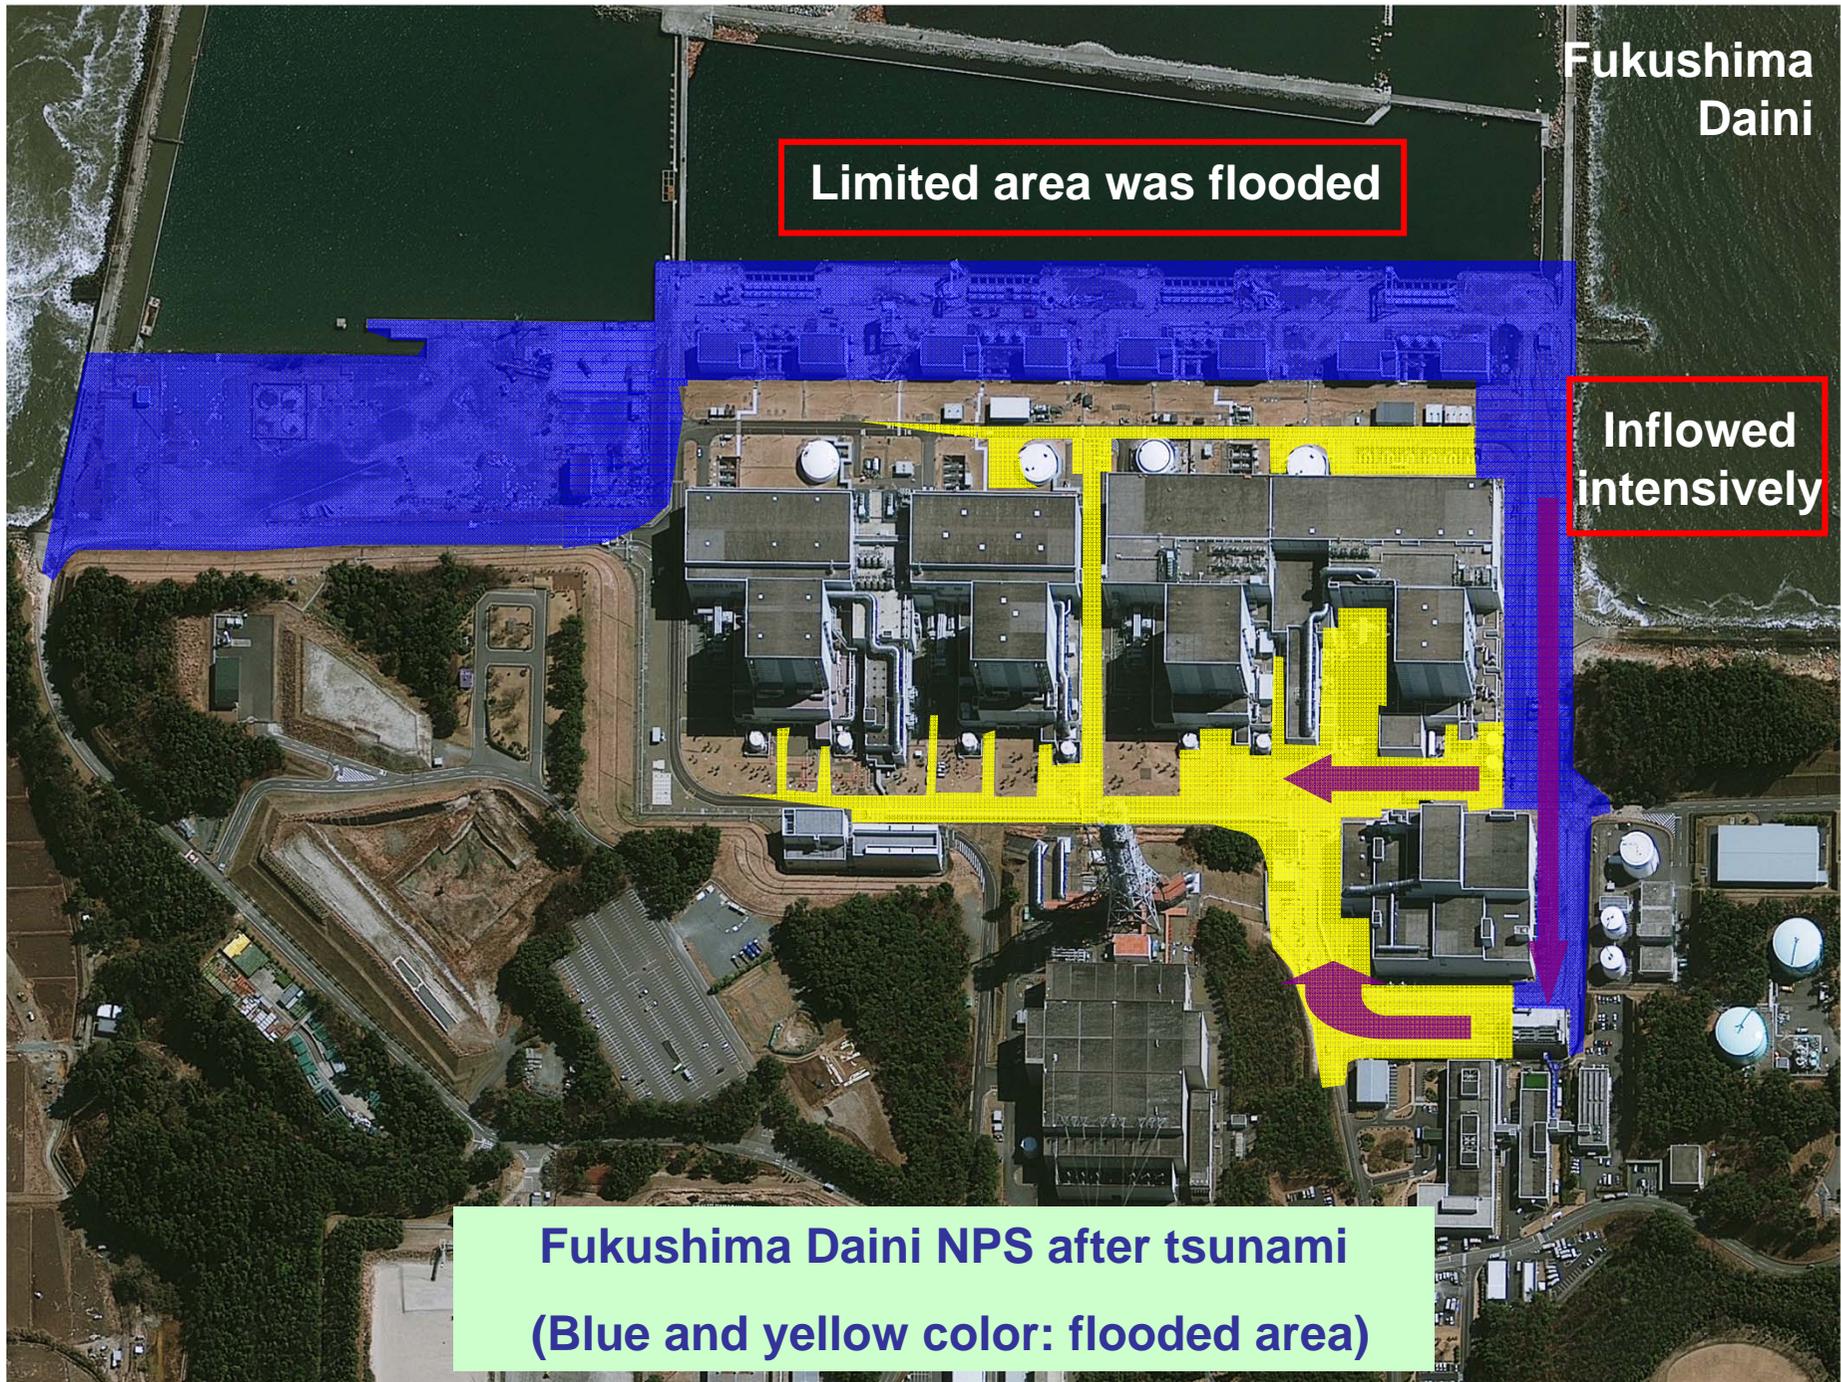
**Fukushima Daini NPS after tsunami**

At Fukushima Daini, the height of the tsunami was about 14m on the south side of Unit 1, where it was highest, but the overall height was 7m, and the plant suffered less damage compared to Fukushima Daiichi.

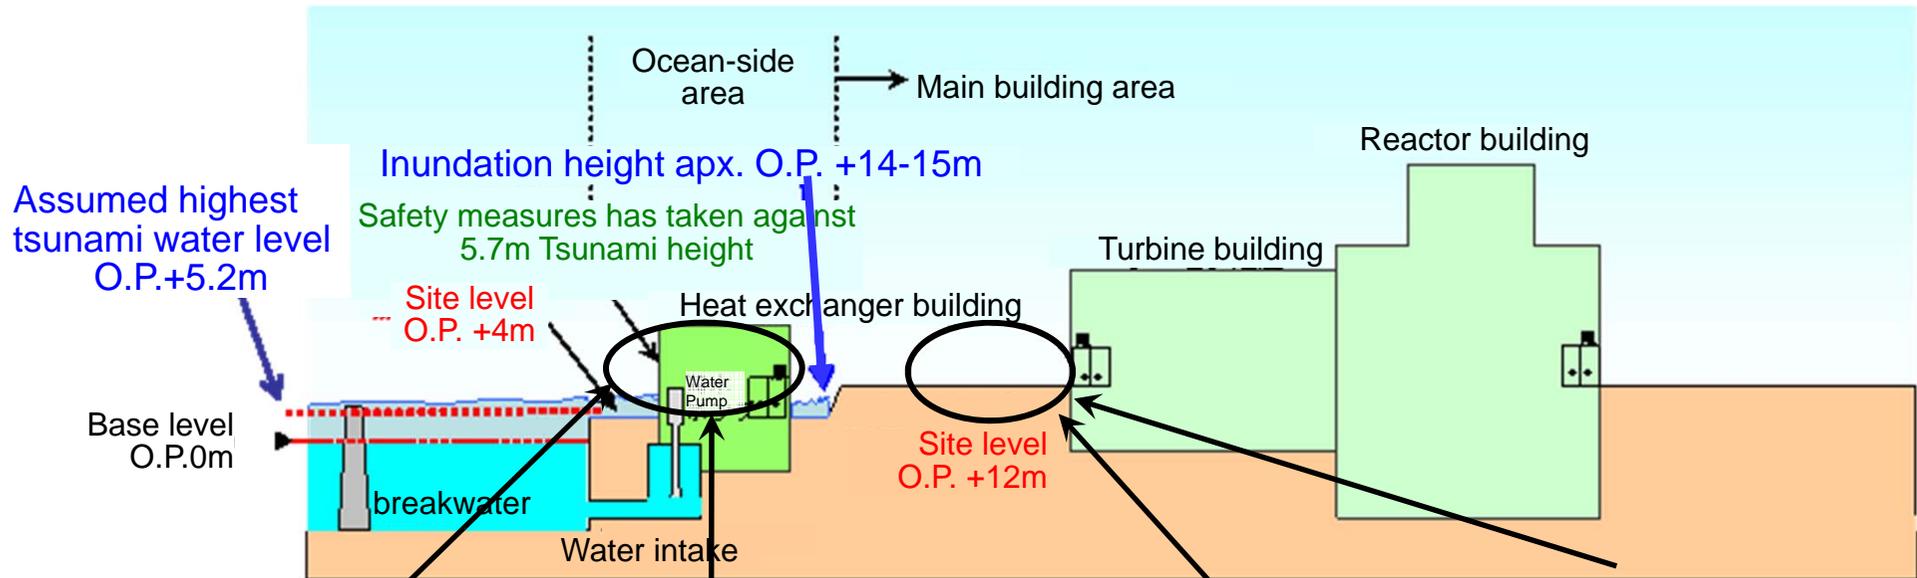
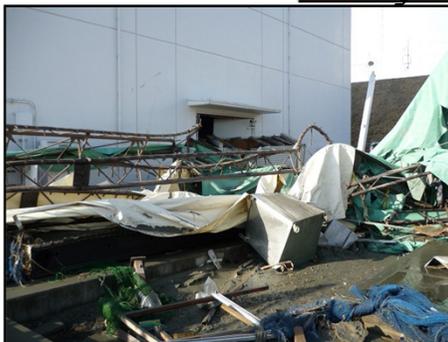
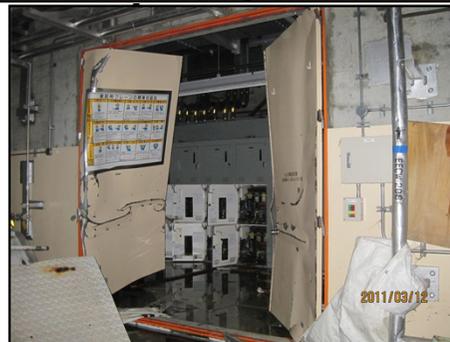
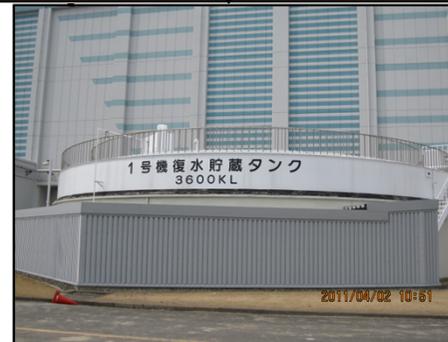
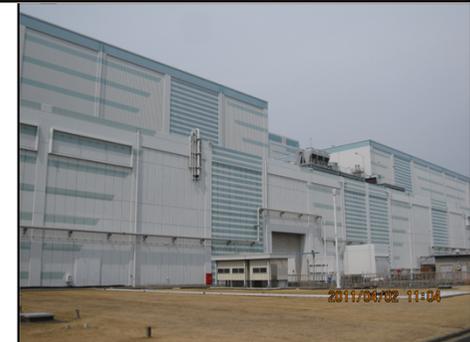
**Fukushima Daini Nuclear Power Station**  
**Flooding height and depth, etc.**  
**(Further investigations are currently underway)**

Assumed highest  
tsunami water level  
O.P.+5.2m

Inundation height apx. O.P. 7m  
(South of Unit 1 O.P. +14-15m)

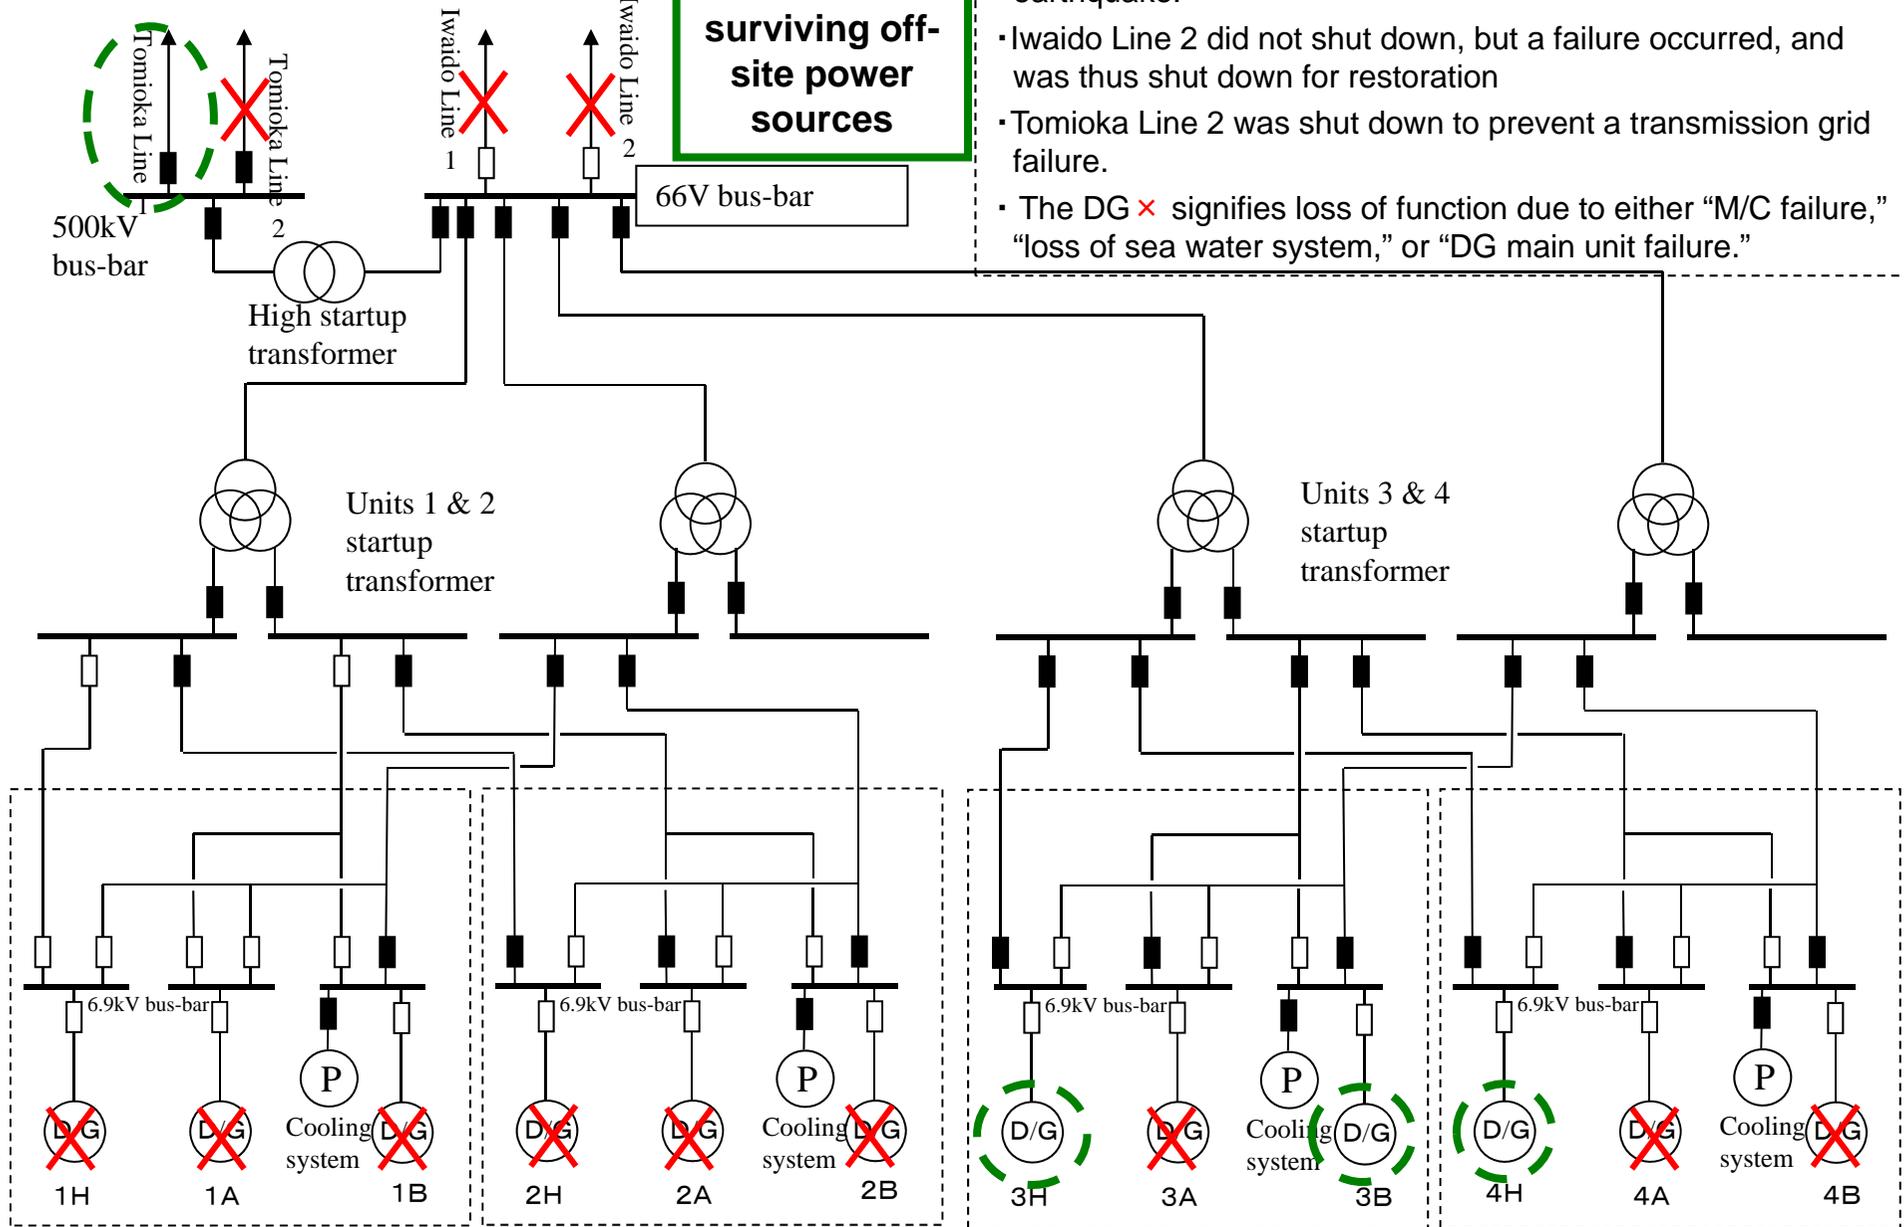
**Some surviving off-site power sources**

- Inspection of the Iwaido Line 1 was in progress from before the earthquake.
- Iwaido Line 2 did not shut down, but a failure occurred, and was thus shut down for restoration
- Tomioka Line 2 was shut down to prevent a transmission grid failure.
- The DG ~~×~~ signifies loss of function due to either “M/C failure,” “loss of sea water system,” or “DG main unit failure.”

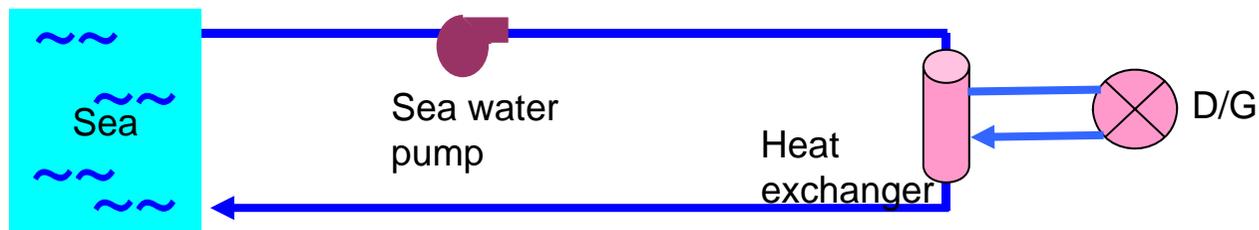
### Sea water-cooled DG (10)

All function was lost after the tsunami

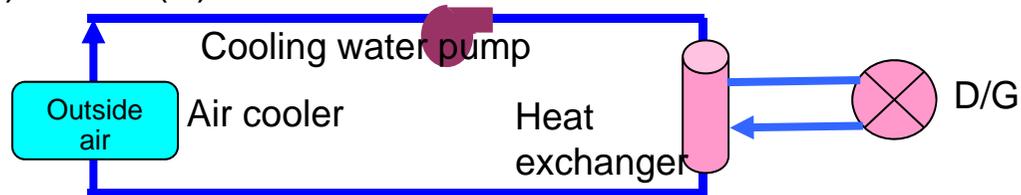
### Air-cooled DG (3)

Power was secured in Unit 6 (B) only

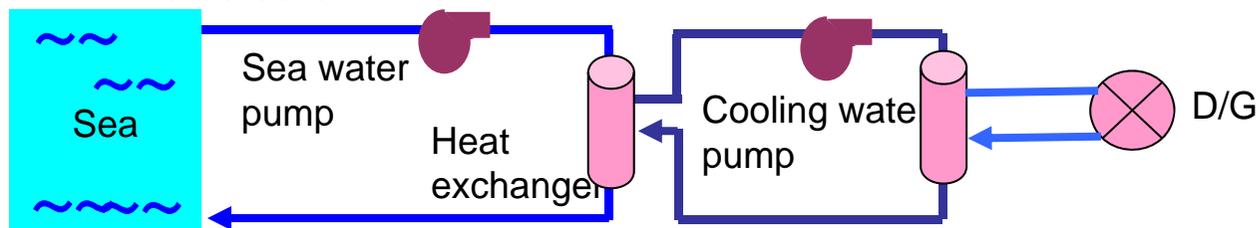
### Sea water-cooled DG (12)

Power was secured in Unit 3 (B)(H) and Unit 4 (B) only

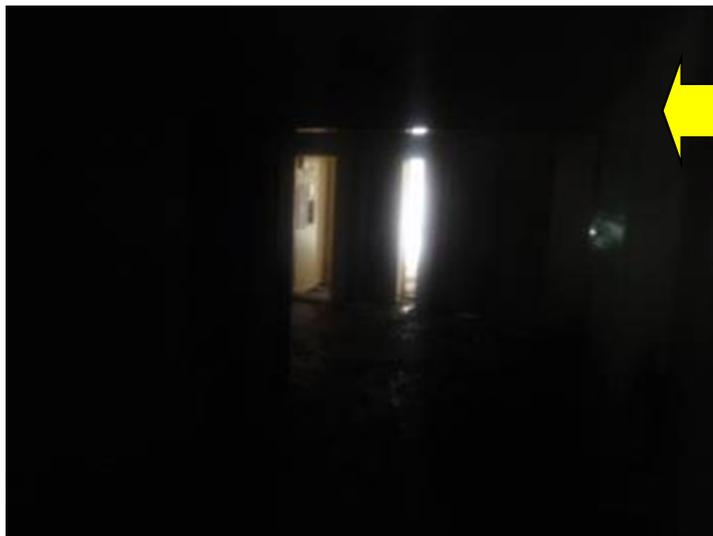
### Work in complete darkness

Photo of the Service Building entrance taken from inside the building. Objects were scattered on the floor.

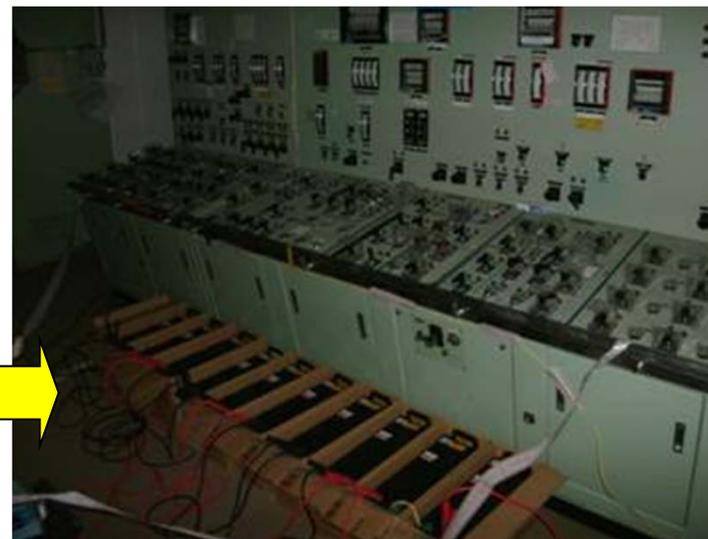
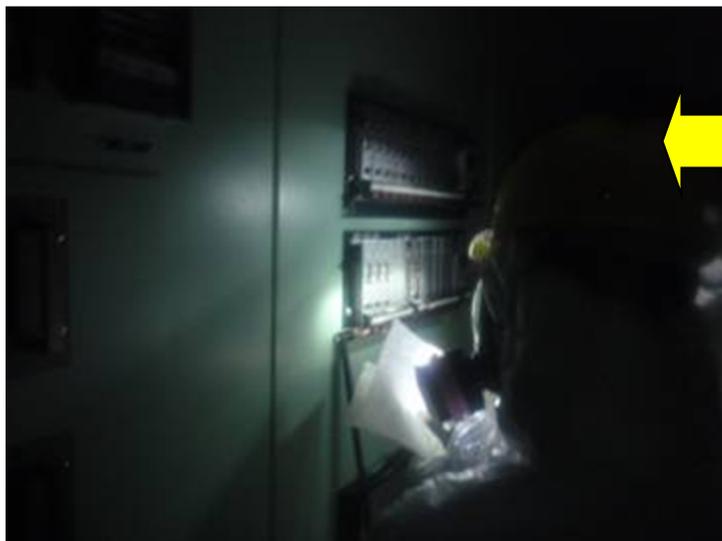
### Temporary instrument power

As there was no power, temporary batteries were connected and used as a power supply for instruments.

Confirmed readings in complete darkness using a light
