Reactor Division

MSRE SYSTEMS AND COMPONENTS PERFORMANCE

JUNE 1973

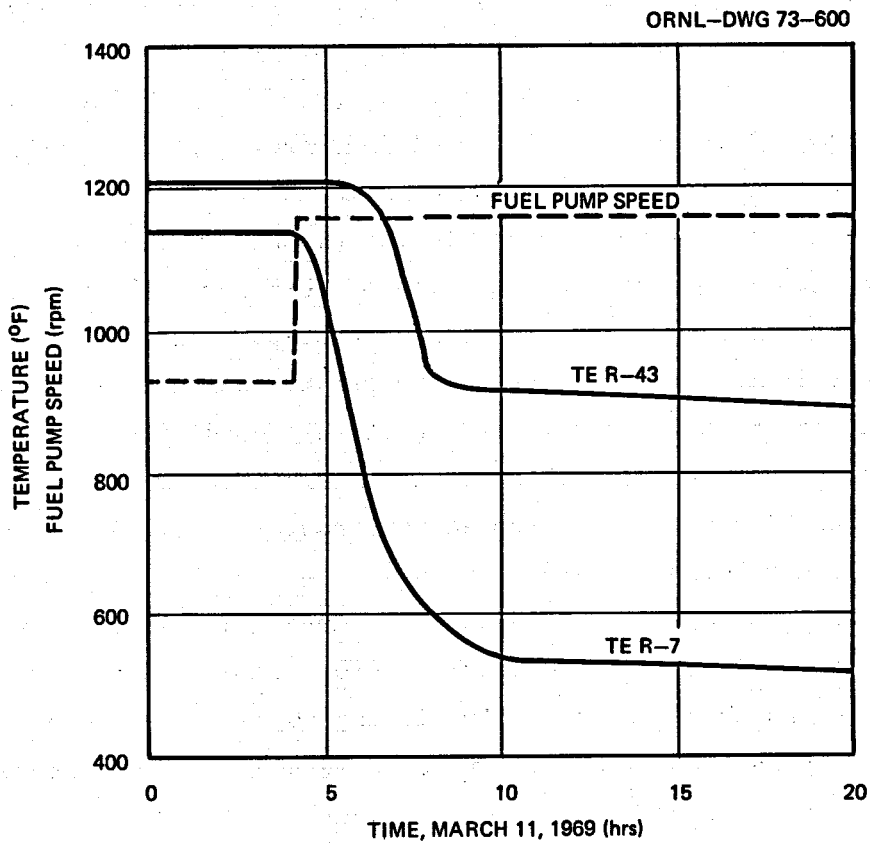
Fig. 5.13 Effect of Fuel Pump Speed (i.e. circulating bubbles) on Reactor-Access Nozzle Salt Level (as indicated by wall temperatures)

The effect of a direct change in the amount of circulating bubbles can be seen in Fig. 5-13. At the beginning of this period the fuel-pump speed was lower than normal and it can be seen that the RAN salt level was very high. Other indications such as the reactivity balance led to the conclusion there were no bubbles circulating at this condition. When the fuel-pump speed was increased, with no other change in operating temperature or pressure, the RAN salt level dropped very rapidly. (Note the abscissa in Fig. 5-13 is now hours instead of days.)

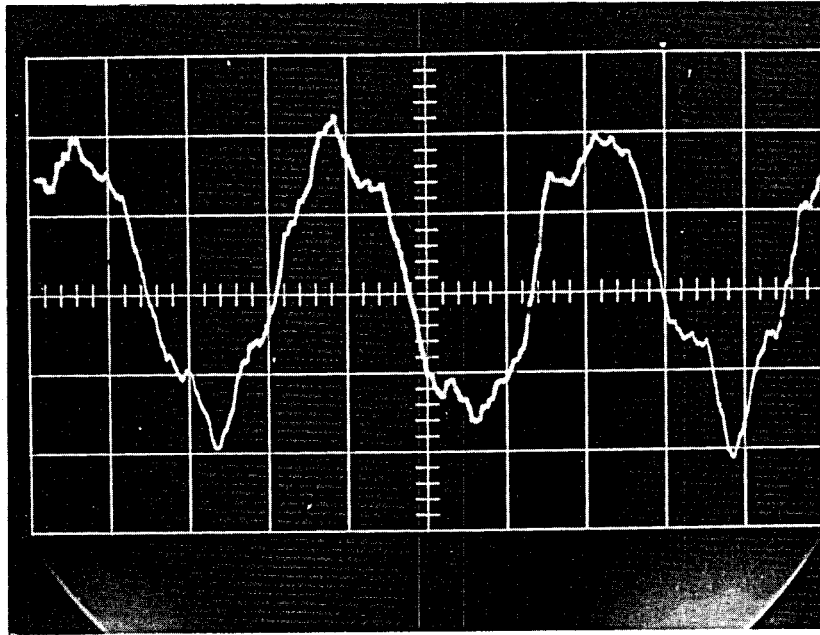
Normal Trace - Taken 12/19/67

The operating experience with the vibration monitoring system has clearly shown that the displacement meter alone is not adequate to monitor the condition of the bearings. Some system of maintaining a history of the frequency spectrum is also required. We used photographs of the oscilloscope trace to document the normal operating vibrations, and additional

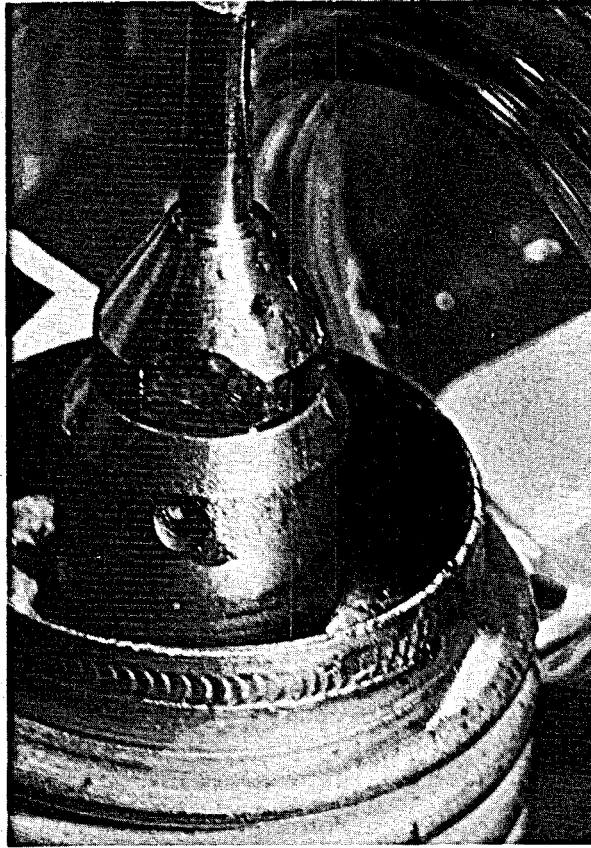
PHOTO R27812

Examination of PCV-522 — The stem of the control valve shown in Fig. 8.6A, was covered with an amber oil-like coating and there was an accumulation of oil in the recess formed by the bellows-to-stem adapter. The tapered flat (flow area) on the stem had small accumulations of solids; the body was coated with a similar material and had a semisolid mass of material on the surface near the seat port as shown in Fig. 8.6B. A gamma scan⁶ of this material indicated the presence of ⁸⁹Sr, ¹⁴⁰Ba, and ¹⁴⁰La.

Fig. 8.6A PCV-522 Valve Stem

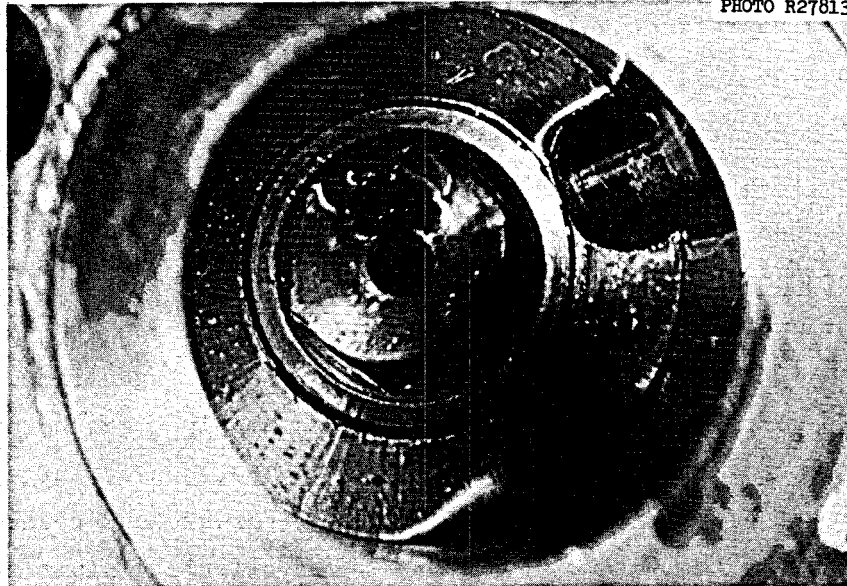
PHOTO R27813

Fig. 8.6B PCV-522 Valve Body

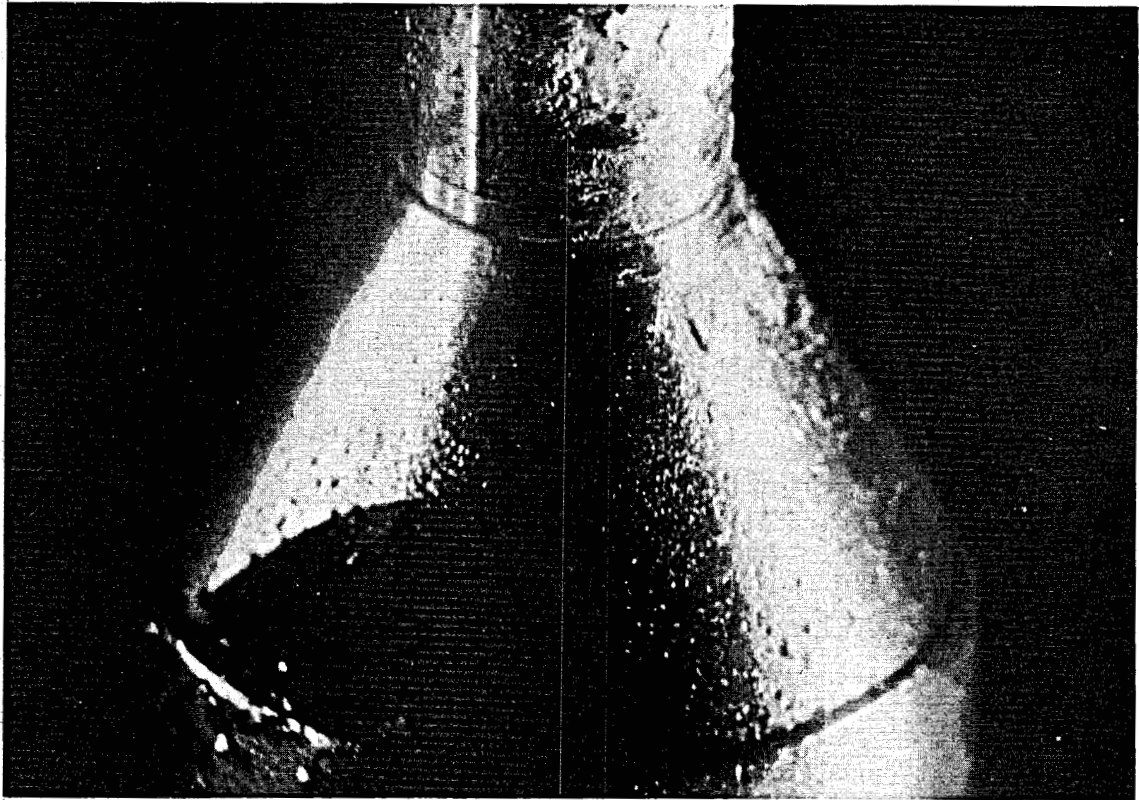
PHOTO R28500

The cone of the inlet valve to this bed (shown in Fig. 8.7) was shiny as though wet with an oil-like material. The small metallic chips near the large end of the cone were a result of the sawing operation. There was some white amorphous powder on the tapered section of the valve trim and appeared to be adhered fairly strongly to the metal surface. A similar material was found in the valve body. The material removed from the stem was described as an isotropic, faintly colored material, varnishlike in appearance with a pebbly surface. The predominant isotope in the material was ^{132}Te . The refractive index of the varnishlike material was 1.526 compared with 1.50 for a distilled fraction of the lubricating oil used in the fuel pump.⁶

Fig. 8.7 Charcoal Bed Inlet Valve Stem HV-621

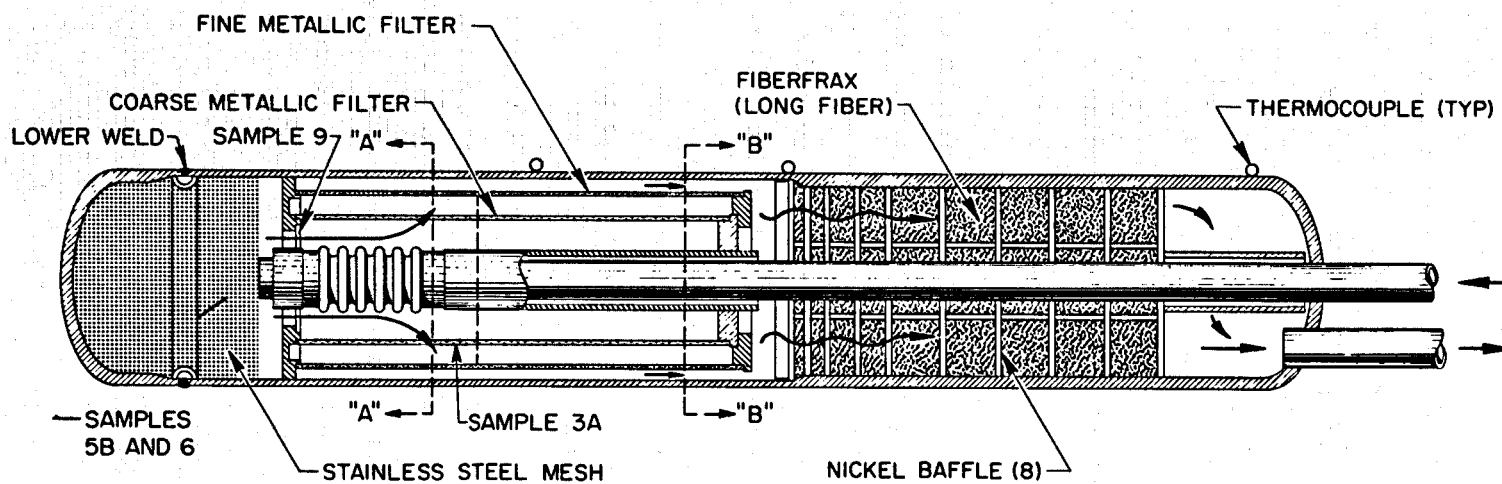
As a result of extensive laboratory tests on organic vapor traps,⁷ the filter-valve assembly was replaced with a particle trap and an organic vapor trap in series and upstream of the pressure control valve (PCV-522) whose flow coefficient was increased to 0.865. The Mark I particle trap,⁷ shown in Fig. 8.8 was designed to remove particulates and mist. Gas from the fuel-pump bowl entered at the bottom of the unit through a central pipe, reversed flow in the Yorkmesh, and passed in succession through two concentric cylinders of porous metal (felt metal) and a bed of inorganic fibers. The first felt metal filter was capable of stopping 96.7% of particles greater than 0.8 μ and the second — 99.4% particles greater than 0.3 μ .

Fig. 8.8 Line 522 Particle Trap (Mark I) and Location of Sampling Points During Subsequent Examination

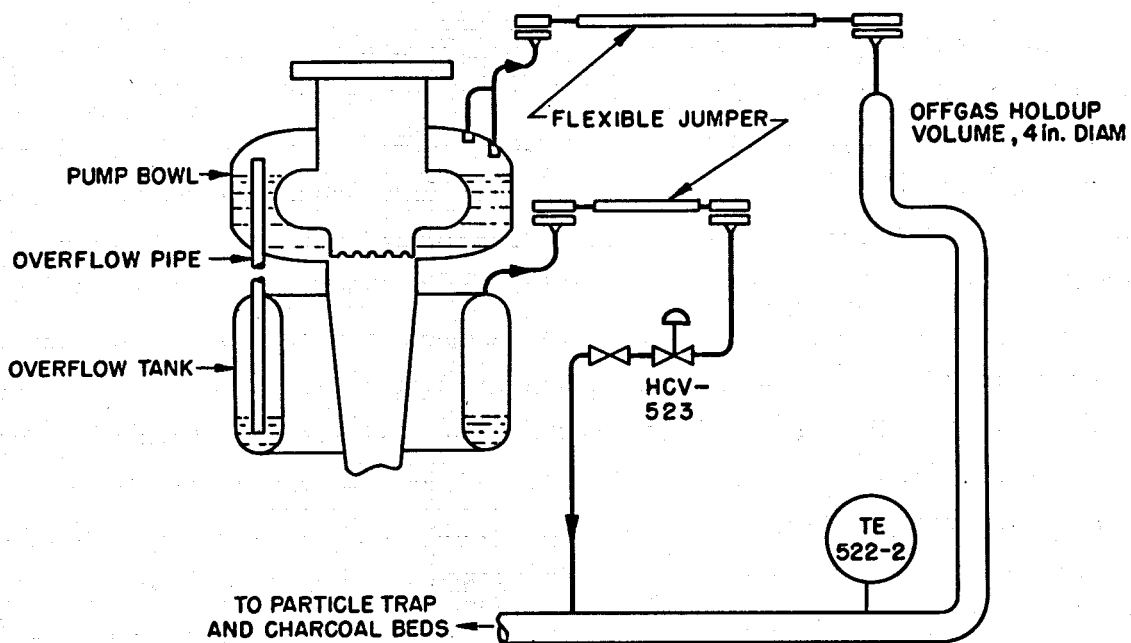
ORNL-DWG 67-4764

Fig. 8.9 Off-Gas Piping Near Fuel Pump and Overflow Tank

fuel salt at low power. Then, two days after power operation was resumed at 5.8 MW, a plug developed in line 522 somewhere between the pump bowl and the junction of the overflow tank vent with the 4-in. holdup line. The first indication was a decrease over a few hours from 107°C to 71°C at TE-522-2, as the plug caused the off-gas to bypass through the overflow tank (OFT). The presence of the plug was confirmed when HCV-523 was closed to build up pressure in the OFT to return salt from the tank to the pump bowl; pressure in the pump bowl also built up. Efforts to remove the restriction by applying a 10-psi differential either forward or backward were unsuccessful.

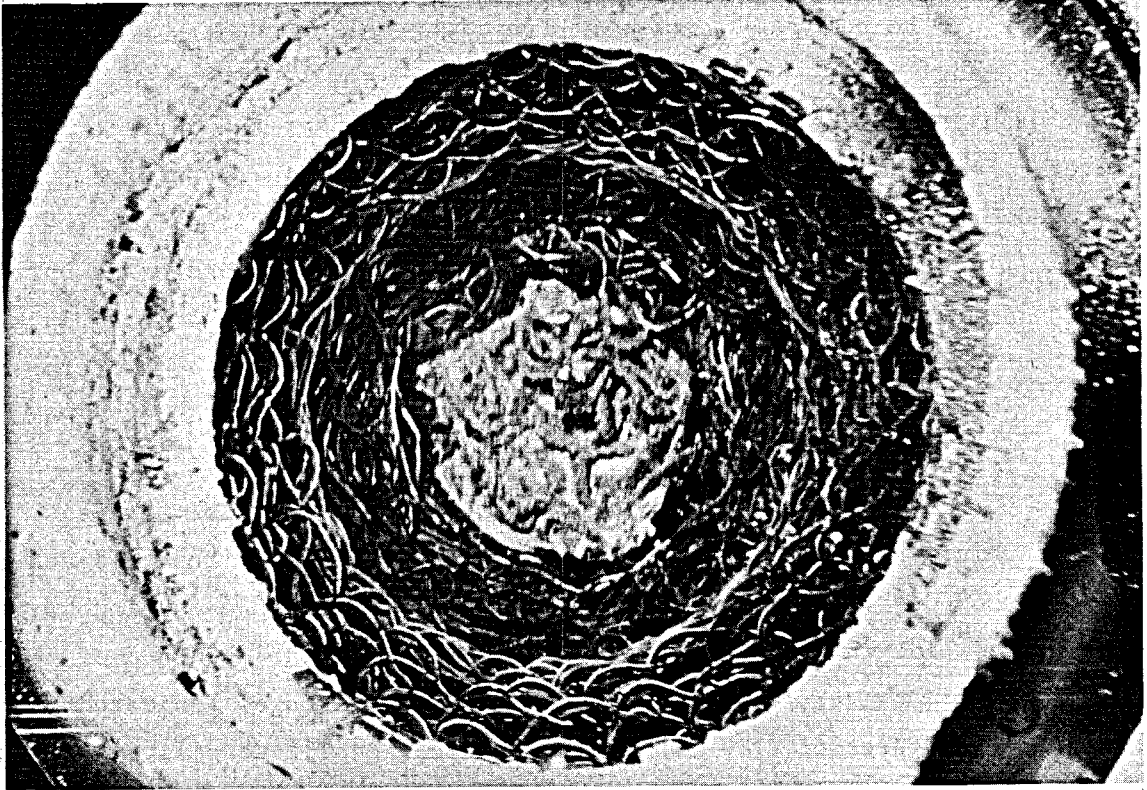
PHOTO R32824

Since the inlet pipe temperature probably increased several hundred degrees during power operation of the reactor, it is believed that this restriction behaved similar to a thermal valve. This could account for the unexpected increase in pressure drop while at power and the decrease in pressure drop when the power was reduced or when the off-gas was delayed via the drain tank.

Fig. 8.10 Inlet to Yorkmesh Section MSRE Particle Trap Mark I

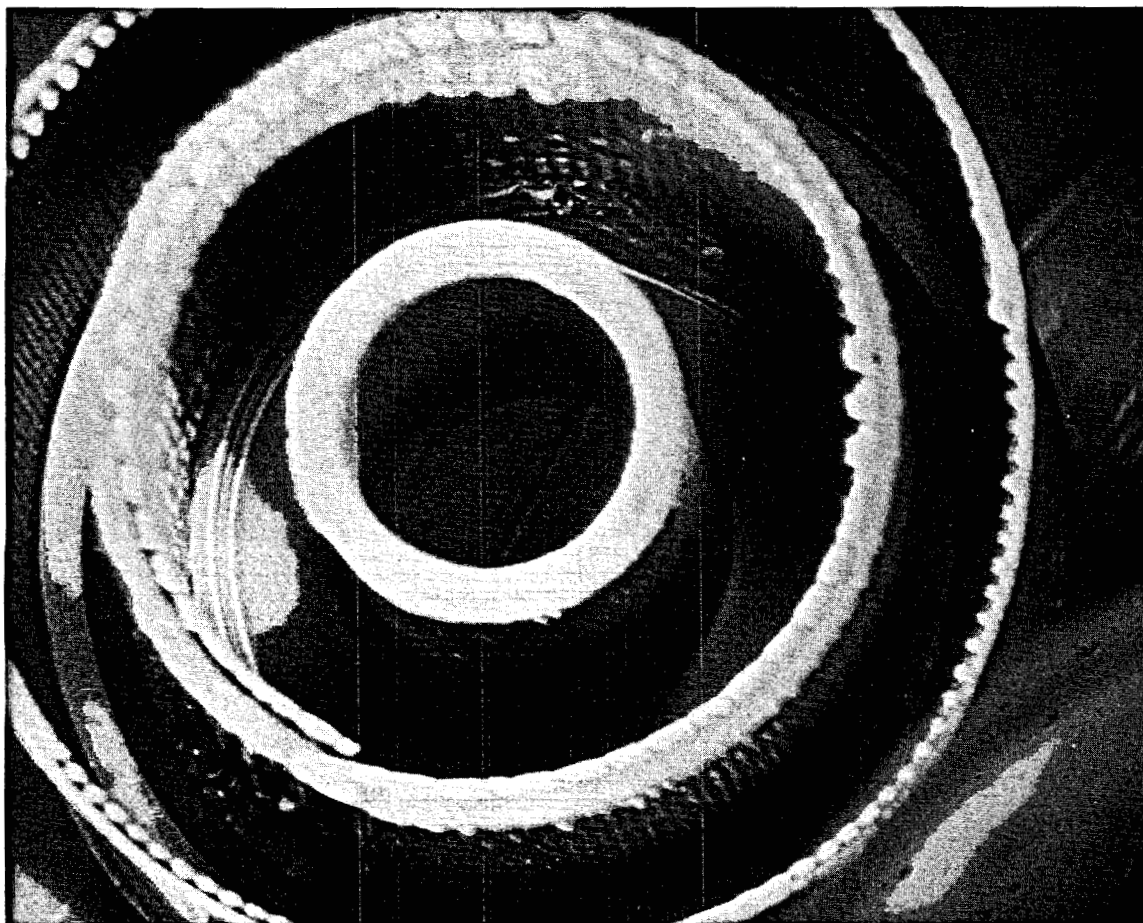
It is believed that these coatings were deposited by condensation and sputtering of the oil from the adjacent filter and that the dark brown color indicates that the porous metal screen had operated at a much higher temperature than had the outer wall (during operation the trap was immersed in a tank of water for cooling by natural convection). The lower surface of the upper flange (view B-B, Fig. 8.8) contained a deposit which had the appearance of organic residue. The deposit was amber colored, and the fractured edge (Fig. 8.11) gave the impression that the material was brittle. There is as yet no explanation for formation of this deposit or how it came to be formed in this particular location. The radiation level on the outside of this section of the filter was 200 to 360 R/hr.

Fig. 8.11 Upper End of Porous Metal Section — MSRE Particle Trap Mark I

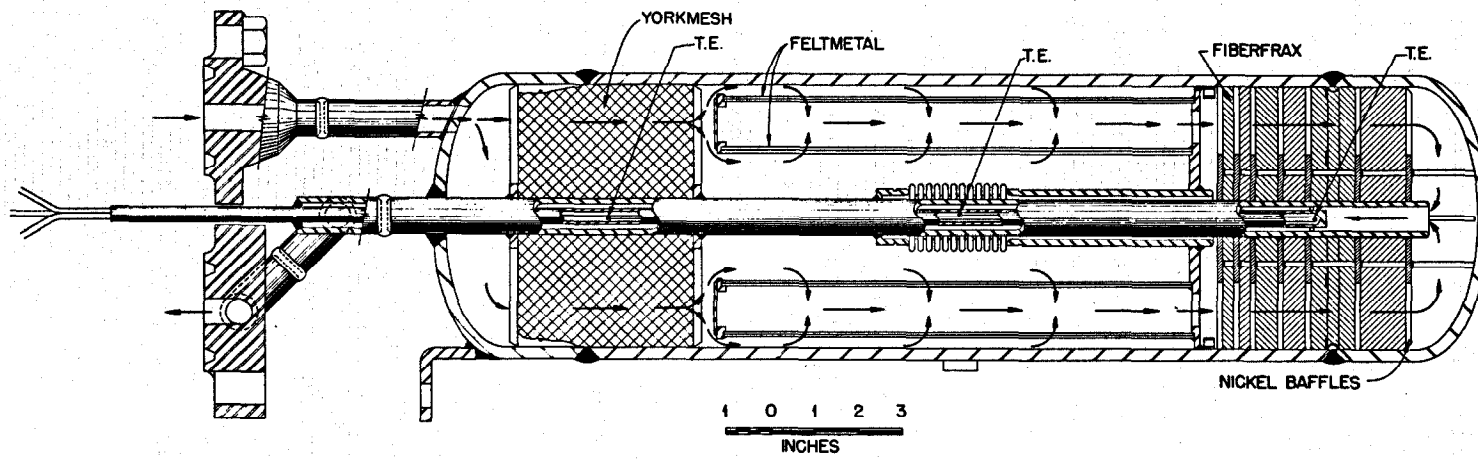
ORNL-DWG 67-4766

Fig. 8.12 Line 522 Particle Trap Mark II, Particle Trap Subassembly

As a result of the operating experience with and detailed examination of the first particle trap, the MK-II trap,⁶ (shown in Fig. 8.12) was designed with the following features:

Since the pressure control valve (PCV-522) was operated in the fully-opened position and it appeared that nothing would be lost by eliminating the charcoal trap, both were removed to make room for two new MK-II particle traps which were installed in parallel in January 1967.

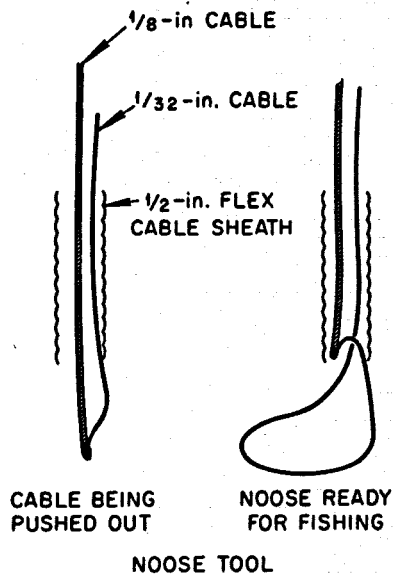
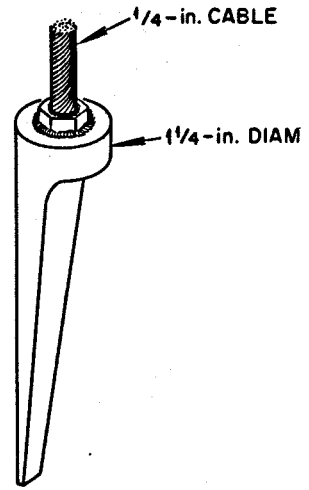
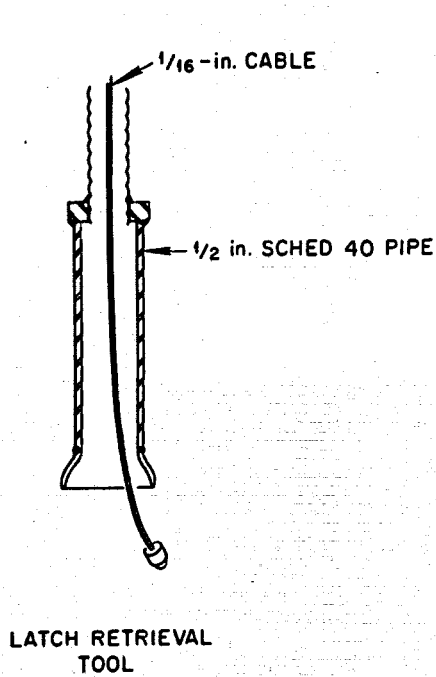
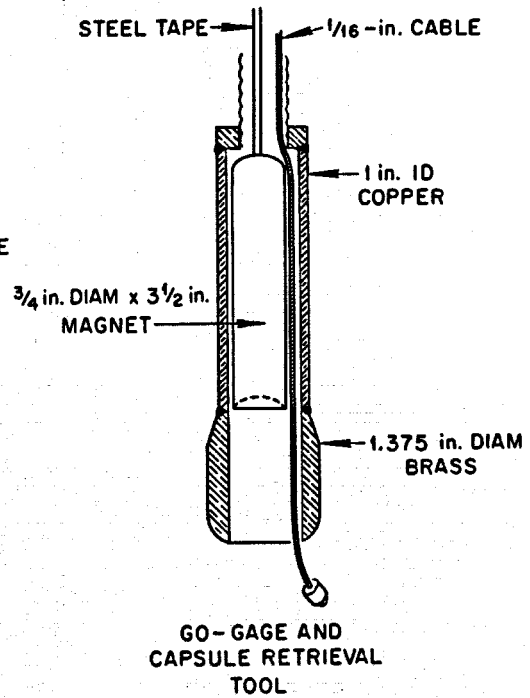
ORNL-DWG 67-11788

reactor drained before repair. No resistance was detected until the valve was practically closed. Therefore, both valves were closed and when Area 1C was opened, as expected, the cable was coiled up within; however the latch, capsule, and about 6 in. of cable were missing. The reactor was then drained and grappling tools were fabricated of flexible tubing and cables which could be inserted through the sampler into the pump bowl. Four of the five tools which were most successful at grasping a dummy latch are shown in Fig. 18.3.

Fig. 18.3 Tools Developed for Retrieval of Latch and Capsule from Sampler-Enricher

While retrieval efforts were in progress, a replacement 1-C assembly which was on hand, was equipped with a latch made of 430 stainless steel and with a sleeve to prevent future tangling of the cable in the gears of the drive unit. However, subsequent examination of the old drive unit in

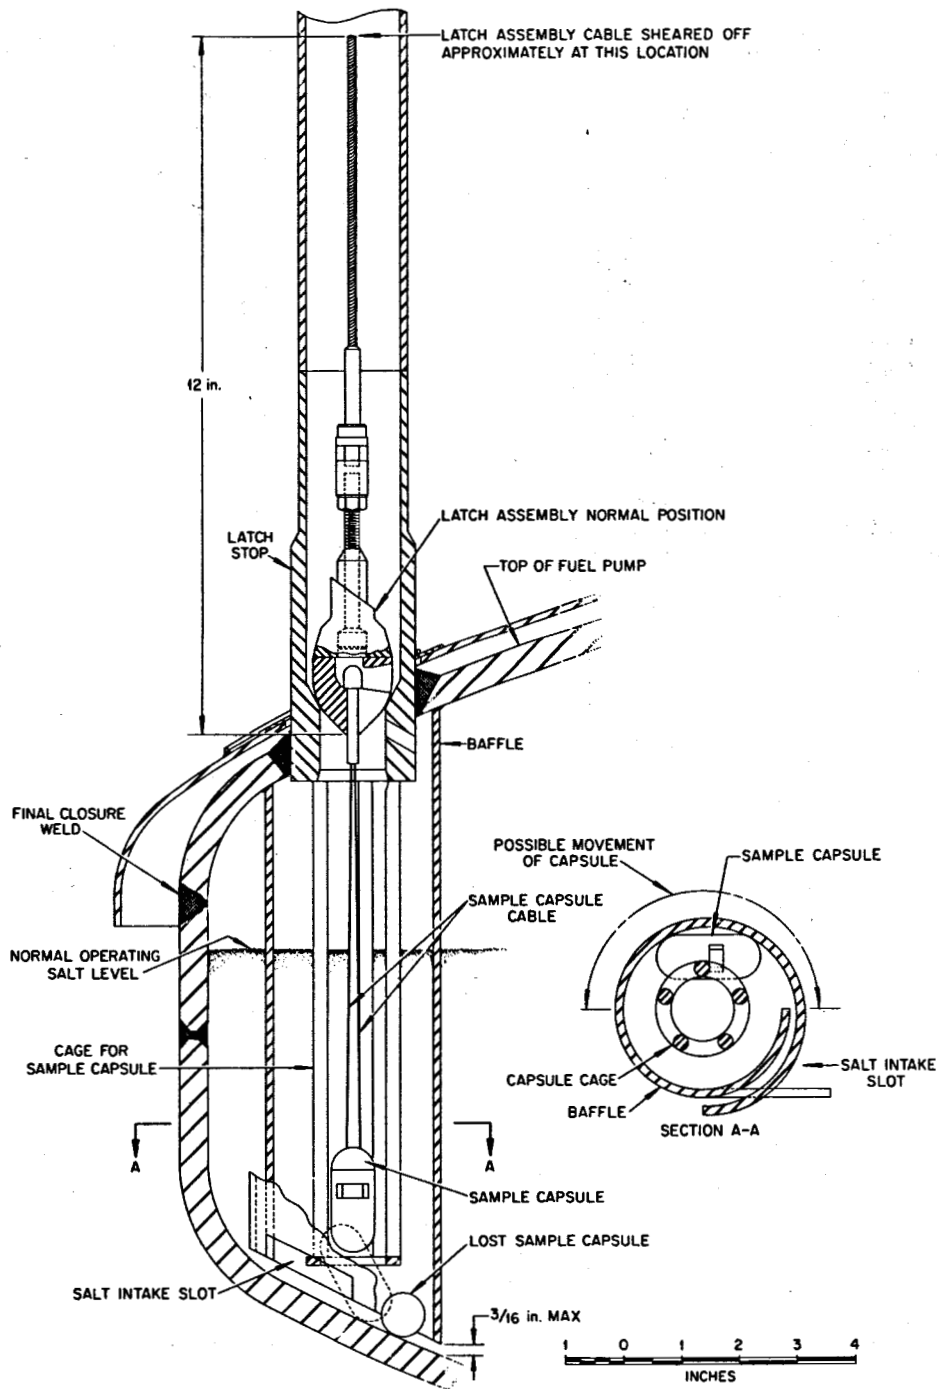
Fig. 18.4 Location of Sampler Latch and Capsules in Fuel Pump Bowl

a hot cell revealed that the cable was not tangled in the gears as had been assumed; the failure to withdraw or insert was due to a sharp kink in the cable which became lodged in the 17/32-in. diameter channel of the latch positioner.

microphone on the fuel pump indicated that the 1/2-in. dia. magnet lifted an object a few inches and then dropped it. After many attempts, the magnet came up with an object which later proved to be the corroded top of the old capsule. Further efforts with either magnet were unsuccessful and the second capsule was abandoned.

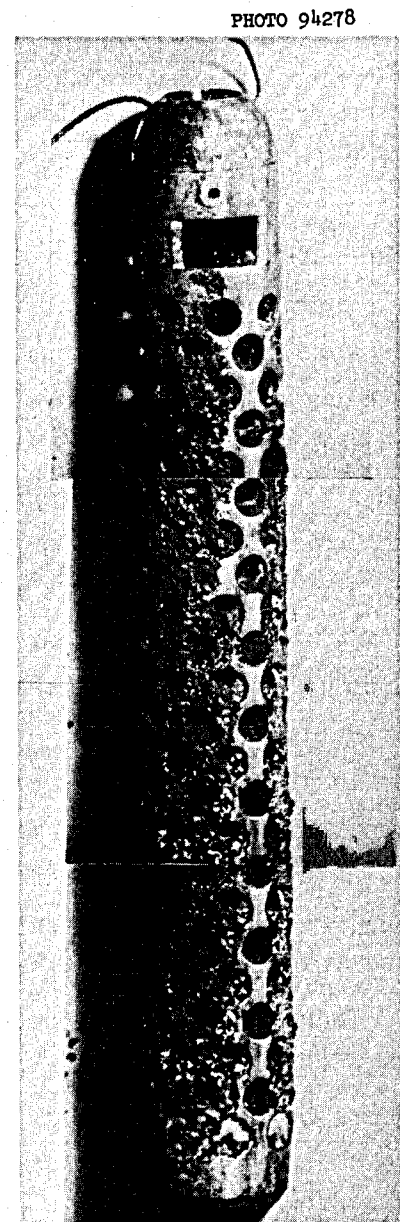
Fig. 8.5b Nickel Cage Beryllium Rod Assembly after Exposure to MSRE Fuel Salt for 10.5 hr

When the beryllium addition capsules were withdrawn, they were encrusted with solids as shown in Figure 18.5b. As a result, the capsules were difficult to load into the bottom part of the transport tubes even though the plastic liner was removed. Also the enriching capsules were sometimes difficult to load because of their length (6-1/4 in.). The cables of these long capsules were occasionally caught in the threads of the mating parts of the transport container and were difficult to unload at the hot cell.

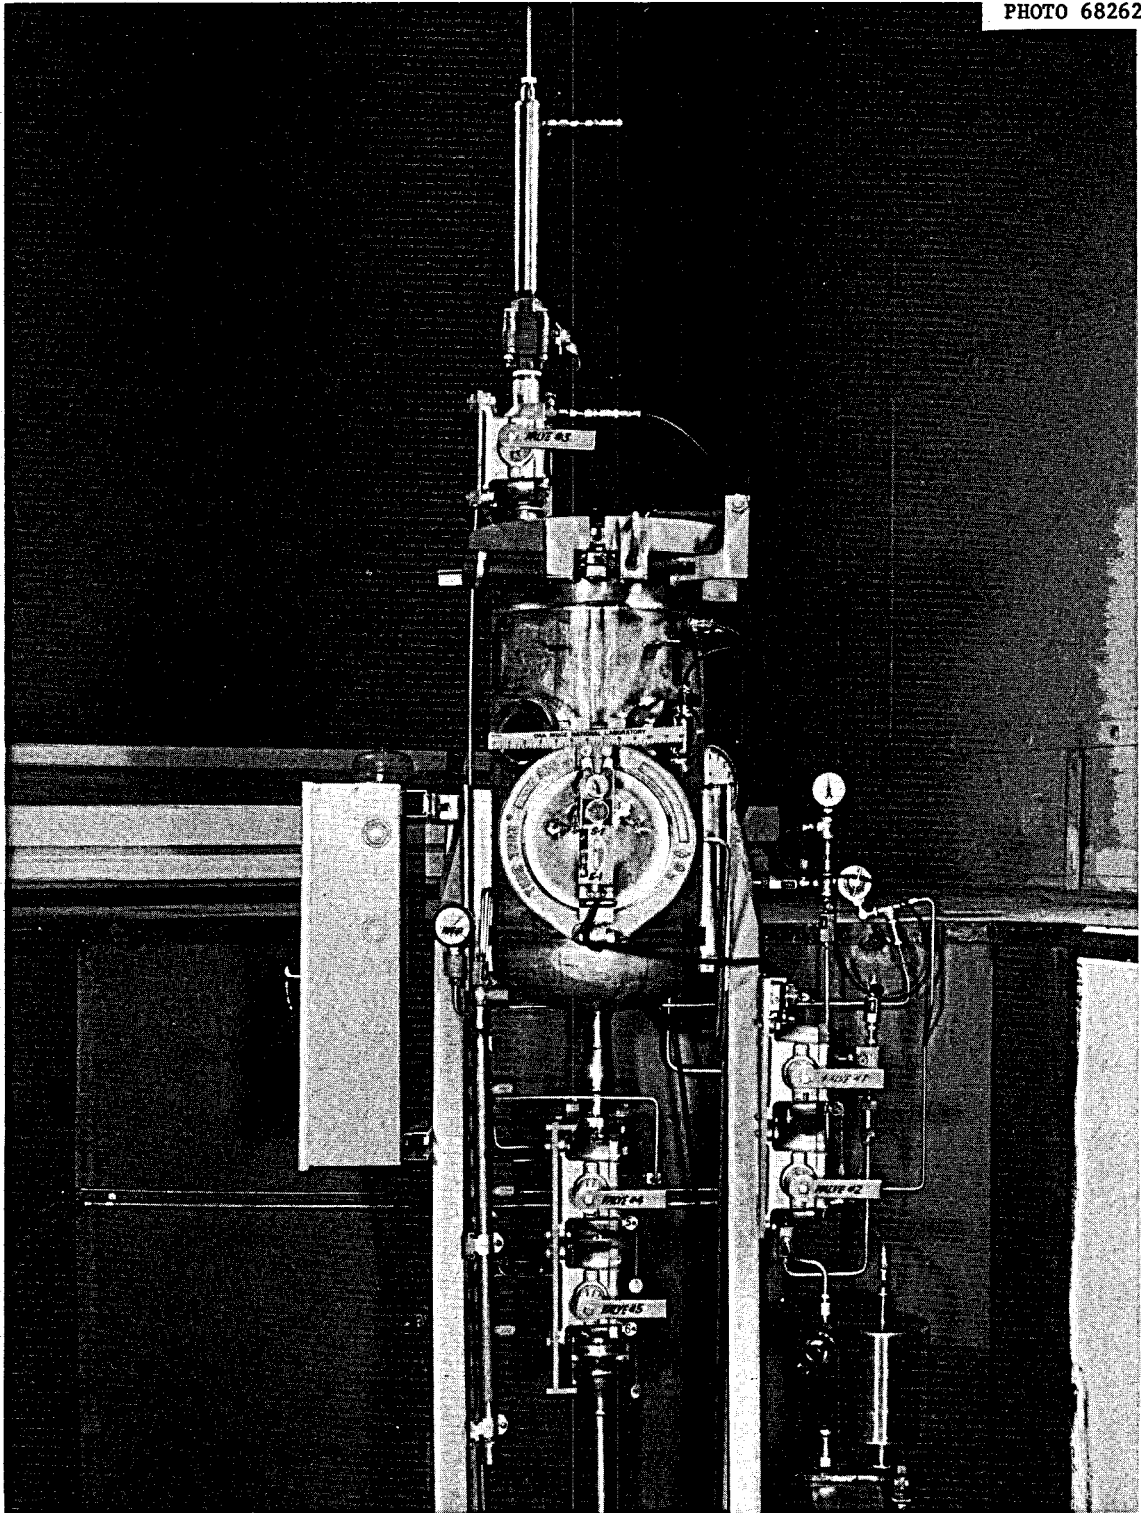
Fig. 18.6 Coolant Salt System Sampler

The coolant salt sampler operated relatively trouble-free throughout MSRE operations. Only 81 coolant system samples were taken as opposed to 745 cycles for the fuel system.

Early in 1966 during one sampling operation, the latch failed to slide freely through the transfer tube. No reason for the difficulty could be found. However, the outside diameter of the latch was reduced and no similar trouble was reported.

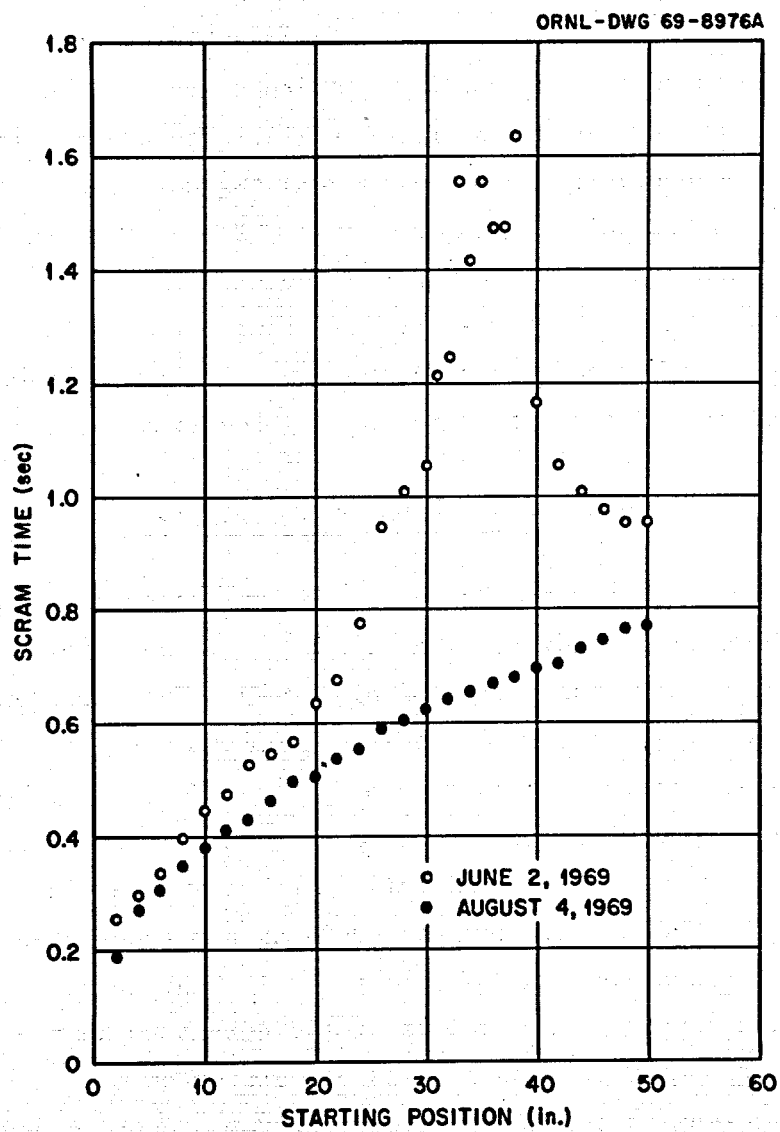
Fig. 19.4 Incremental Rod Drop Times

The reactor was shut down in June 1969 by manually scrambling all the control rods. The assembly in thimble T-3 (R-4 and V-1) was at 35.0 in. and did not scram.⁵⁹ The rod was inserted 0.2 in. and scrambled again, this time the rod dropped freely. Repeated attempts to make the rod stick followed this incident but were unsuccessful. Fig. 19.4 shows the results of scram tests at 2-in. increments taken on June 2 before the rod was examined and clearly shows the area of high drag.

It was obvious from the No. 3 rod failure to scram that the method of testing each rod by a single 50-in. scram was inadequate. The method failed to expose any local areas of high drag. The incremental method of testing, scram time vs starting position, as shown in Fig. 19.4, showed no region of excessive drag for any of the rods. In an effort to provide a quick testing procedure that would not require numerous rod drops, yet would reveal regions of abnormal drag, a procedure developed for the EGCR was renovated. The output from the 1000-ohm position potentiometer was amplified and transmitted by wire to the main ORNL area, where it was passed through a filter with a 5-Hz time constant to remove transmission noise, digitized at 2000 samples/sec, and stored on magnetic tape. The data was then sent to the IBM-360 computer for smoothing and analysis by a program especially developed for this purpose. This procedure when activated during a rod drop from 50 in. gave about 1800 data points during the drop. From this velocity and acceleration curves were generated. Data taken before repair of the sticking rod assembly (R-4 and V-1 in T-3) showed a region of near zero acceleration between 26 and 40 in., in good agreement with the incremental results shown in Fig. 19.4. After reinstallation, all three assemblies were tested by both incremental drops and the single drop computer analyzed method. Both methods showed reasonably constant accelerations of 10 ft/sec² or more. A typical plot of acceleration vs position is shown in Fig. 19.5.⁵⁹

To correct this difficulty, Rod R-4 was removed and replaced by Rod R-3. This was the rod which had earlier snagged in the thimble. Before reinstalling it, the air exhaust tube (a possible cause of the snagging) was filed smooth to eliminate all the sharp edges. The defective potentiometer was also replaced on the drive (V-1). The greatly improved performance of this assembly (R-4 and V-1 in T-3) suggests that the trouble was in the rod (R-4) rather than in the drive. The extreme radioactivity of rod 3 (R-3) made it impractical to examine.

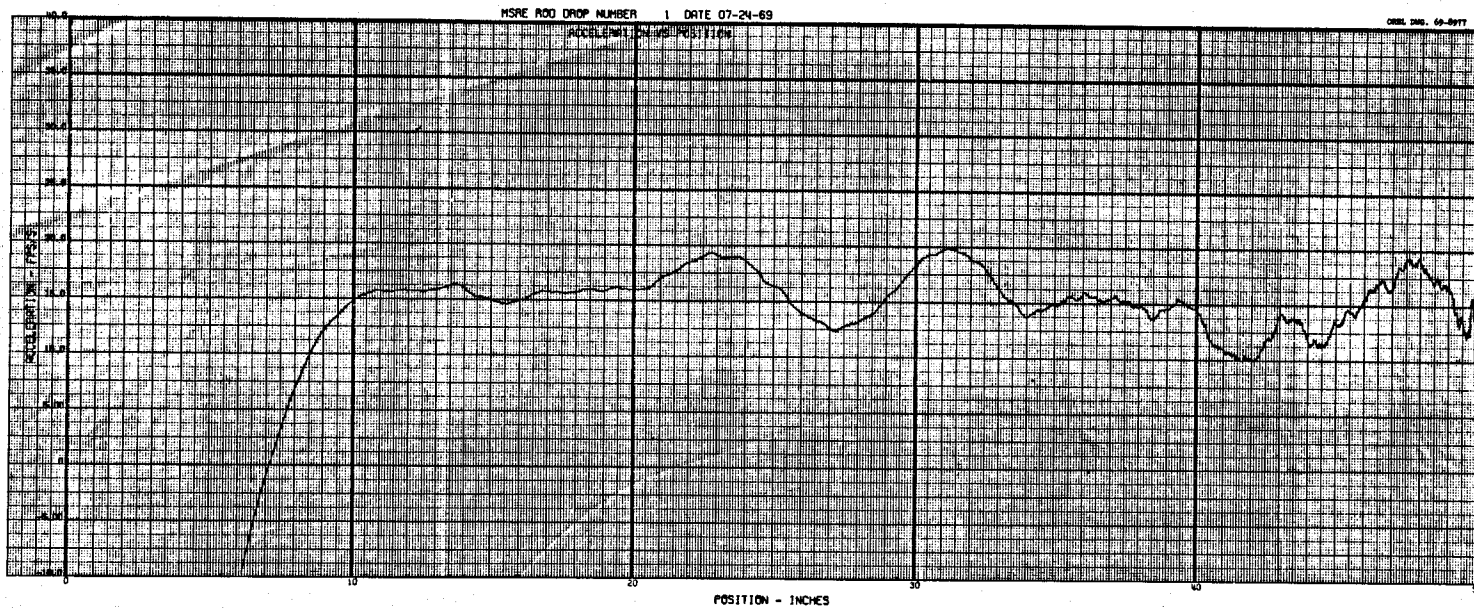
Fig. 19.5 Rod Acceleration Curve

The signal filtering and data smoothing that are required because of the noise that is inherent in the position signal generator and transmission system made it impossible to detect with certainty a zero acceleration zone less than about six inches long if it is more than about six inches below the scram starting point.

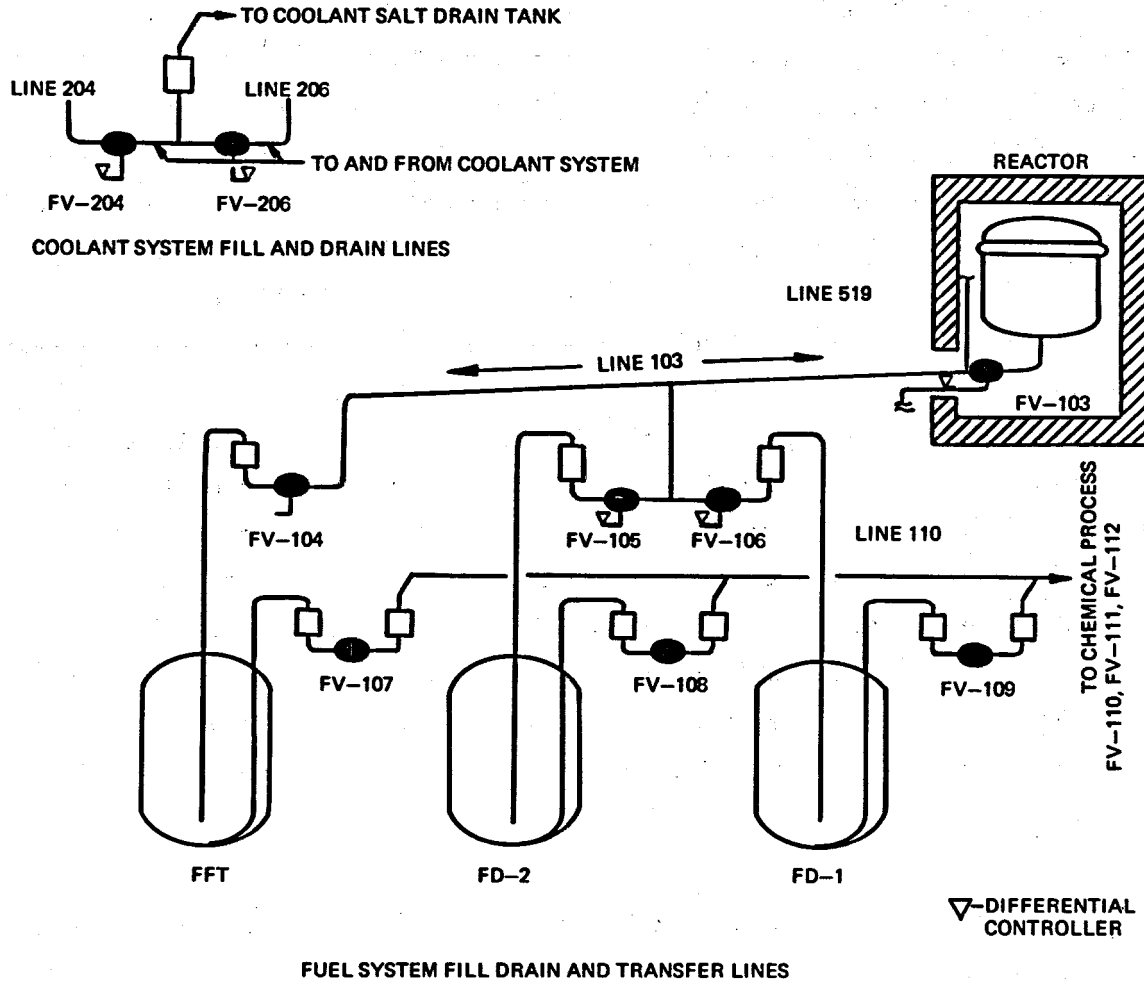
Fig. 20.1 Location of Freeze Valves

FV-104 — This valve operated without difficulty since normally it was deep-frozen or thawed. It was sufficiently spaced away from the line-103 so as to be unaffected by a fuel drain. See Fig. 20.1.

FV's 105 and 106 — FV-105 and FV-106 were difficult to control during a fill or drain operation because of the proximity of the valves to each other and to the 103 line which was common to both freeze valves. See Fig. 20.1. Heat conduction from the hot salt passing through line-103 strongly affected that valve which was to remain frozen. In an emergency drain situation, both valves were thawed and the fuel would drain to both tanks. A scheduled drain required that one of these valves be frozen to direct the salt to the selected drain tank only. In several instances during a scheduled reactor drain the frozen valve thawed which resulted

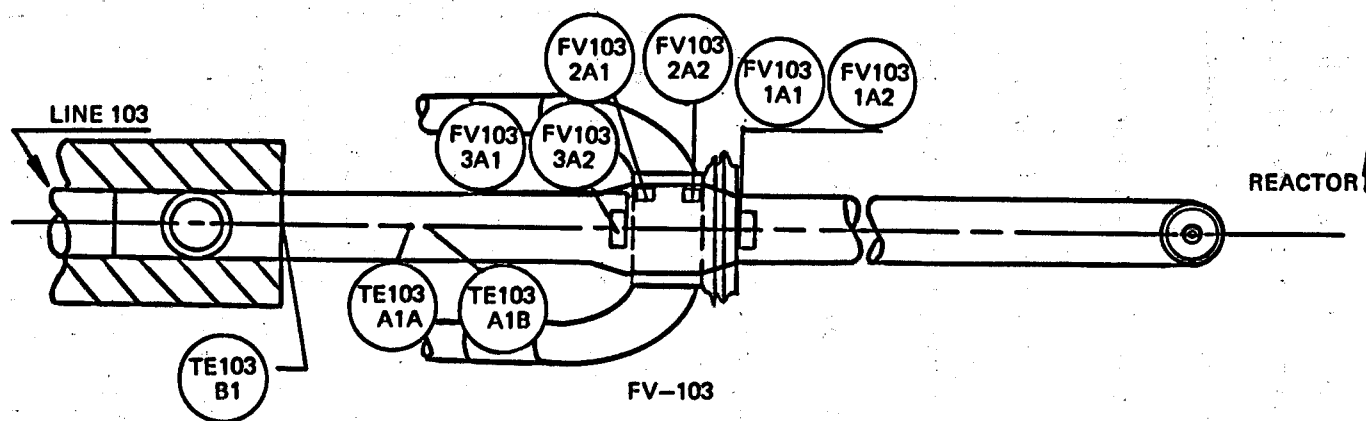
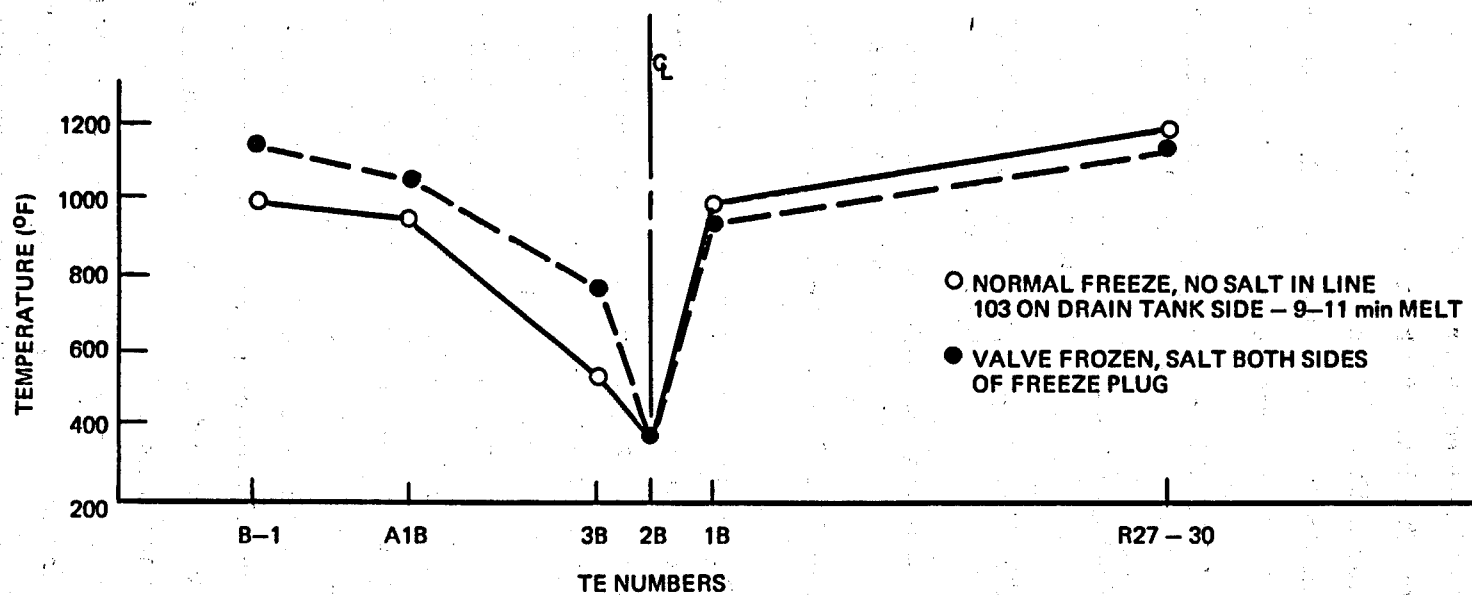
Fig. 20.3 Temperature Distribution at FV-103

set of operating conditions: (1) Immediately following a reactor fill, the line-103 on the downstream side of the valve remained full of salt for a period of several hours; (2) Line-103 was then emptied of salt leaving no salt on the drain tank side. Figure 20.3 shows the temperature distribution for both conditions.

The temperature adjustments required for the proper valve operation resulted in only one shoulder control module being effective in each condition of the valve shown in the figure. During the initial freeze cycle, the TS-FV-103-3A1 was the principal control and after the line-103 was drained of salt, the TS-FV-103-1A1 was the key temperature control since there was no salt below TS-FV-103-3A1. During a thaw cycle, the 1A1 temperature responded very slowly since the mass of heat (reactor vessel) was on that side of the valve. The 3A1 temperature responded very rapidly since the source of heat was through the frozen plug and the ambient temperature. Selection of these temperature alarm points was carefully made after many tests.

Once the valve conditions were established, FV-103 operated well except for one unscheduled drain which occurred on April 15, 1969. This was caused by an upward 50°F drift of the setpoint of the FV-103-3A1 module from 750°F to 810°F plus an administrative change of the FV-103-1A1 setpoint from 1010°F to 1050°F.

The upward drift had occurred prior to the previous freezing operation and a short plug (<2 in.) of salt was formed in the valve. The controls and freeze test indicated a good freeze. At the time of the incident, the salt temperature was not at 1210°F for which the controls were originally adjusted, but at 1110°F with the cooling gas flow controlling the valve center temperature at 420°F.

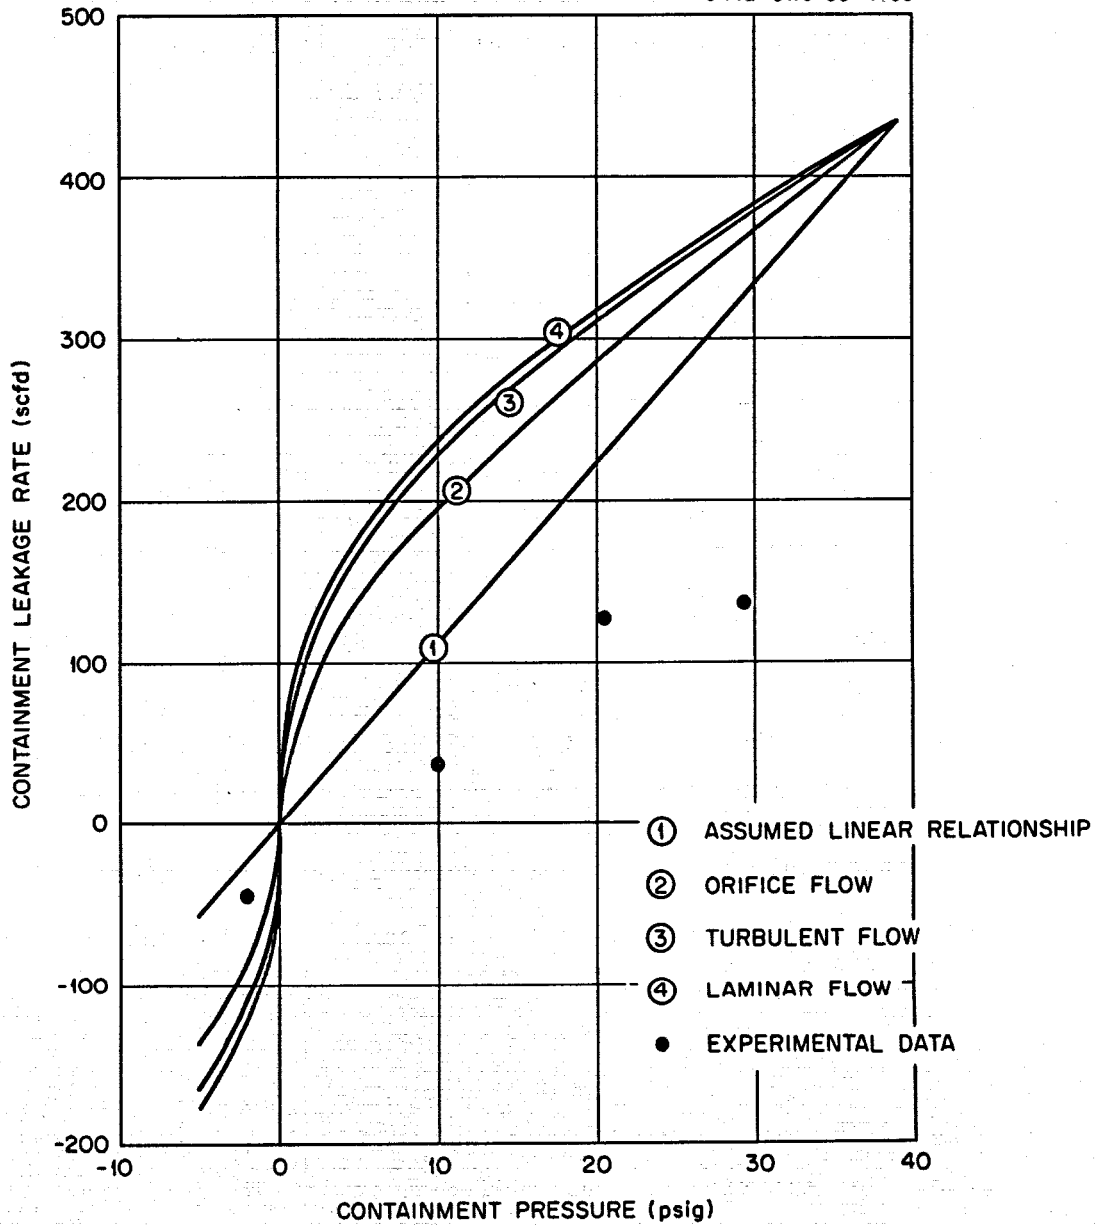
Fig. 22.2 Secondary Containment Leak Rates

Leak-rate data was then taken at 30, 20, 10, and -2 psig with the component-coolant-pump domes valved back into the system. These are plotted in Fig. 22.2 along with curves which relate the allowable leakage at various pressures to the allowable leakage at 39 psig (MCA pressure) for

various flow regimes. Also shown is the highly conservative linear relationship which has no physical basis.

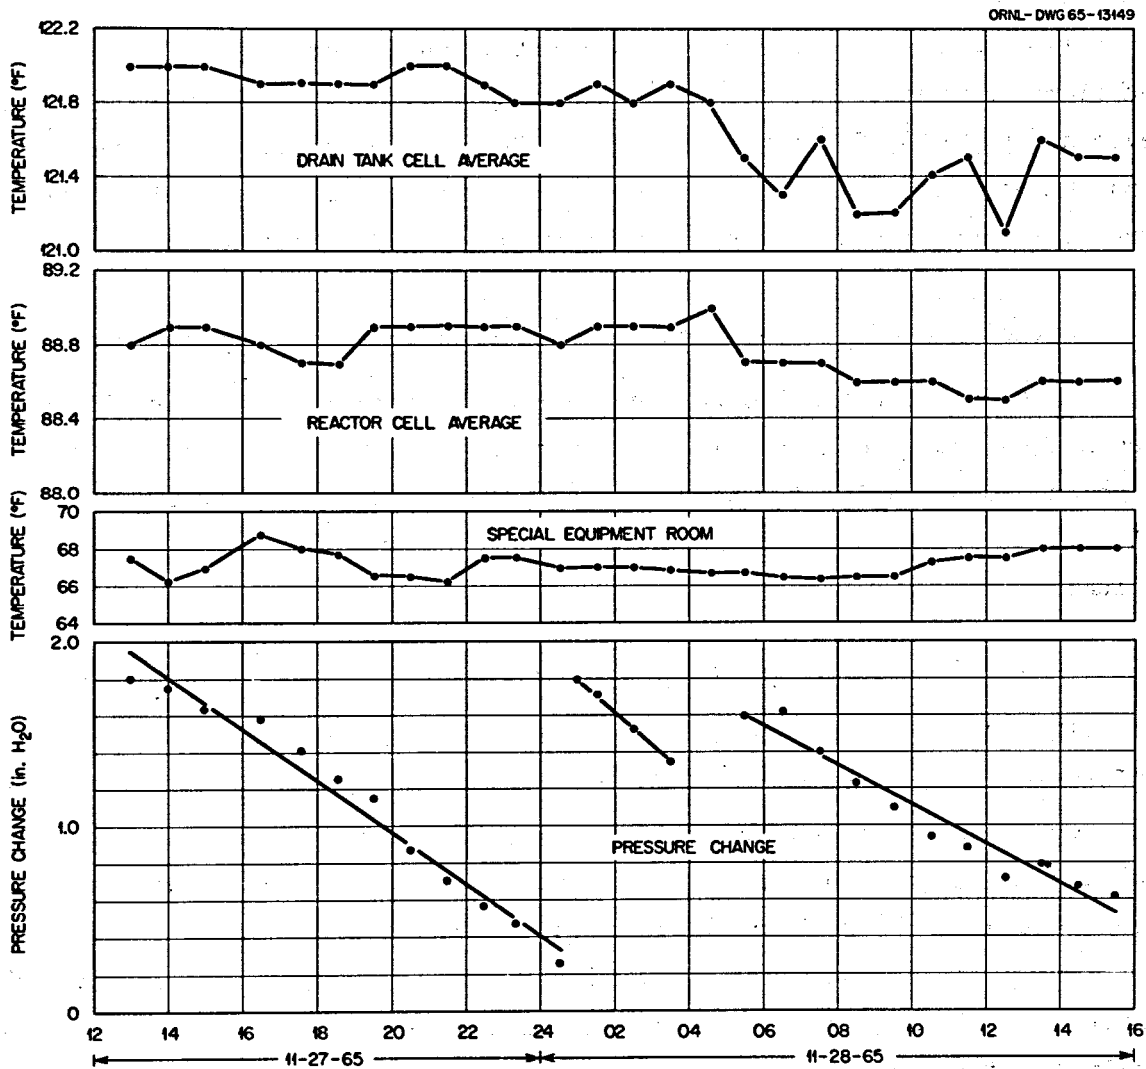
Fig. 22.4 Containment Conditions During Leak Rate Test at 30 psig

the same time of the day and at the same operating conditions. Calculations of intervals of several days were more consistent than shorter periods. Figure 22.4 is a plot of the data used to determine the leakage rate at 30 psig in 1965.
