Reactor Division

MSRE SYSTEMS AND COMPONENTS PERFORMANCE

JUNE 1973

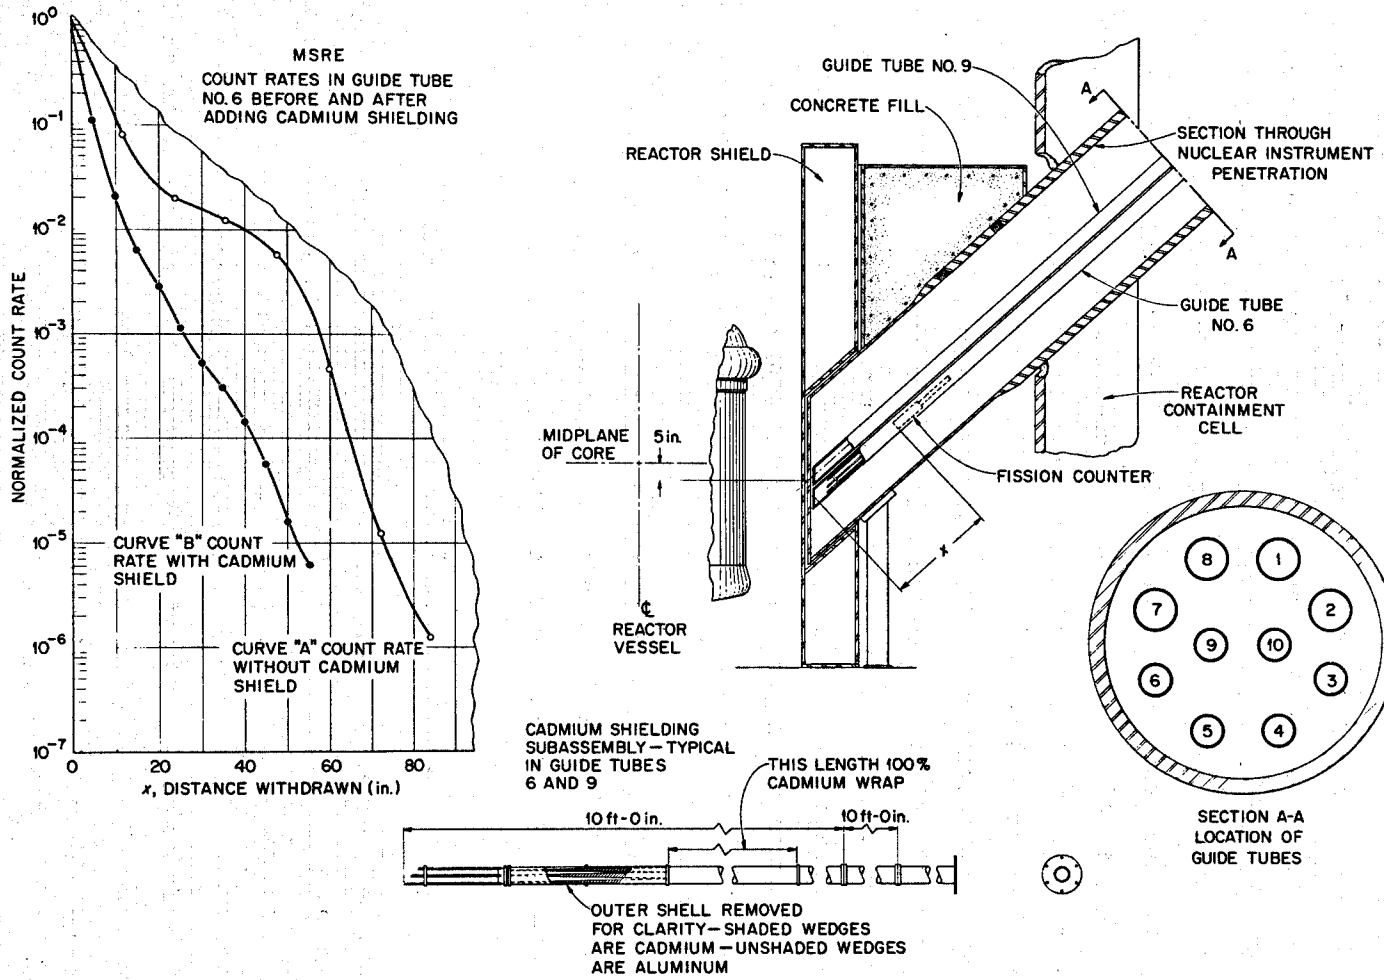
Fig. 24.2 Guide Tube Shield in the MSRE Instrument Penetration

Initial criticality tests disclosed that the neutron flux attenuation in the instrument penetration did not follow an ideal exponential curve. The deviation was too large to be adequately compensated for by the vernistats in the wide-range counting channels. This is illustrated by curve A of Fig. 24.2 which shows fission counter response (normalized count rate) vs withdrawal from the lower end of the penetration in guide tube 6. It was reasonable to conclude from this, and from similar curves, that the excess neutrons responsible for the distorted part of the curve were entering the penetration along its length. The count rates in other guide tubes nearer the upper half of the penetration were even more distorted than curve A. Since a flux field with attenuation per Curve A precluded successful operation of the wide-range counting instrumentation, shields of sheet cadmium were inserted in guide tubes 6 and 9 to shield the fission chambers from stray neutrons. Curve B of Fig. 24.2, normalized count rate vs distance, shows the improvement for guide tube 6.

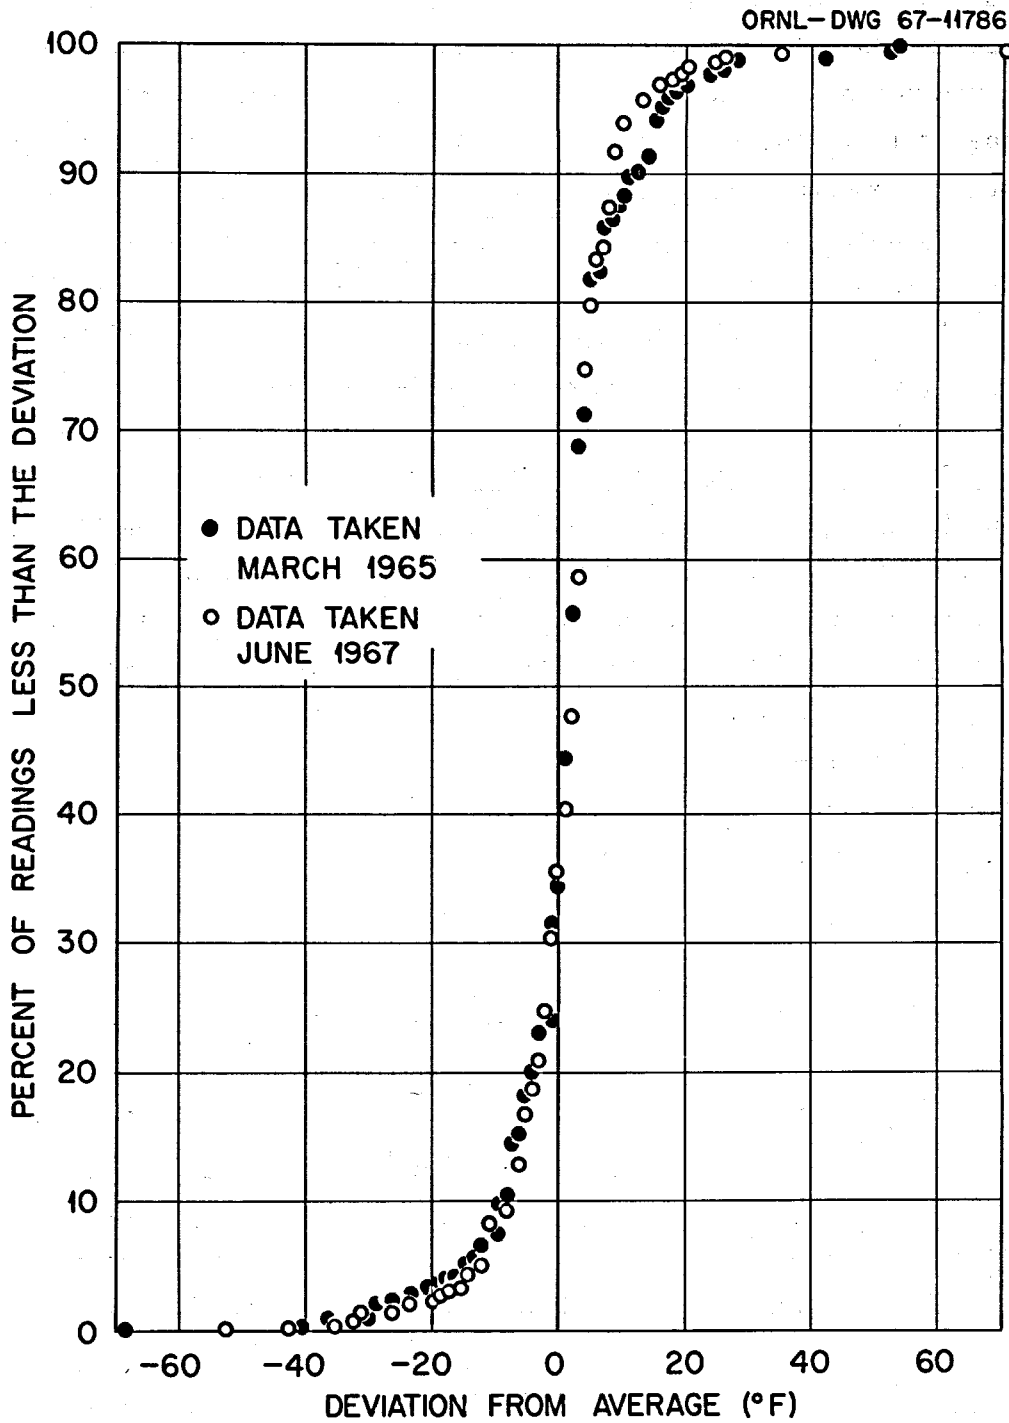
Fig. 24.3 Comparison of MSRE Thermocouple Data from March 1965 and June 1967

Only three thermocouple wells were provided in the circulating salt systems, one each in the coolant radiator inlet and outlet pipes and one in the reactor neck. The remaining thermocouples were attached to the pipe or vessel walls. The thermocouples on the radiator tubes were insulated to protect them from the effects of the high-velocity air that flows over them during power operation; the others were not insulated and thus were subject to error because of exposure to heater shine and to thermal convection flow of the cell atmosphere within the heater insulation. In March 1965, with the fuel and coolant systems circulating salt at isothermal conditions, a complete set of readings was taken from all the thermocouples that should read the temperature of the circulating salt. A similar set of data was taken in June 1967 at the start of Run 12. The results of the two sets of measurements are shown in Table 24.5. Comparison of the standard deviations for the radiator thermocouples with those for the other thermocouples shows the effect of insulation on reducing the scatter. Comparison of the sets of data taken over two years apart shows very little change, certainly no greater scatter. Figure 24.3 shows that the statistical distribution of the deviations on individual thermocouples from the mean also changed little in the two years.

The scatter in the various thermocouple readings was reduced to an acceptable level by using biases to correct each reading to the overall average measured while both fuel and coolant systems were circulating salt at isothermal conditions. These biases were entered into the computer and were automatically applied to the thermocouple readings. The biases were revised at the beginning of each run and were checked when isothermal conditions existed during the runs. Generally the biased thermocouple readings were reliable. However in a few cases, there were shifts which caused calculational errors.
