Status of nuclear power plants in Fukushima as of 22:00 March 20 (Estimated by JAIF)

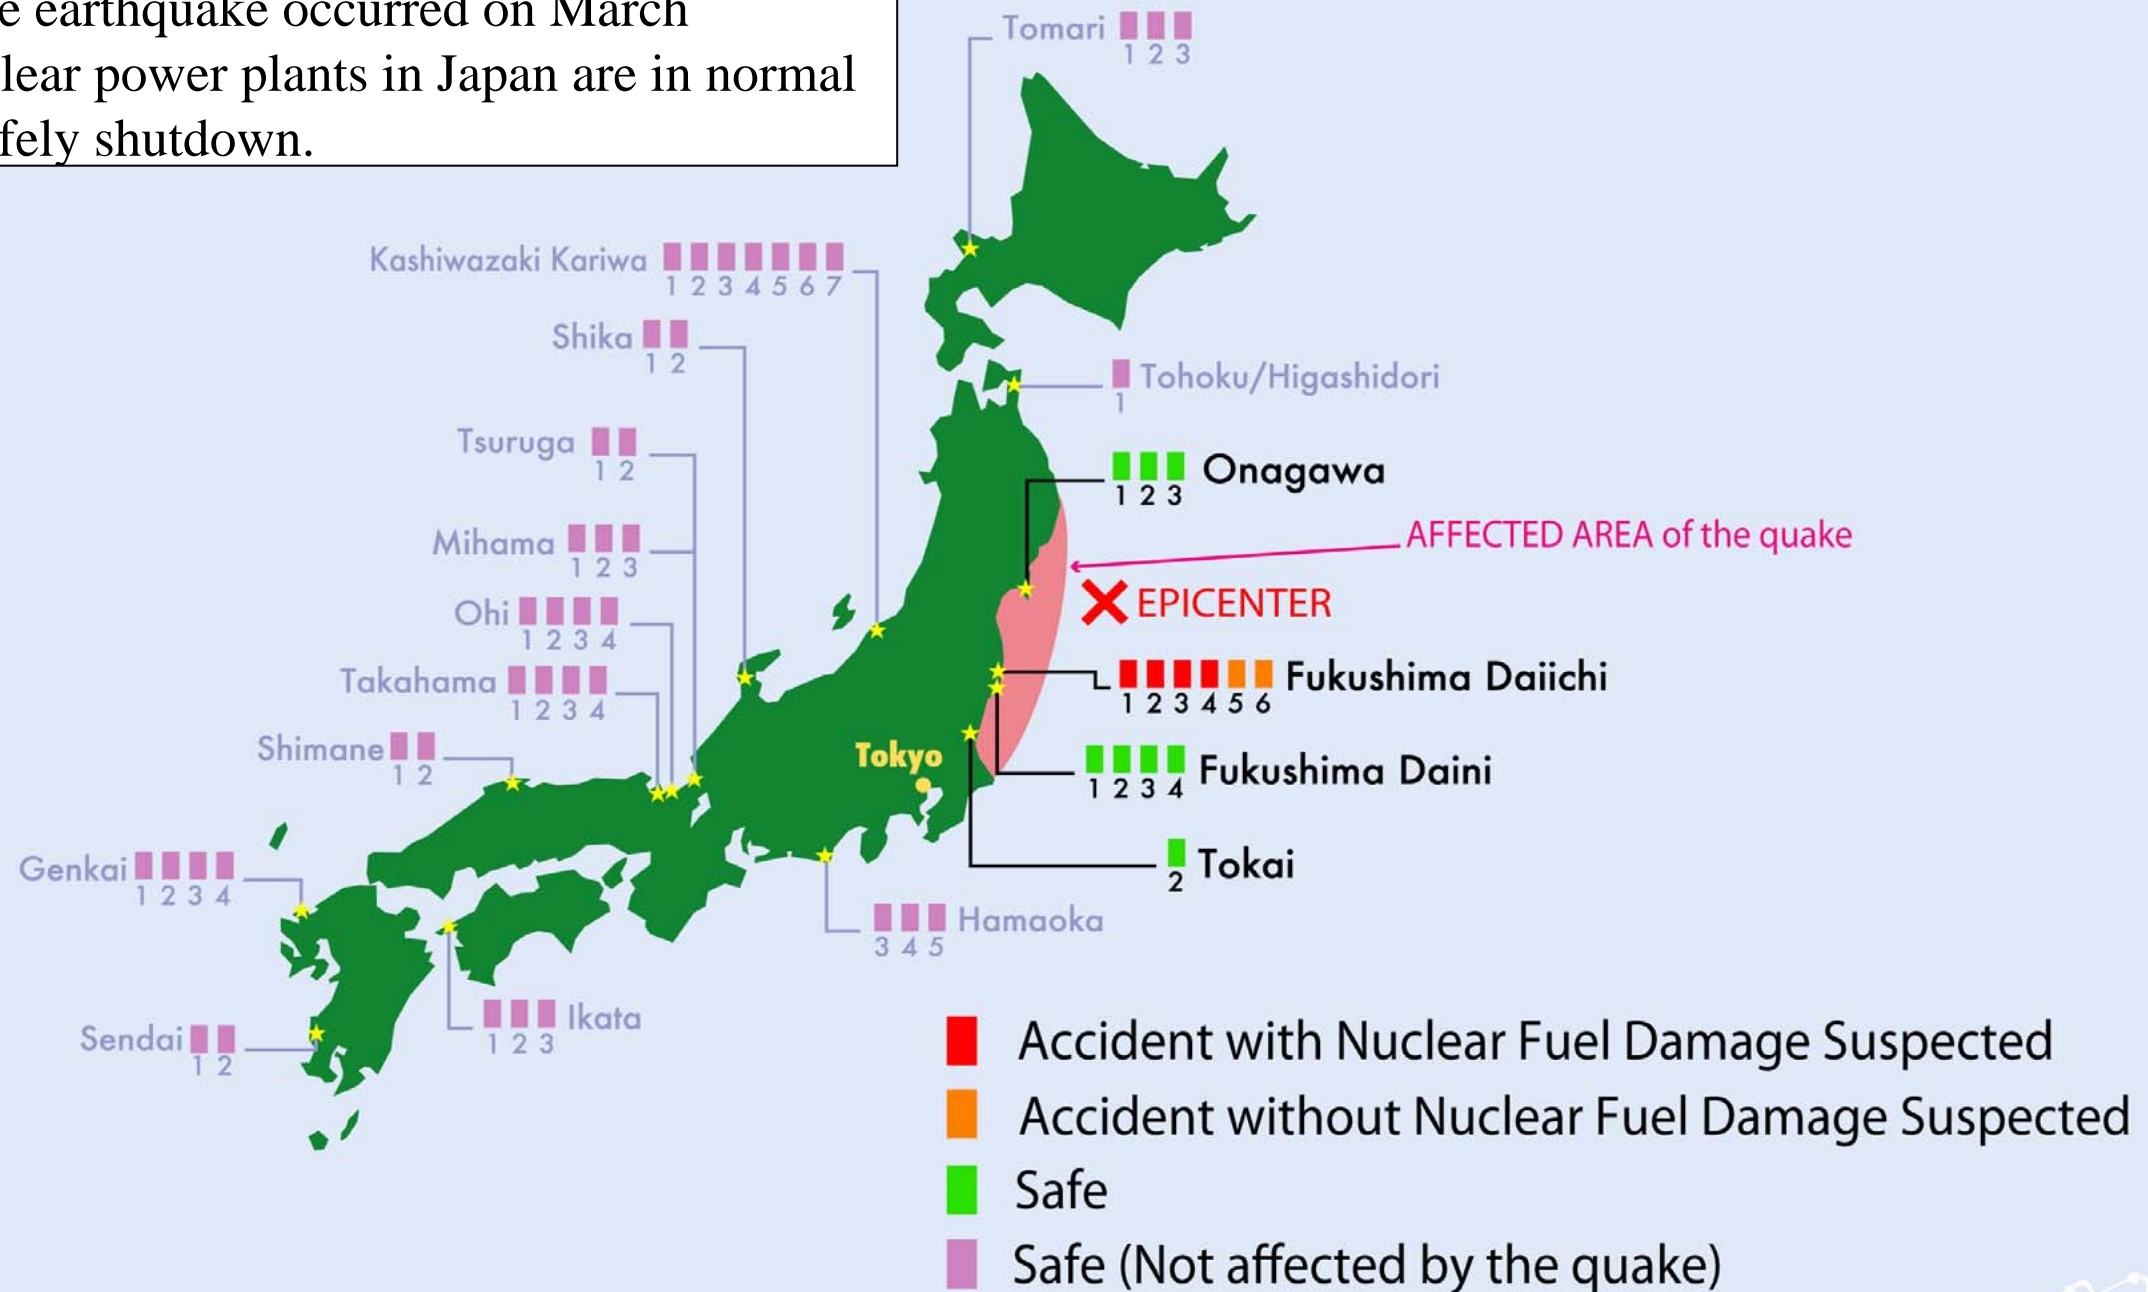
Status of the Nuclear Power Plants after the Earthquake

The accident that brings environmental impact is going on at several unit in Fukushima Daiichi Nuclear Power Station after the earthquake occurred on March 11th. Other nuclear power plants in Japan are in normal operation or safely shutdown.
