Status of nuclear power plants in Fukushima as of 16:00 March 27 (Estimated by JAIF)

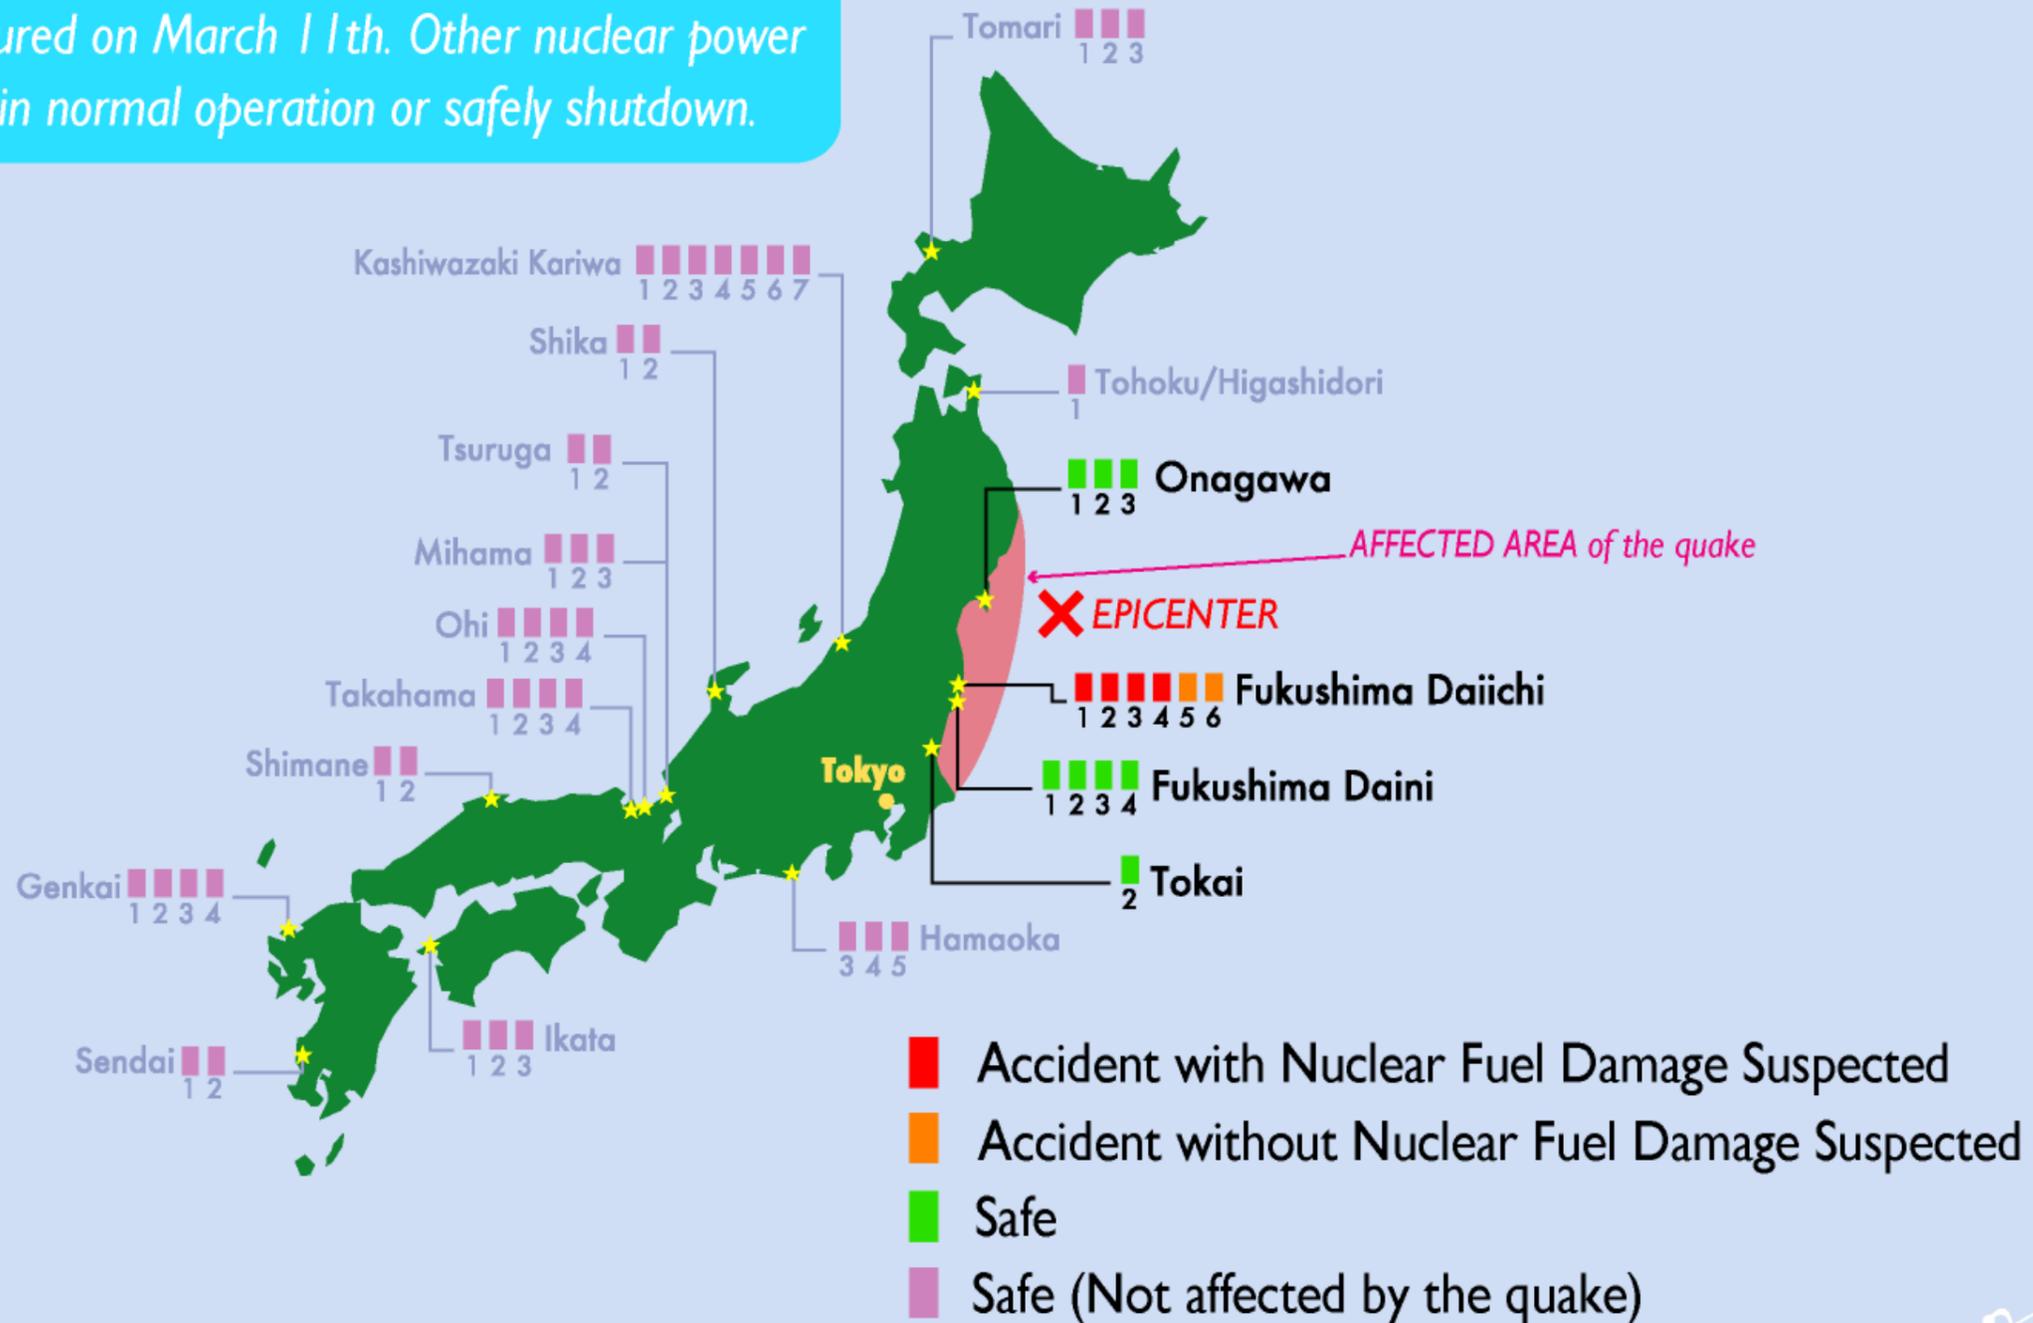
Status of the Nuclear Power Plants after the Earthquake

The accident that brings environmental impact is going on at several units in Fukushima Daiichi nuclear power Station after the earthquake occurred on March 11th. Other nuclear power plants in Japan are in normal operation or safely shutdown.
