# Information on Status of Nuclear Power Plants in Fukushima

Japan Atomic Industrial Forum, Inc.

**Status of nuclear power plants in Fukushima as of 10:00, April 4th (Estimated by JAIF)**

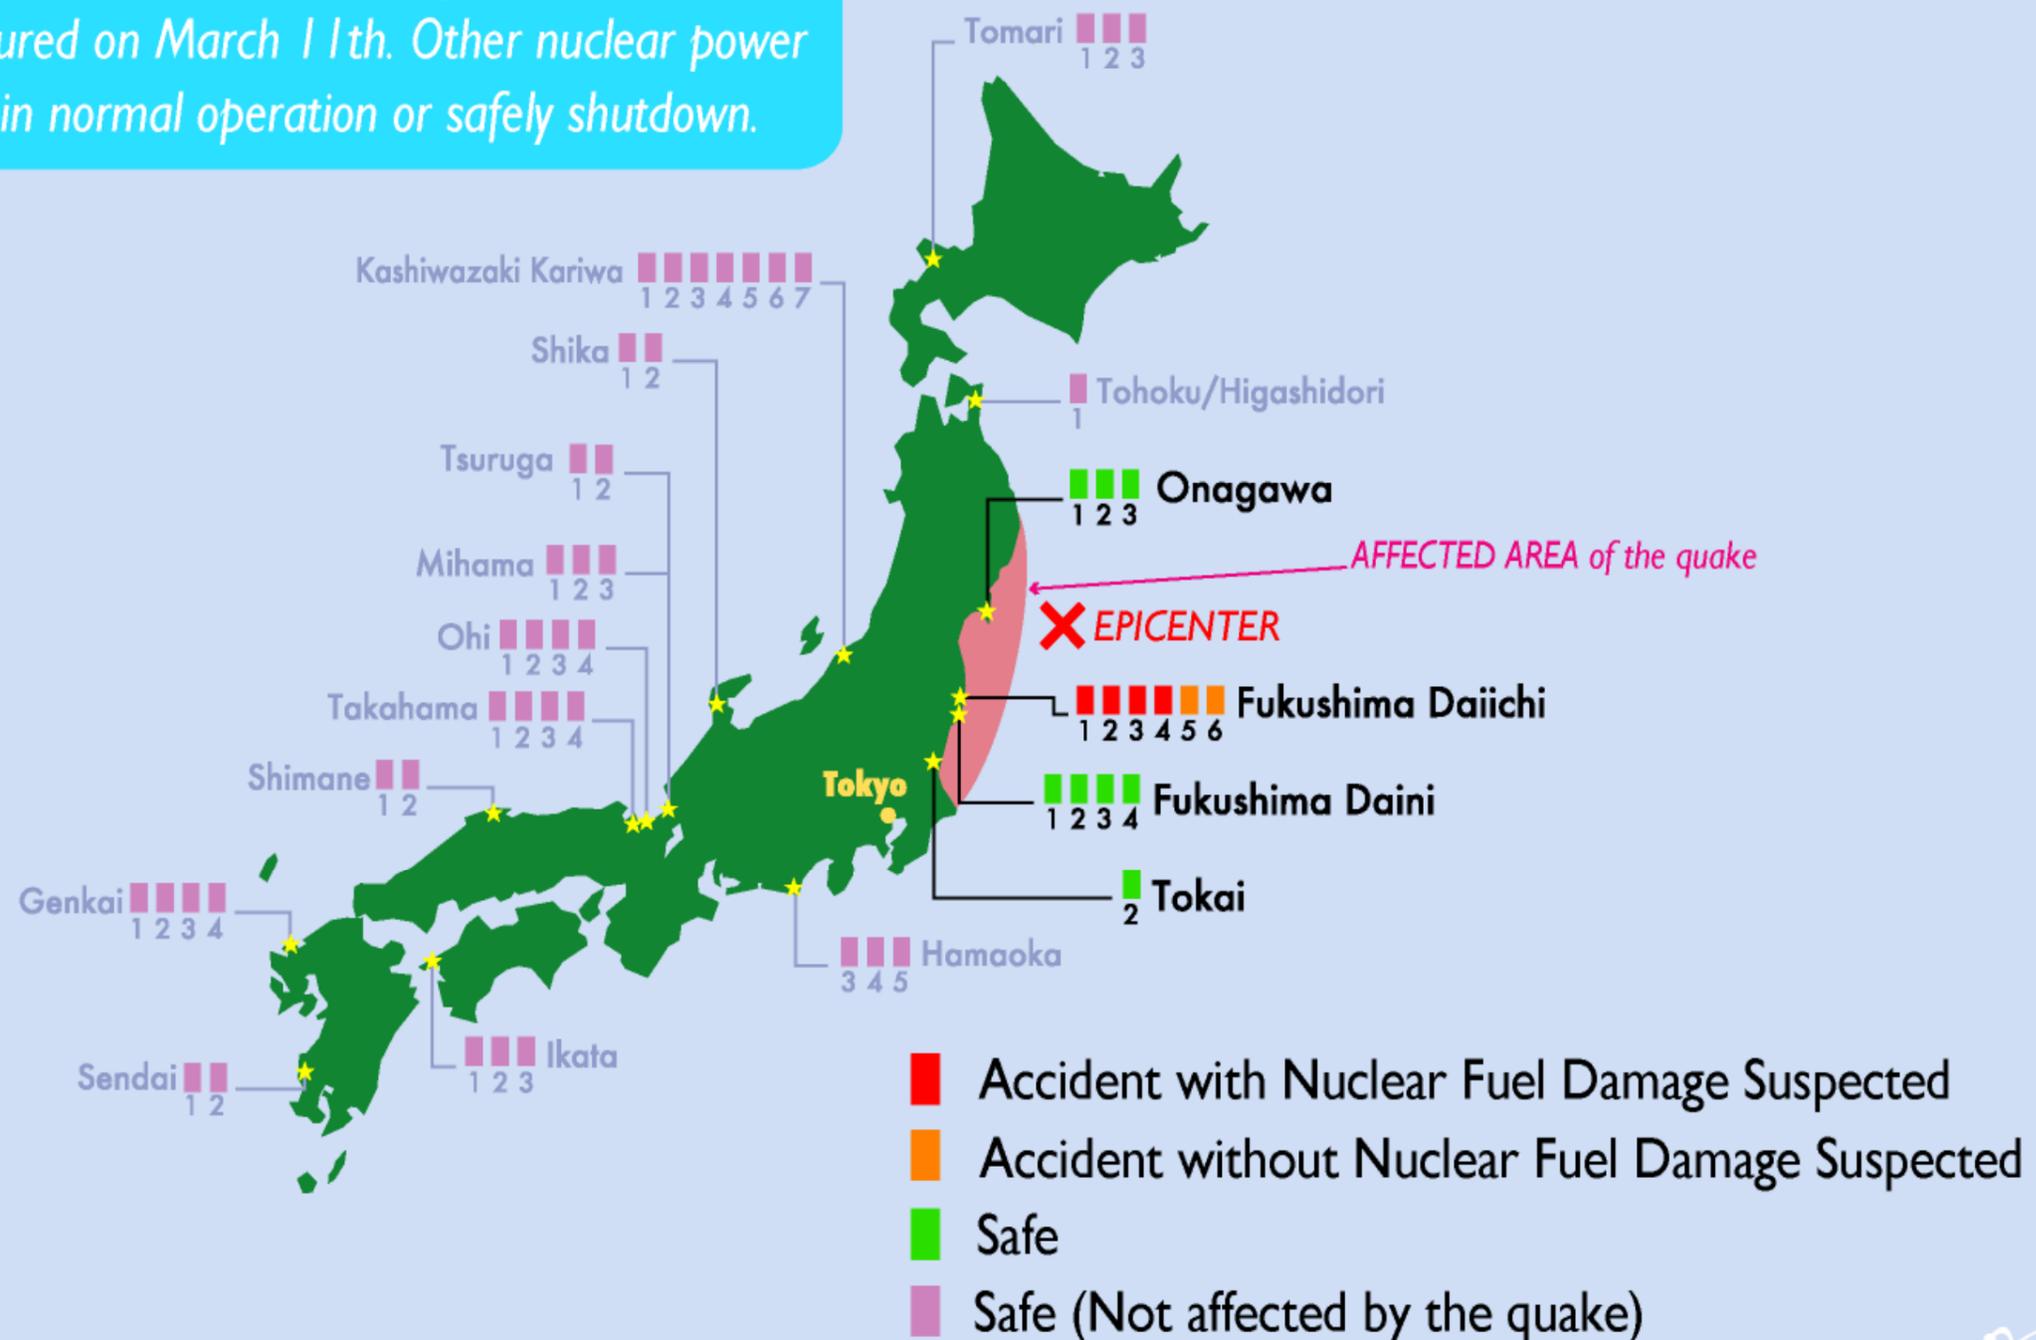
# Status of the Nuclear Power Plants after the Earthquake

The accident that brings environmental impact is going on at several units in Fukushima Daiichi nuclear power Station after the earthquake occurred on March 11th. Other nuclear power plants in Japan are in normal operation or safely shutdown.
