Information on Status of Nuclear Power Plants in Fukushima

Japan Atomic Industrial Forum, Inc.

Status of nuclear power plants in Fukushima as of 20:00, April 5th (Estimated by JAIF)

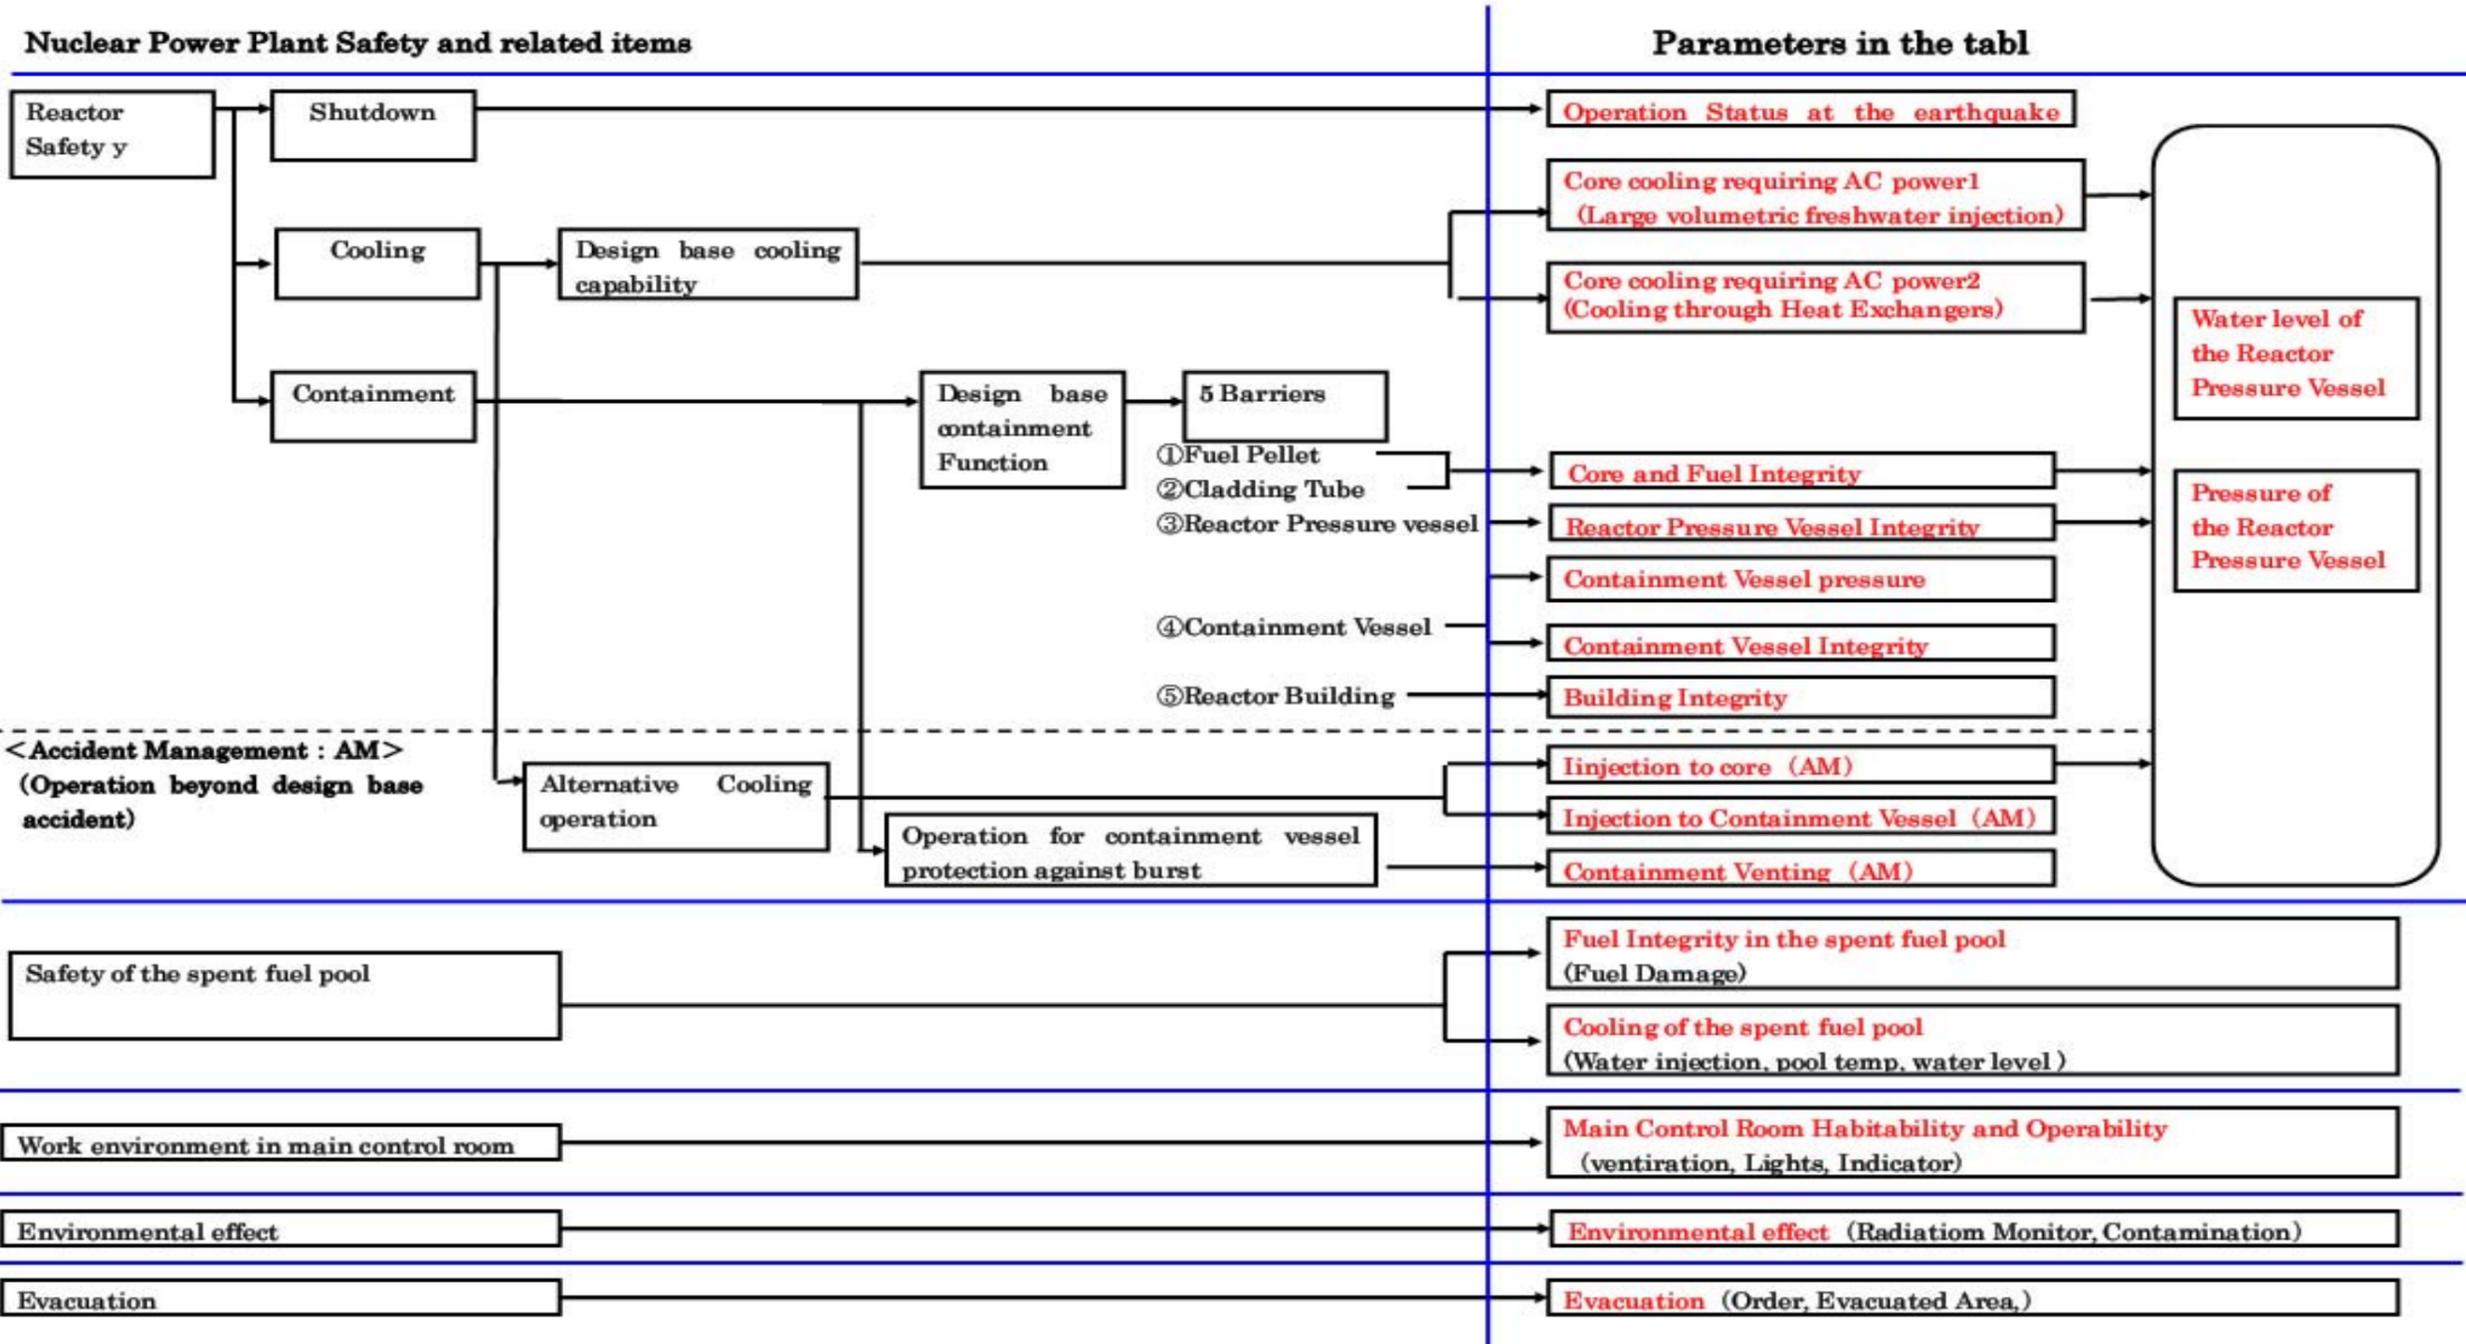
JAIF picks up these parameters to evaluate safety condition of the nuclear plants during this accident from the view point of the principles of nuclear power plant safety, which are "Shutdown", "Cooling" and "Containment". Then we create the chart. The following diagram is to show the correspondence relation of these parameters in the table to nuclear power plant safety.

Parameters in the Table

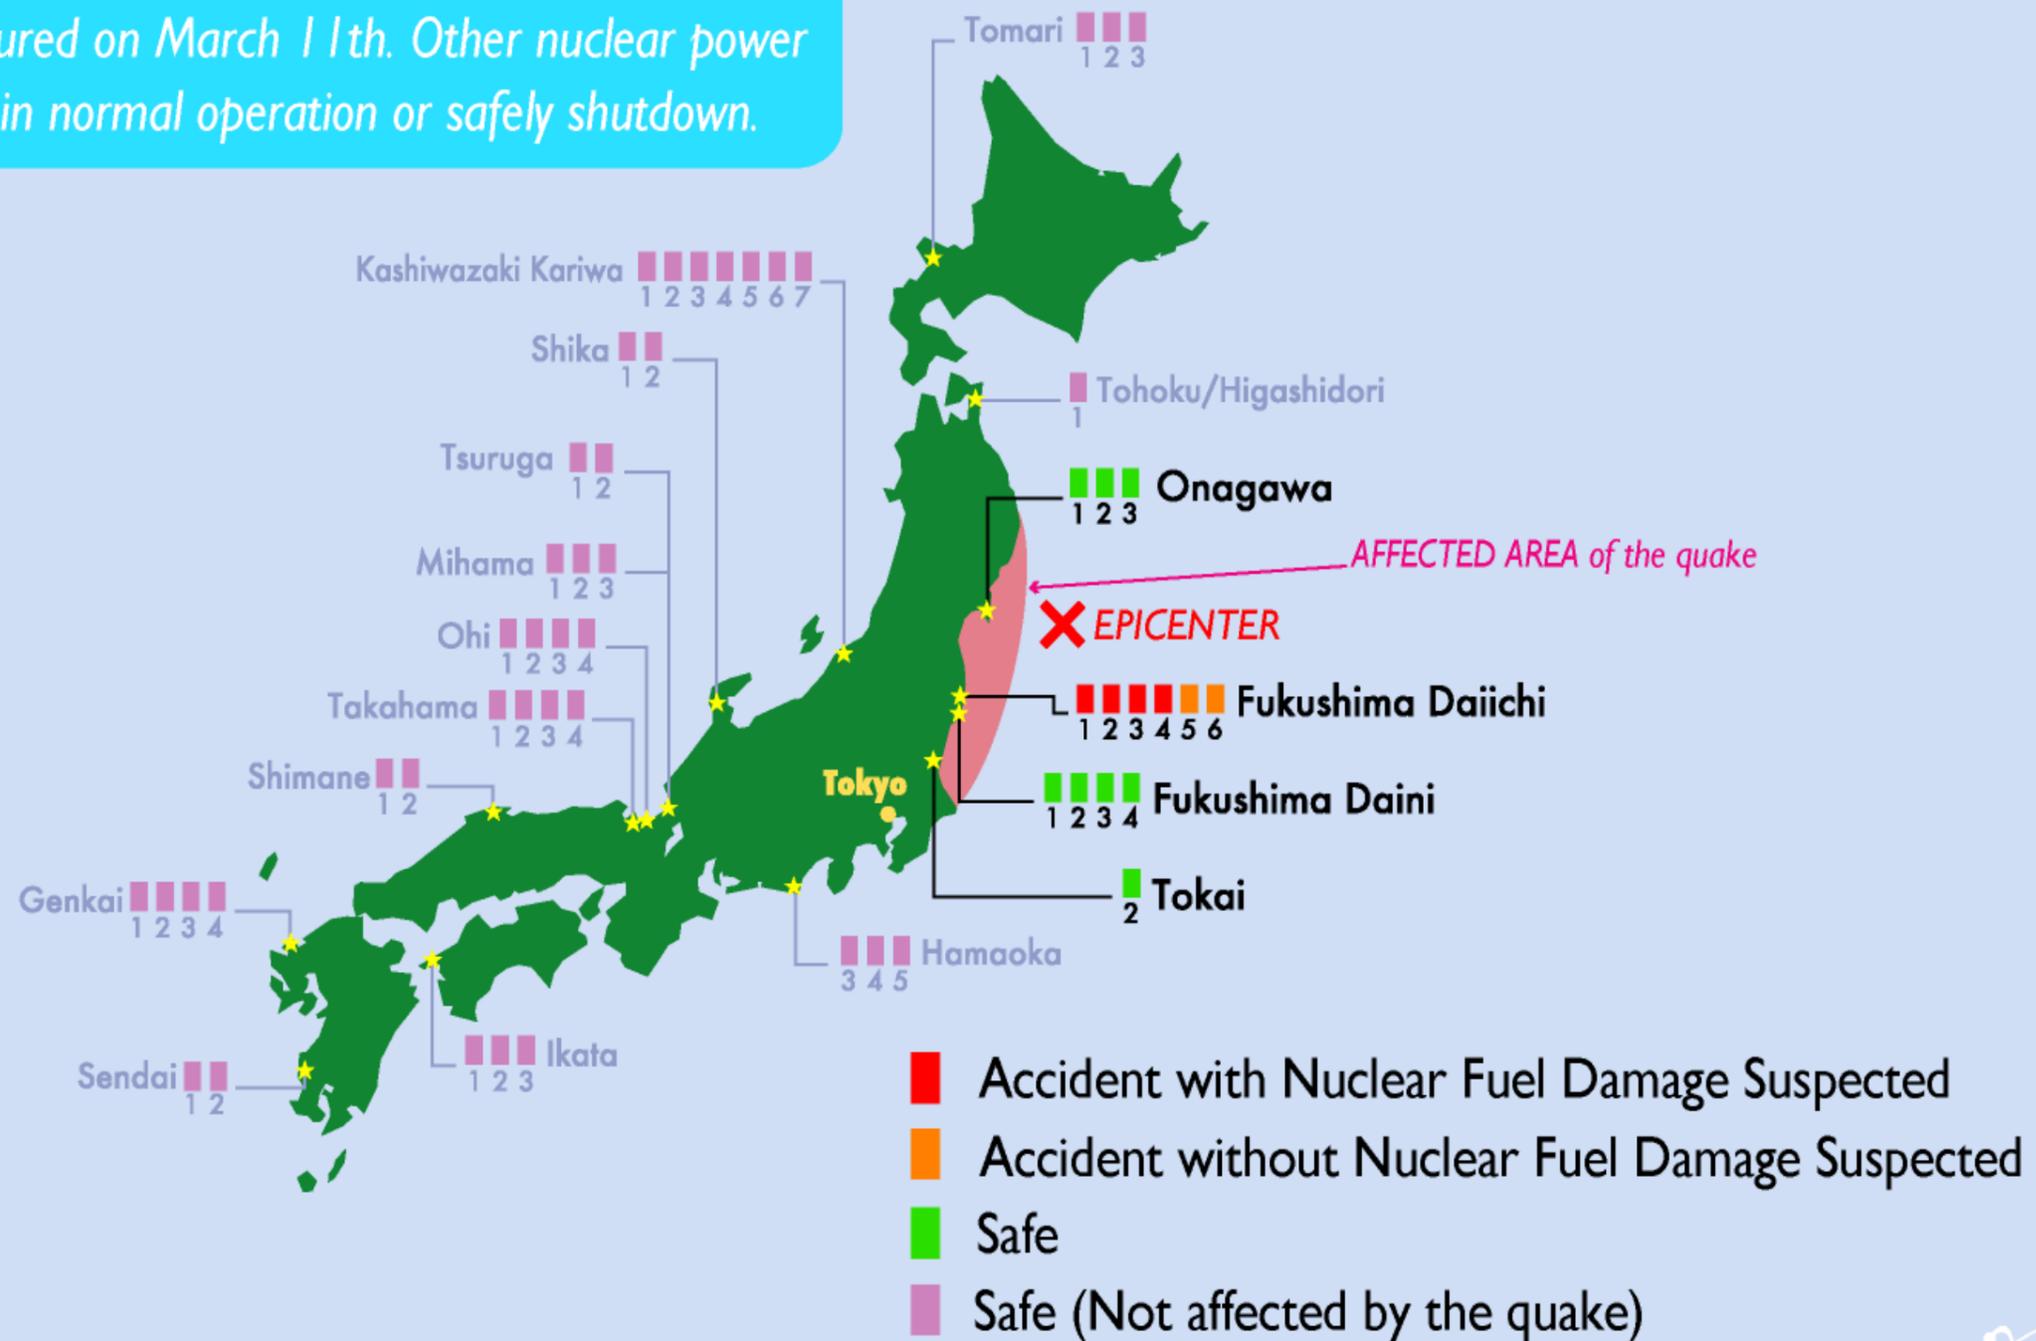
Status of the Nuclear Power Plants after the Earthquake

The accident that brings environmental impact is going on at several units in Fukushima Daiichi nuclear power Station after the earthquake occurred on March 11th. Other nuclear power plants in Japan are in normal operation or safely shutdown.
