Fukushima Nuclear Accident Interim Report:

**Effects of the Earthquake and Tsunami on the
Fukushima Daiichi and Daini Nuclear Power Stations,
especially on electric and I&C systems and equipments**

July 27, 2011

Tokyo Electric Power Company

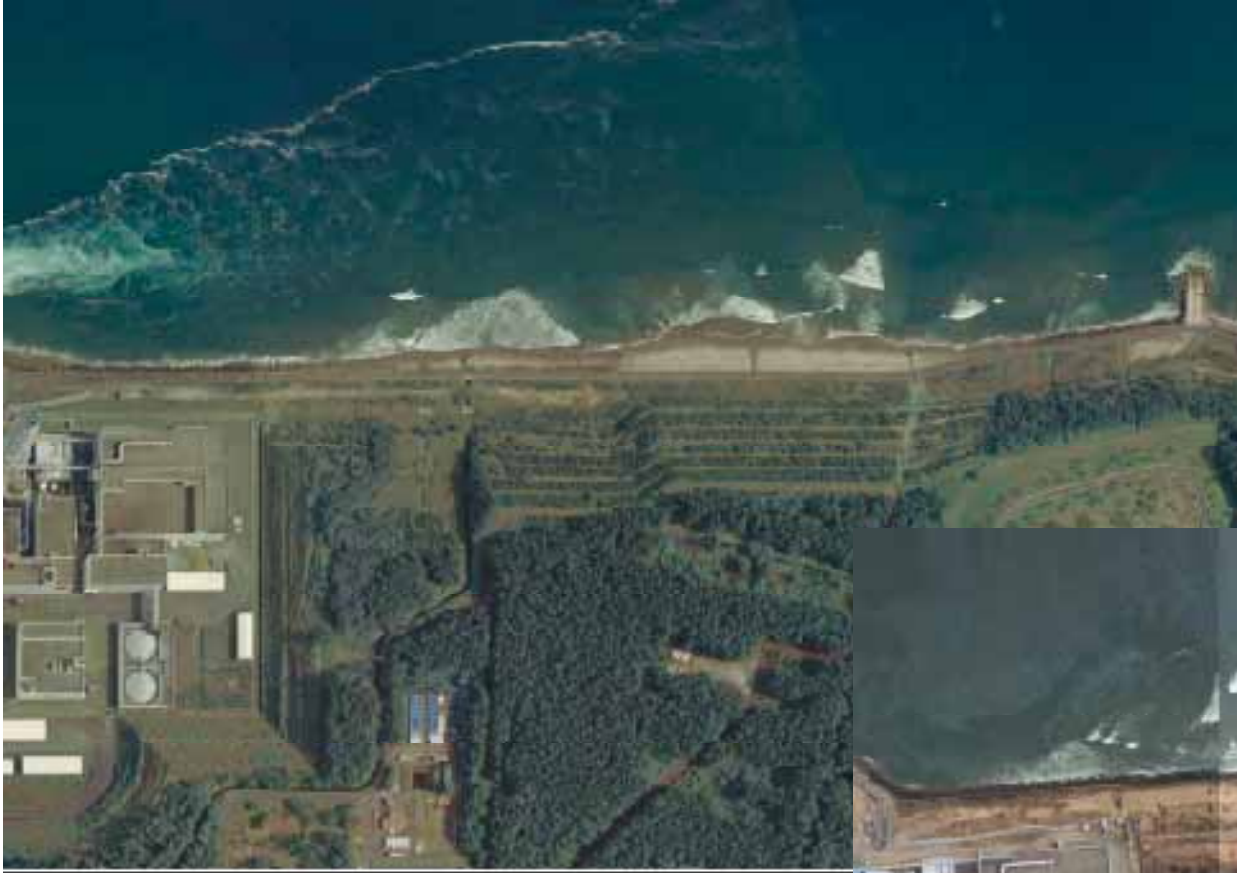
Pictures before / after Tsunami @1F

Trees were stripped away

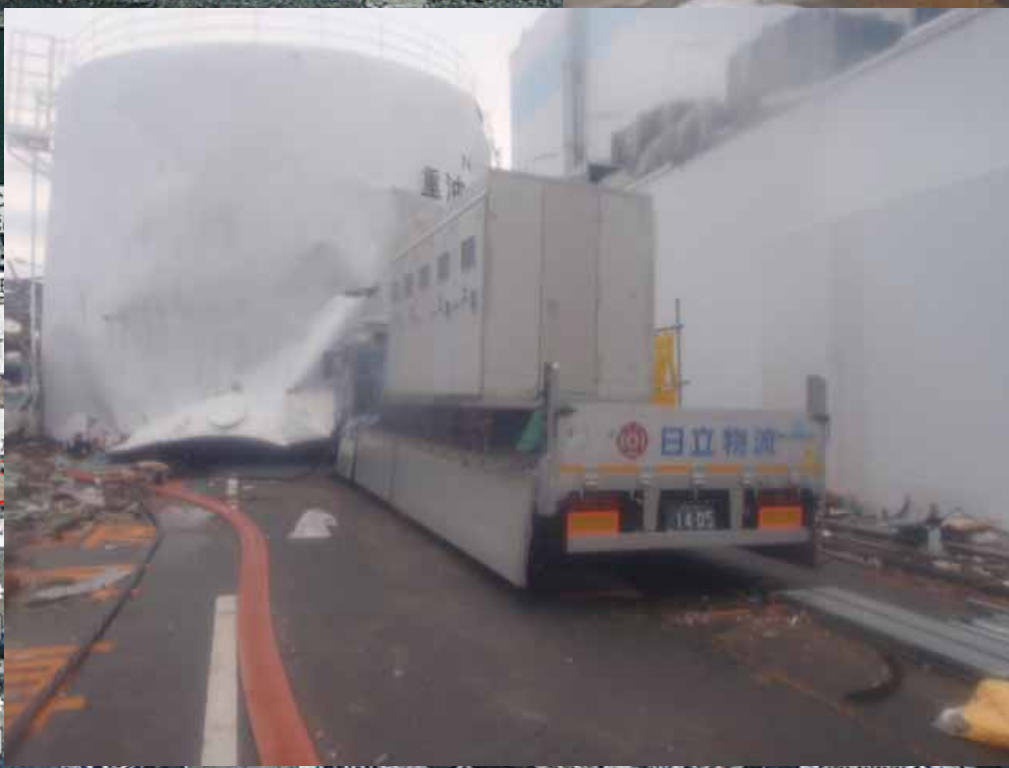
Damages by Tsunami @ 1F (1/3)

Heavy oil tank floated

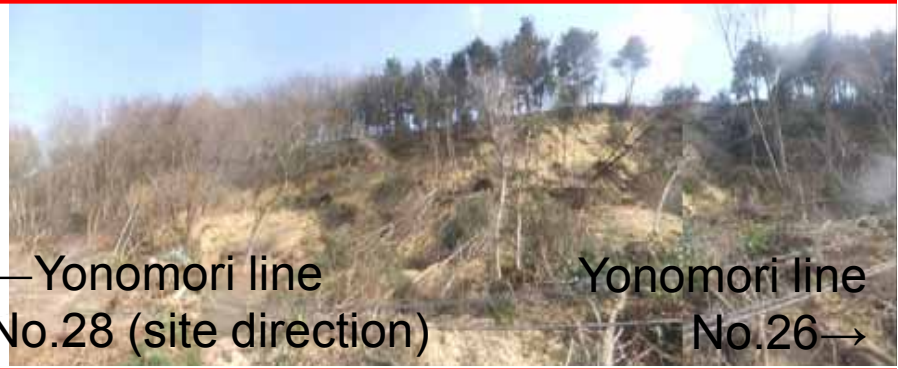
Collapse of filled soil & sand (viewpoint 1)

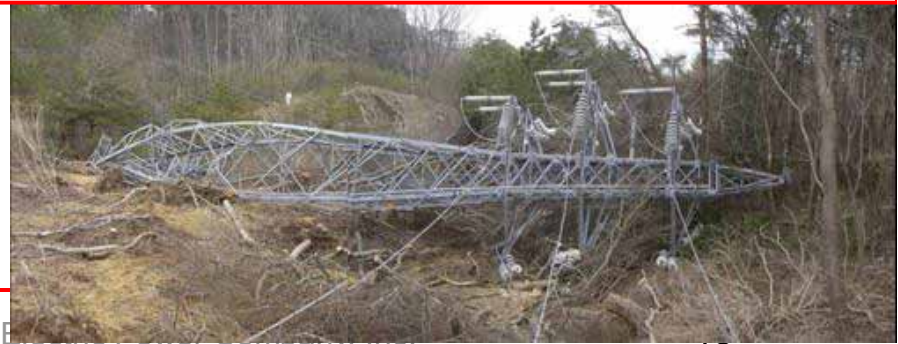
Transmission tower collapse (viewpoint 2)

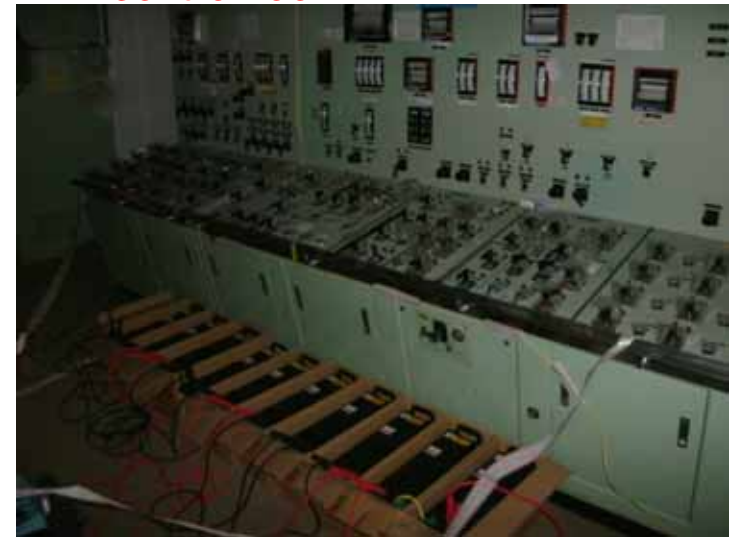
Batteries brought into the control room

- Used **batteries taken from cars** for recovery of important instrumentations.
- Put **Engine-Generators** to provide power for the **control room lightings**.
- Tried to connect a **power supply cart** to **P/C 2C** with temporary cable. The hydrogen explosion of Unit 1 caused damage of the temporary cable.
- Hurdles for the work:
 - **Darkness** and **suspensions due to aftershocks**, tsunami alarms,
 - Puddles, openings of manholes, debris and other obstacles caused by the tsunami,
 - **Influence of the hydrogen explosions**

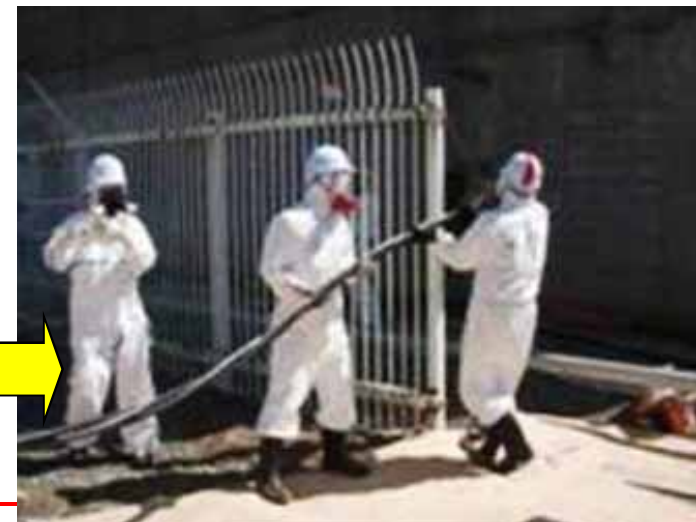
Setting up a temporary power source (2):

Laying of cable was done by man power

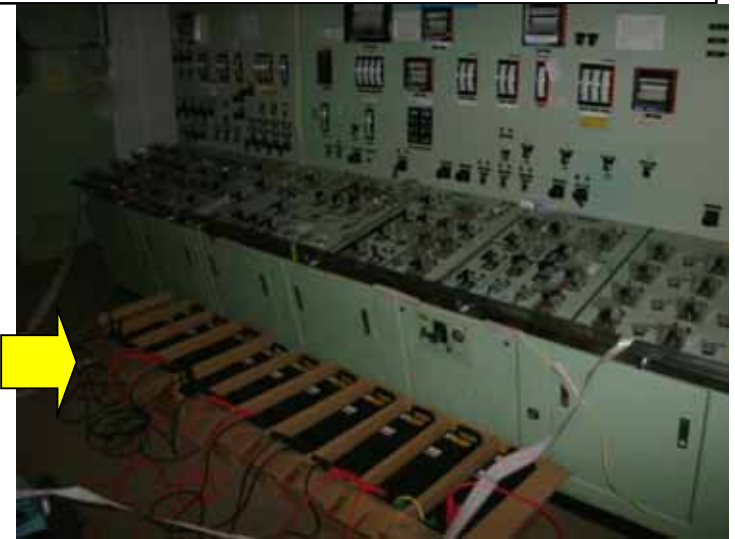
Supervising (1)

Check indicated values only with a flashlight in complete darkness

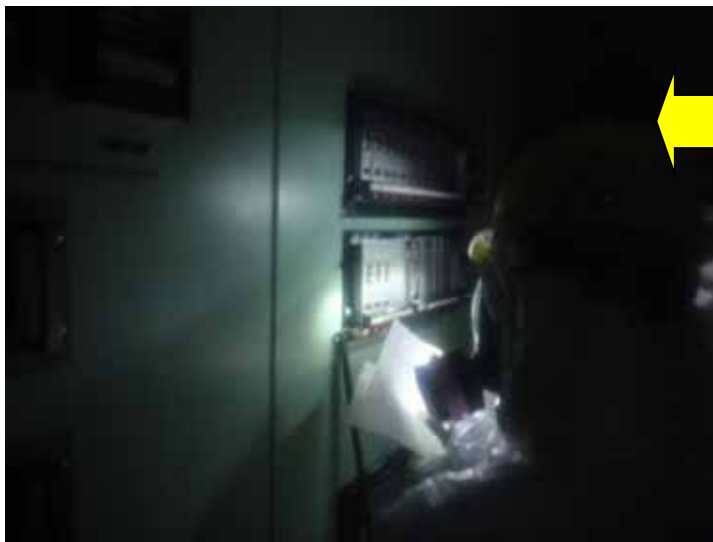
Supervising (2)

Supervising at a deputy supervisor's desk wearing a full face mask in complete darkness

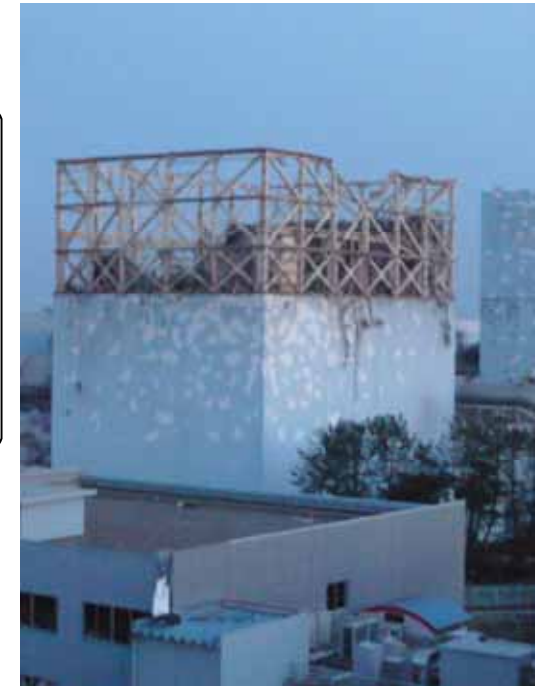
March 12 **15:36** Explosion occurred.
Hoses prepared for injecting sea water were damaged.

- Evacuation from around the reactor building, rescue and transport of injured workers
- Site investigation of the impact of the explosion in order to ensure safety
- Laying out sea-water injection hoses again

19:04 **Injection of sea water started**
